THE ARTIFACT, ITS CONTEXT AND THEIR NARRATIVE: MULTIDISCIPLINARY CONSERVATION IN HISTORIC HOUSE MUSEUMS

A Joint Conference of ICOM-DEMIST and three ICOM-CC Working Groups:
*Sculpture, Polychromy, & Architectural Decoration; Wood, Furniture, & Lacquer; and
Textiles*

The Getty Research Institute, Los Angeles, November 6-9, 2012

Historical and Current Perspectives on the Care, Presentation, Interpretation and Use of Collections in Historic Houses

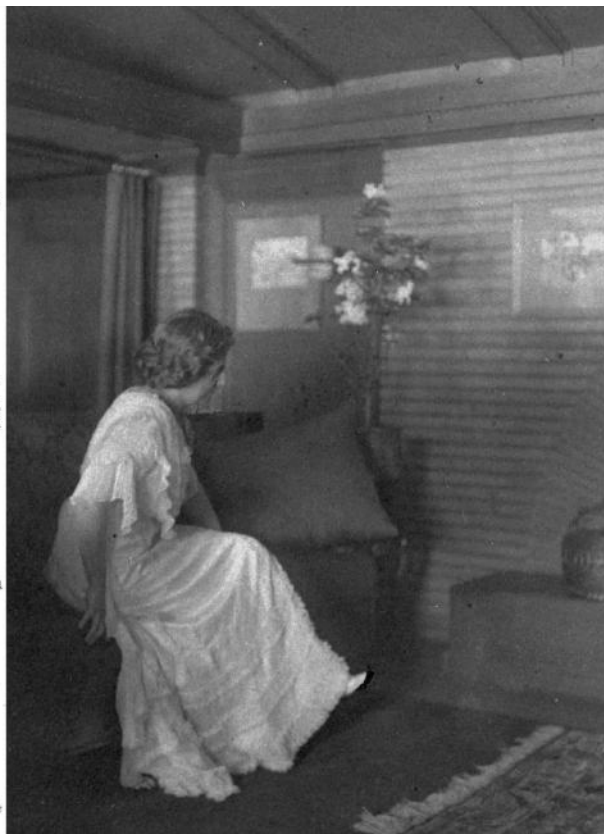
Fig. 2. Left: letter from Wright to Isabel Martin. Right: Isabel Martin in the Reception Room, c. 1912. Note that the prints shown are mounted and placed as Wright suggested in the letter.
©University Archives, State University of New York at Buffalo.

Advances in digital printing encouraged us to experiment with digital copies of the Japanese prints. We went to great lengths to create compelling digital copies, which we termed 'replicas.' The replicas allow us to display the images Wright specified, while preserving the original prints by protecting them from further light damage in archival storage

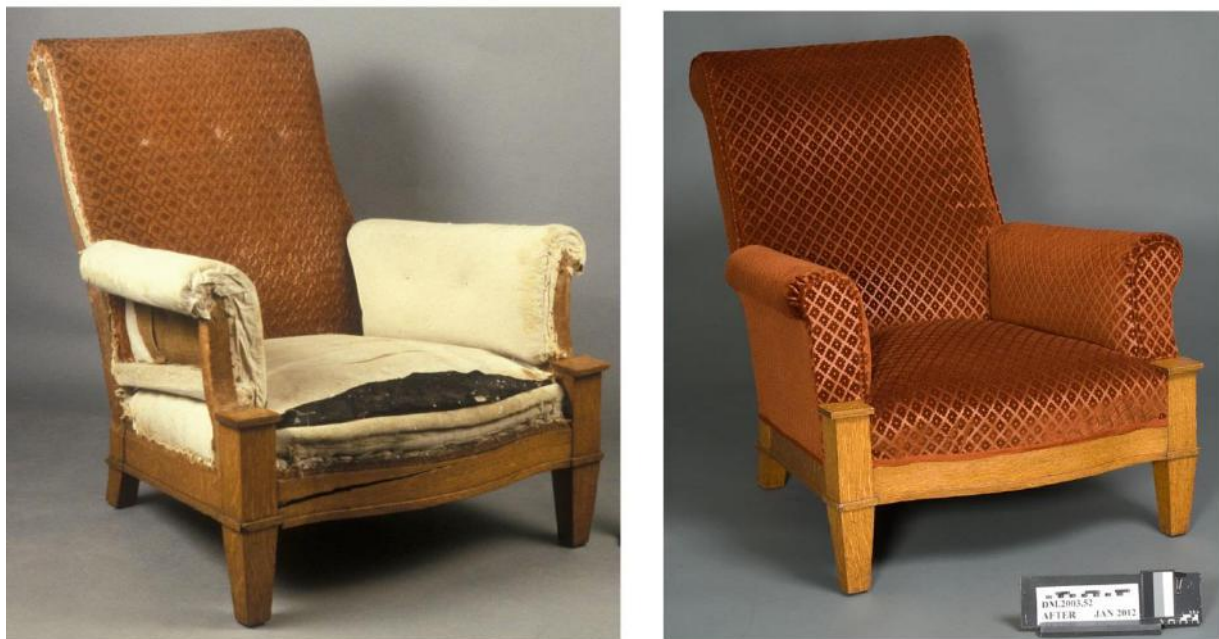
Fig. 3. Reception Room arm chair. Left: original cover preserved on inside back. Right: chair after treatment with new cover. ©NYSOPRHP/Darwin Martin House.

Some pieces required a tremendous amount of study to determine the original fabrics and colors whereas others were more straightforward. On one chair there was ample evidence, as the entire original inside back fabric was in situ. This discovery engendered discussion about conserving and exposing this fabric. If we did this, how should we treat the rest of the chair—with a ‘neutral’ fabric or with one that was similar to the original? Or, should we cover the chair in a replacement fabric? Because the chair would be displayed in the Martin House (vs. in a museum exhibition), the latter option was selected. The original fabric had a fairly generic design, in a still-popular color, so we were able to choose a new fabric from several on the market (Figure 3). The original fabric was retained in situ, and was protected by a Tyvek undercover between the old show fabric and the new.

Decent-sized pieces of the original cover were preserved on another arm-chair; these served as a model for a replacement fabric. The evidence on most of the other pieces, however, was less clear. Six chairs from the Reception Room had fiber/yarn evidence showing that the pieces had been covered with a yellow-gold wool fabric. Knowing this, however, did not make fabric selection easy. Not enough fabric remained to determine its

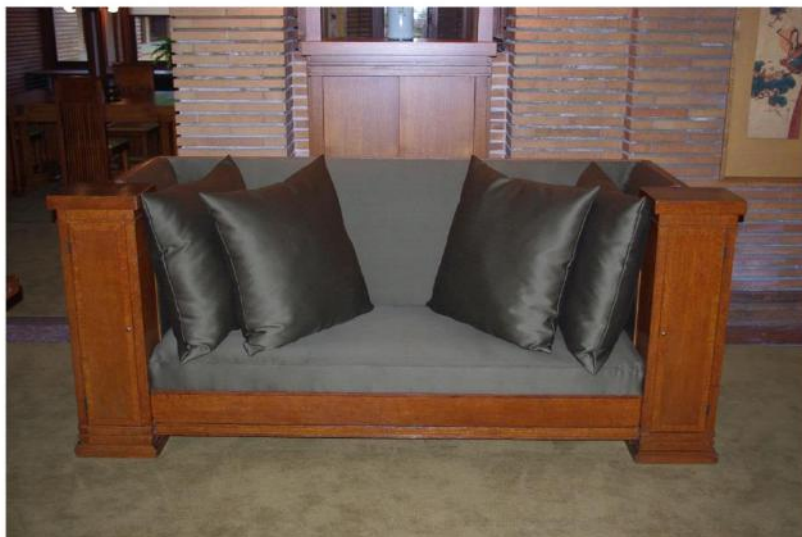
Fig. 4. Top: 1908 view of Living Room, showing sofa. ©Henry Fuermann and Sons, courtesy University Archives, State University of New York at Buffalo and Centre Canadien d'Architecture/ Canadian Centre for Architecture, Montréal.

Bottom: sofa after treatment with new cover.

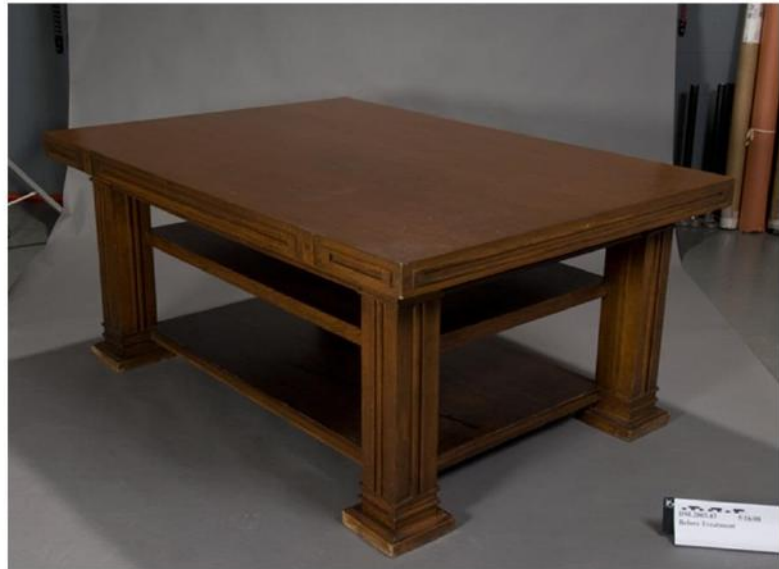
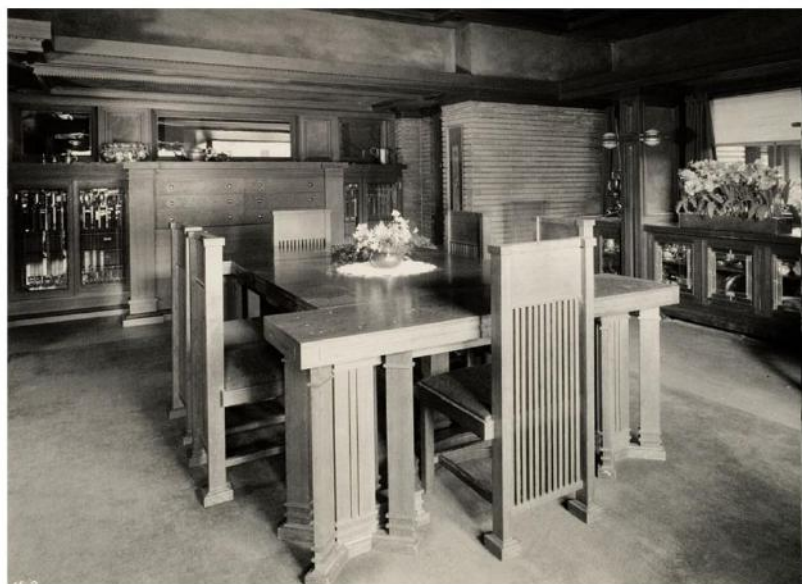
Fig. 5. Top: 'undocumented table' or table fragment. This fragment is now in storage at Peebles Island Resource Center Waterford NY. ©NYSOPRHP/Darwin Martin House.

Bottom: 1908 view of Dining Room, showing table. ©Henry Fuermann and Sons, courtesy University Archives, State University of New York at Buffalo and Centre Canadien d'Architecture/ Canadian Centre for Architecture, Montréal.

The furniture that came to BHS for conservation included a table with two shelves that looked like a possible Wright design (Figure 5). This table did not appear in any of the historic photographs, Wright's drawings, Wright-Martin correspondence, or descriptions of the furnishings. Historic photographs and Wright's drawings did, however, show two other tables; one in the Library and one in the Dining Room. These rooms are at either end of the long, rectangular space that Wright called the Unit Room, composed of the Dining Room, Living Room, and Library (Figure 6). The tables are crucial to the interpretation of the Unit Room, as they not only anchored it, but also counterbalanced the views out the art glass windows. The historic drawings and photographs show the two tables were of similar shape. With twenty legs each, and built-in planters and candelabra, they were altar-like in appearance. Without these unique and complex tables in the furnished spaces, it would be difficult for curators, conservators, and especially visitors, to understand Wright's Unit Room design.

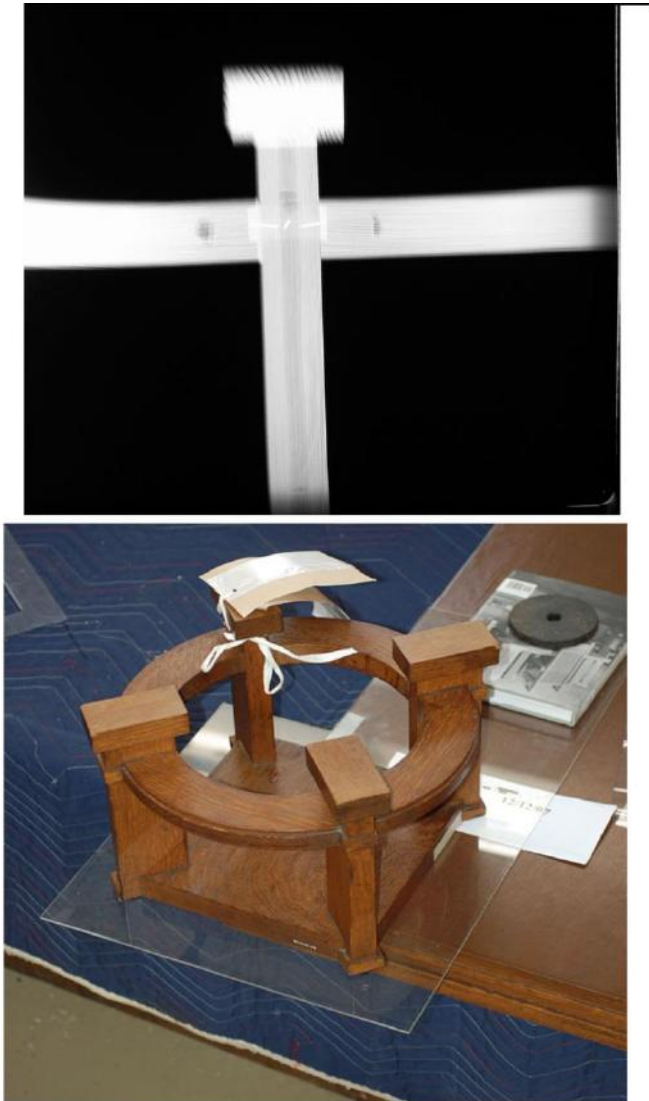
Fig. 7. Top: radiograph of ‘stanchion,’ showing hole for electric wiring. Bottom: table fragment top with ‘stanchion’ place on it; acrylic sheet indicates how corner of original table was cut off. ©NYSOPRHP/Darwin Martin House.

The furniture conservator began an intensive study that incorporated detailed examination and radiography of the undocumented table and two ‘stanchions’ (wooden structures that Wright had designed to support the planters at the corners of the tables), including identification of the function of every hole on the undocumented table, as well as close scrutiny of the original Wright drawings and period photographs (Figure 7). The study not only gave the furniture conservator the opportunity to explore in great depth the construction of two pieces of Wright furniture but proved that the ‘undocumented’ table, now understood to be a fragment, was the extremely modified remains of the library table. The analysis established that both the dining and library tables had been built as Wright had designed them. The study also demonstrated that it would not be possible to reverse the changes that created the surviving fragment. To complete the restoration of the Unit Room, it would be necessary to have reproduction tables.

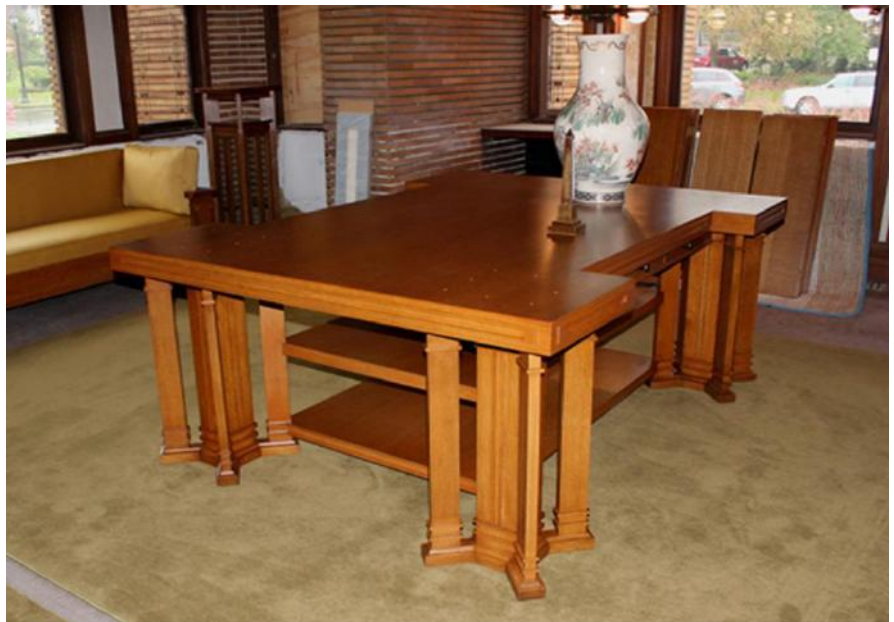
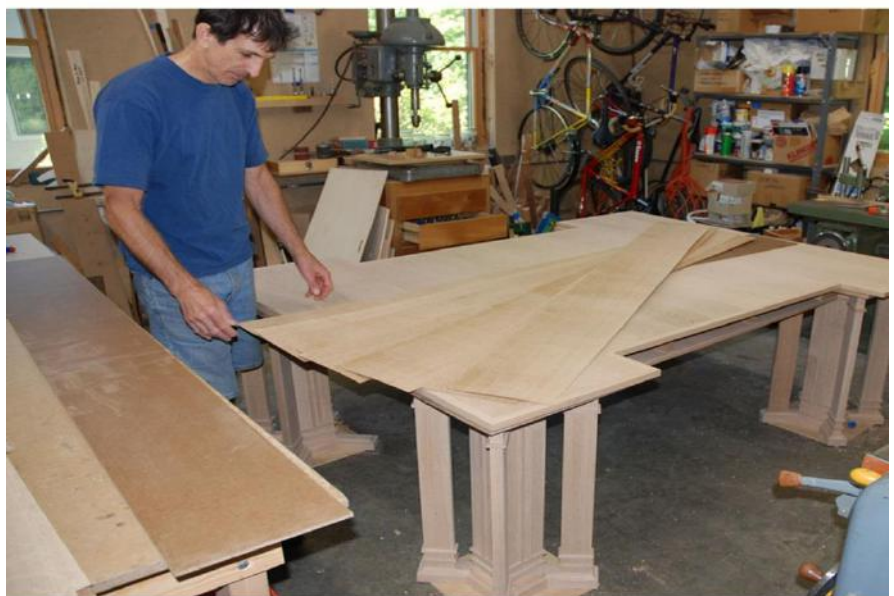
Fig. 8. Top: 2011 view of Library showing reproduction table. Bottom: Tim Coleman selecting veneers for table.

The furniture conservator convinced the MHRC to commission accurate reproductions of the tables and in collaboration with Alex Carlisle, furniture conservator and furniture maker of Williamstown, Massachusetts, made the working drawings. After a national search, Timothy Coleman of Sheffield, Massachusetts was chosen to make the tables. The learning process continued as we worked together on additional construction features. Coleman made the tables using hand-sawn veneers with all the wood coming from a single tree. The result was a high-fidelity match to what remained of the original table, even in terms of the wood grain and ray pattern (Figure 8).

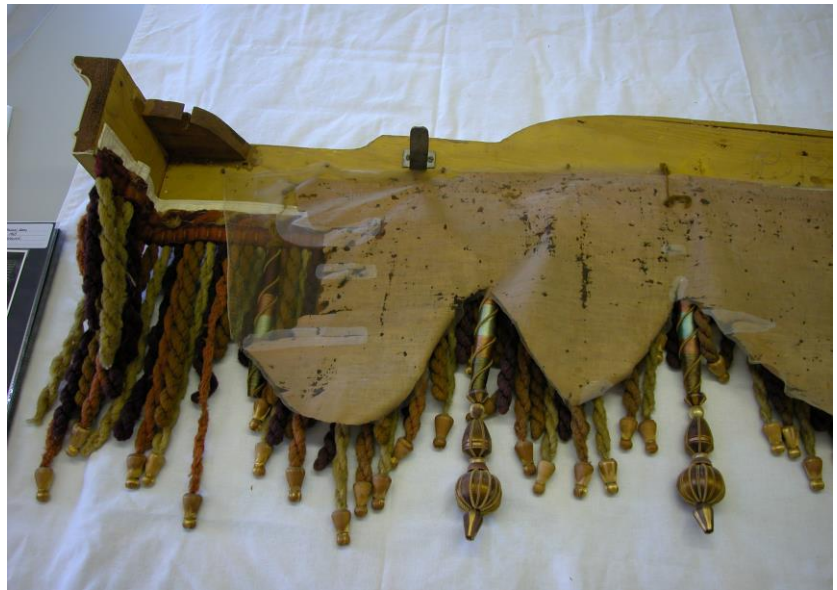
Fig. 1. Fragment of a bobble fringe from Rouse Hill House and Farm (Scott Hill). Published with the permission of the author.

Here is the kind of conservation problem that we, as professionals, all face every day in a house museum. Consider this fragment of the bobble fringe that is currently in the drawing room at Rouse Hill House to the north west of Sydney [1]. The fabric has now been conserved three times and is basically silk dust on a fabric backing. It needs conservation again. What should we do? Should we conserve it again? Should we preserve the original in a box and put in a replica? Should we put it in a box and put up something different or should we do nothing at all, leaving it to gently rot in situ?

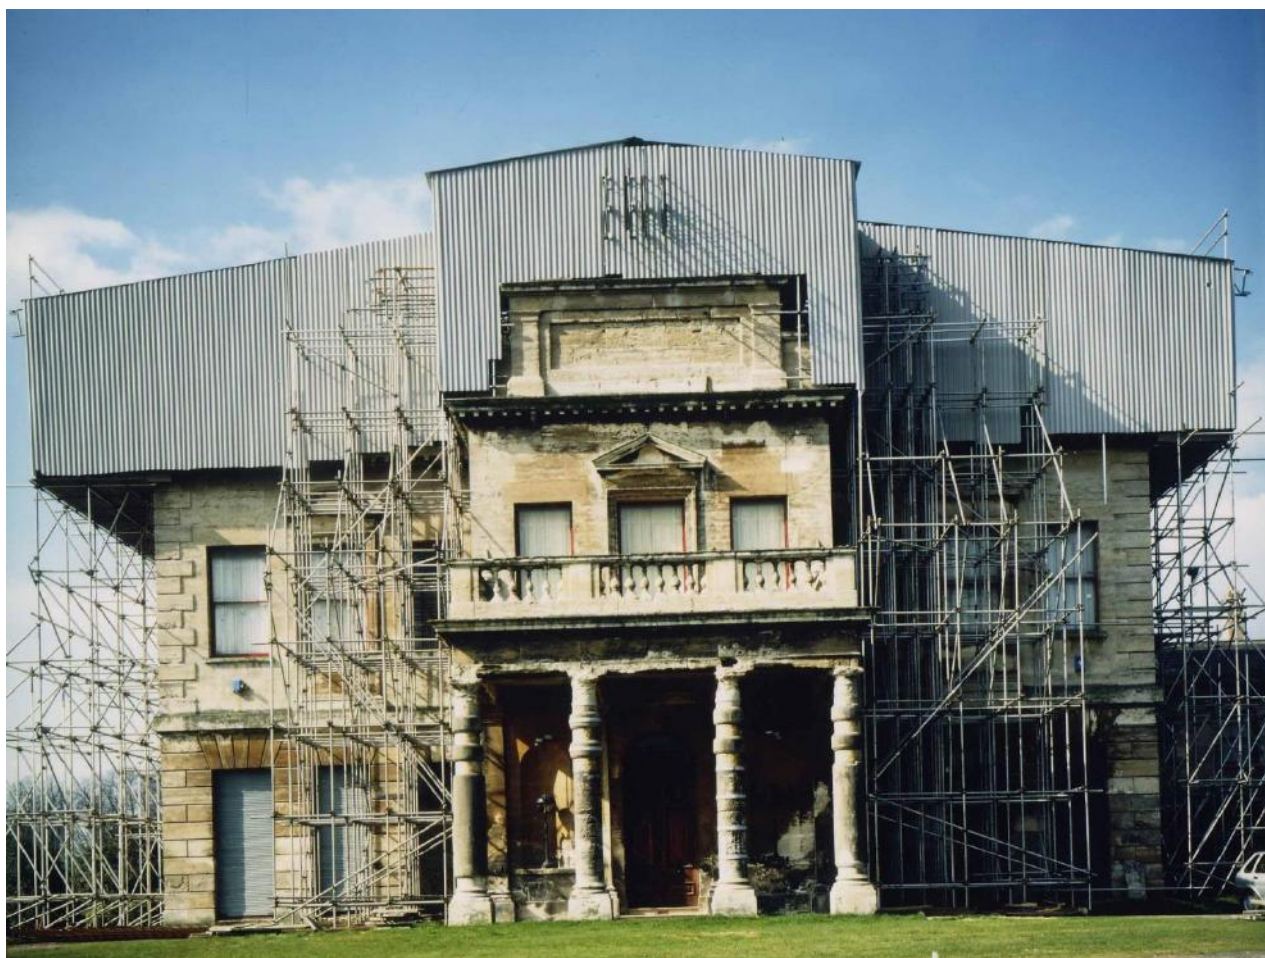
and badly eroded limestone walls were repaired, and all the services replaced. Inside, painstaking work was required to clean and stabilise the decoration, as far as possible without renewing or recreating lost elements. As a result, the fragile interiors have a well-worn and dilapidated air.

Fig. 4. Exterior conservation in progress. © English Heritage

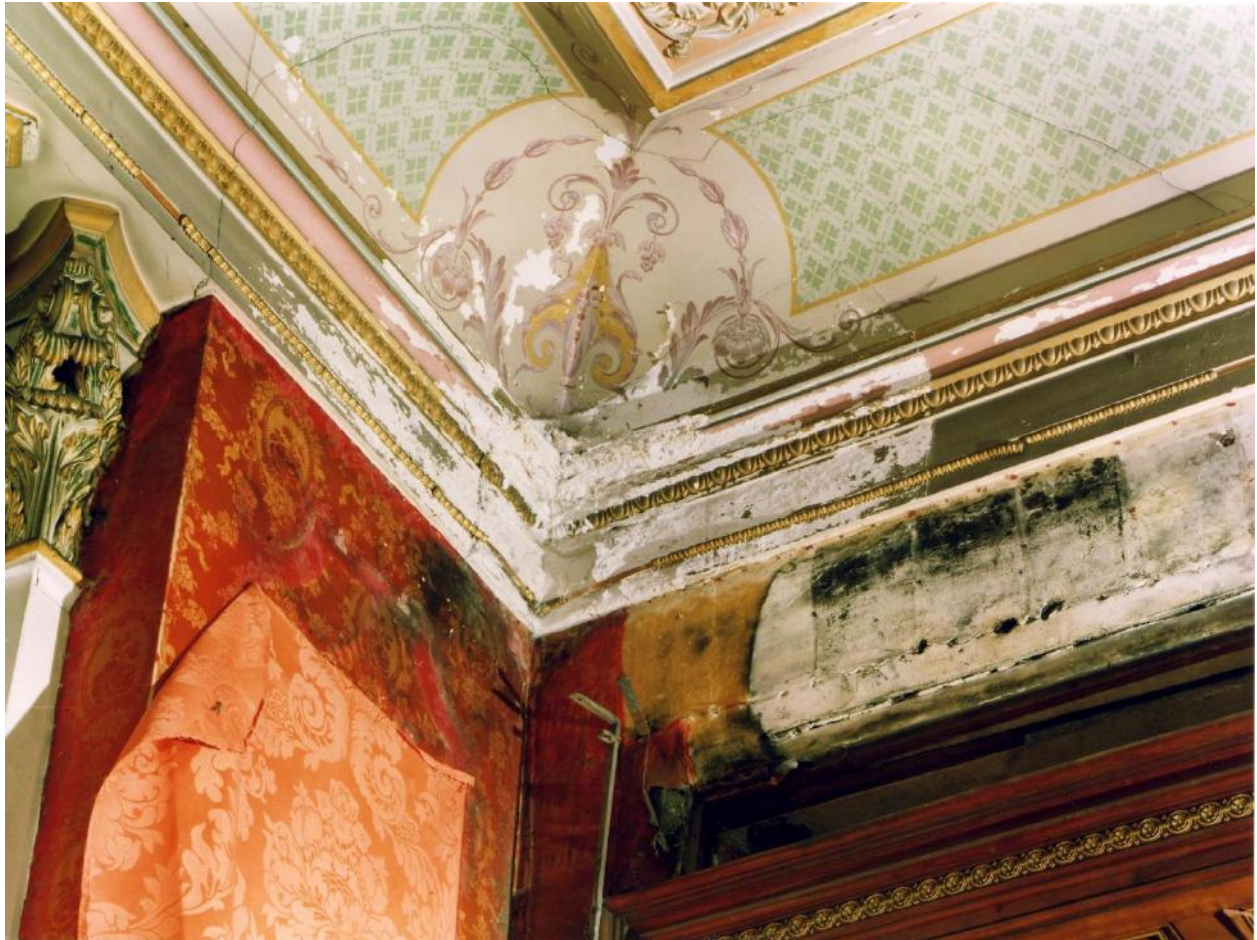
Fig. 6. Damage caused by water ingress. © English Heritage.

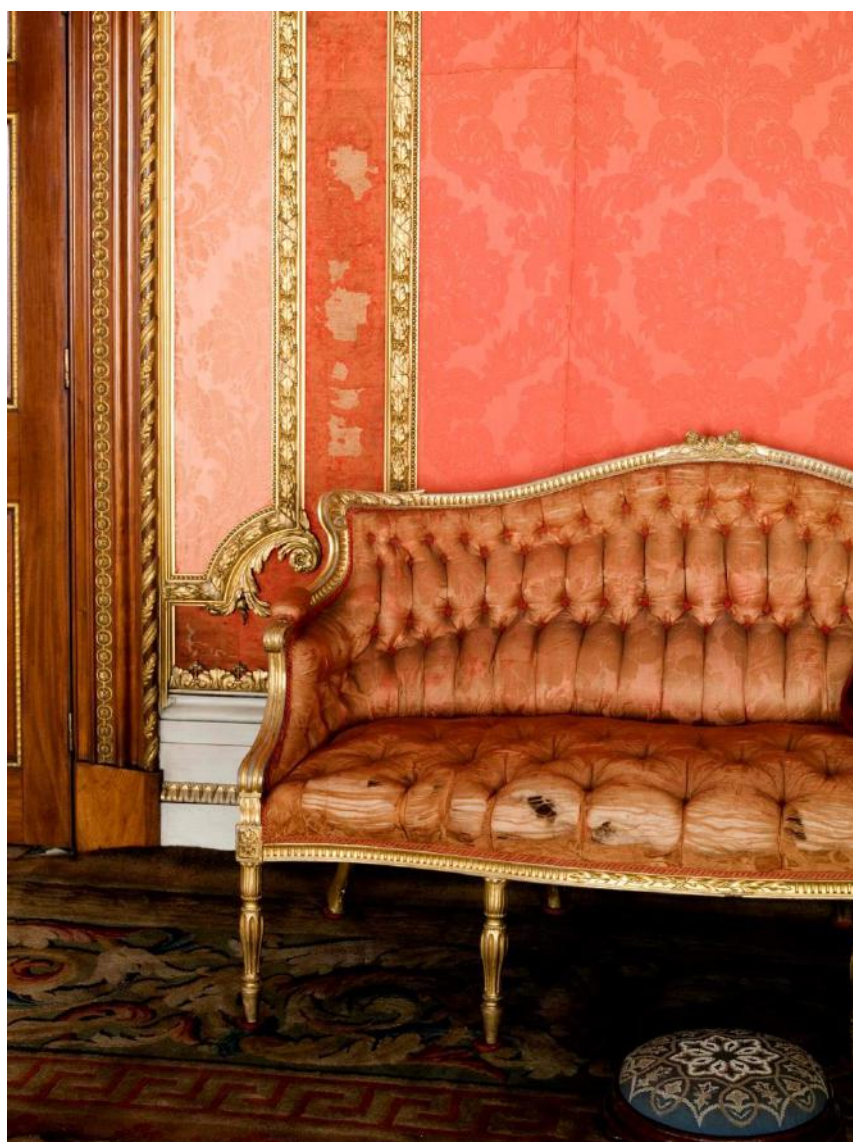
The uncontrolled environment in the house during the latter part of the twentieth century had a particularly detrimental effect on the Victorian silk furnishings. In view of this, we wanted to ascertain the optimum environment for increasing the life of these fragile textiles. The research, which focused on improving preventive conservation of historic silks on open display, came up with some sobering conclusions [Luxford et al, 2010]. The key finding suggested that the long term effects of temperature and humidity appear to be more critical for silks, than light. Therefore, RH levels should be kept low (between 30 and 50 per cent), temperatures should also be kept low (every reduction of ten degrees will double life-expectancy) and, if dyes are stable, the light levels can be raised. This research also predicted that silk could be expected to survive for 250 years at 20 degrees and 50 per cent RH. At 75 per cent RH and 24 degrees the life-expectancy would fall to 125 years. This poses a serious concern for Brodsworth. If we combine historic conditions with current achievable conditions, we have to face the fact that the silks are close to the end of their life. With the predicted rise in temperatures relating to climate change the justification for continued investment in remedial treatment and environmental control is open to question [Lankester & Brimblecombe, 2012].

Fig. 7. Silk furnishings after conservation. © English Heritage.

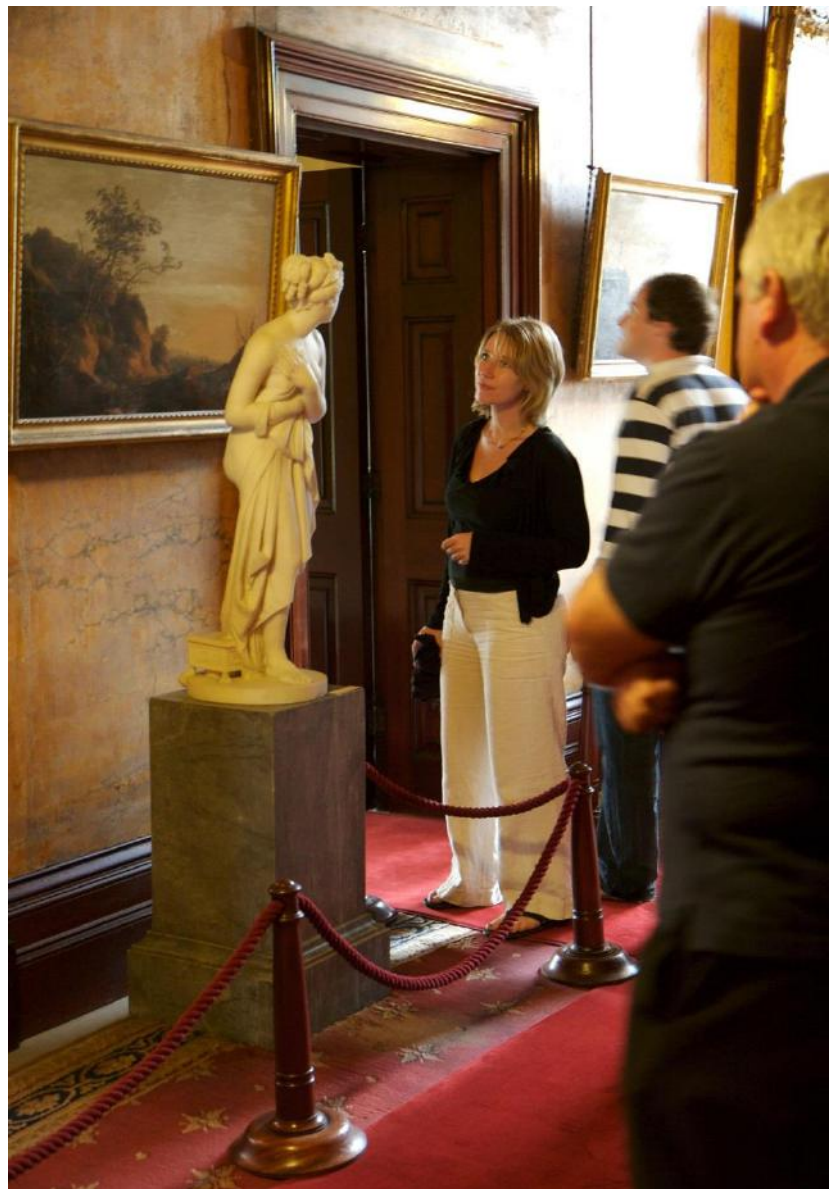
The most striking introductions to the house were the replica carpets in the main thoroughfares where the original carpets were most damaged. Partly practical and partly interpretative, they allow visitors to experience the grand circulation spaces without the visual intrusion of barriers. Elsewhere, visitors are guided through the rooms along drugget runways bounded by ropes. Research into the condition of the carpet fibres under the druggets, which are made of wool with a polyester felt underlay, concluded that no significant damage is being caused to the carpets confirming that the carpet protection is working [Tetley, 2012]. However, although the colours and materials were carefully chosen to be sympathetic, they remain very intrusive. Despite this drawback, they seem to be the only way to allow free-flow visitor movement. There has been a campaign recently to remove barriers from historic houses. The jury is out on the long term implications of a ‘no-ropes’ policy but we do not feel it is appropriate for Brodsworth’s fragile interiors.

Fig. 8. Ropes and druggets at Brodsworth Hall. © English Heritage.

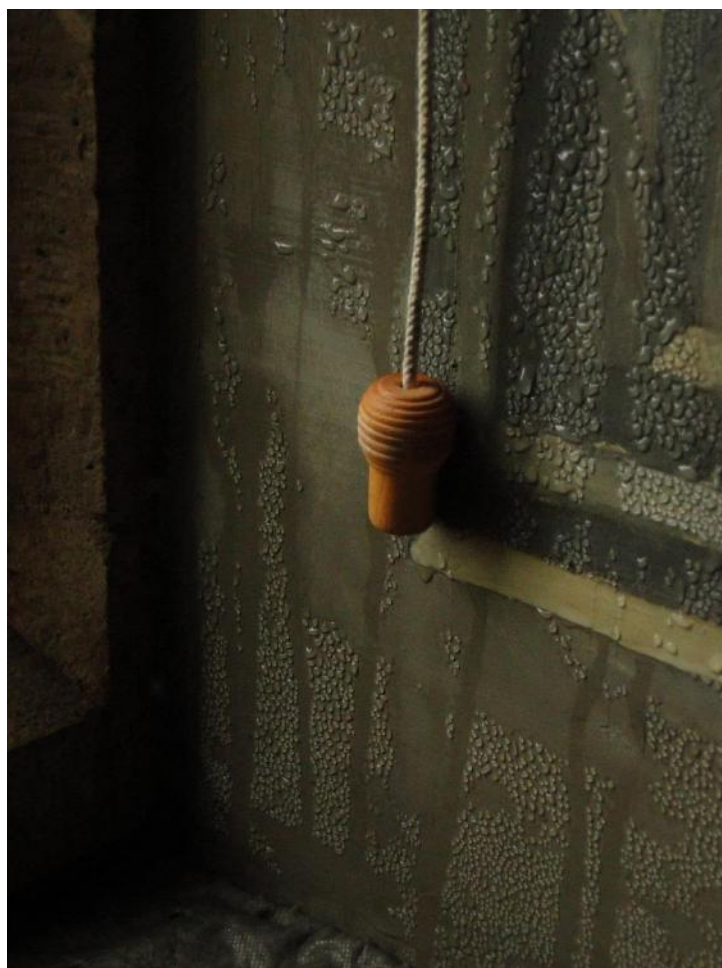
Fig. 3. Condensation on historic wall paintings, Knole. ©Emily Watts

Problems with visitors not understanding what they are observing, and therefore not enjoying their visit to Knole, are compounded by major conservation issues at the property today. The leaking roofs, crumbly walls, failing windows and poor wiring have all contributed to a place that is losing its battle with the outside elements. There is no heating in the showrooms and the relative humidity levels reach 90 per cent and above in winter. As a consequence, the condition of the highly significant collection is deteriorating.

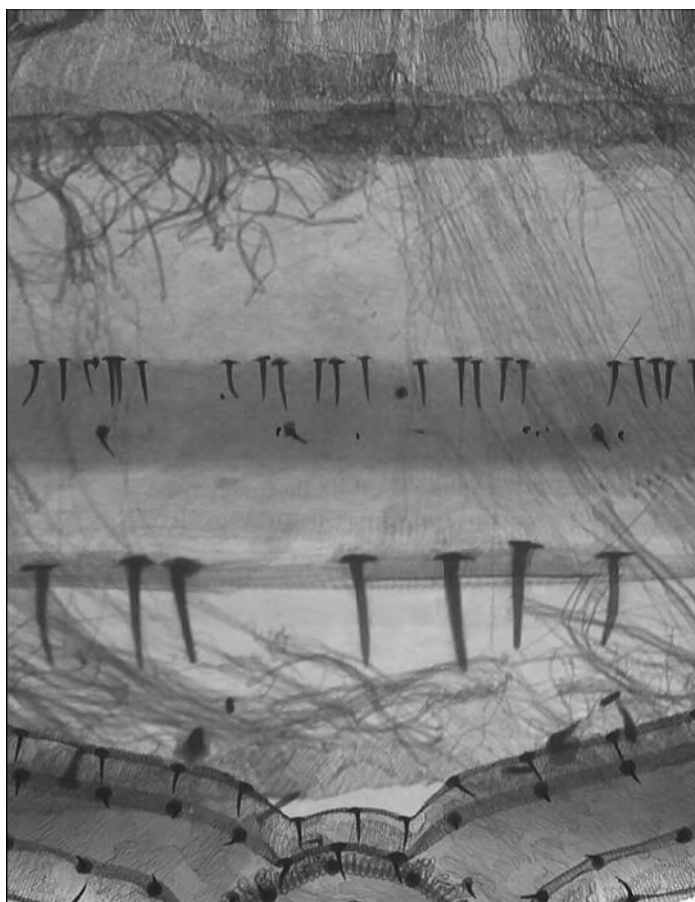
Fig. 4. X-ray image of furniture at Knole. ©NTPL

Last year, as part of a project to carry out detailed documentation of some key pieces of furniture in the collection, Kate Gill, an independent upholstery conservator worked with a company to produce X-radiographies of furniture. The images show details of construction, tacks used, modern interventions using screws for repairs, the presence of tarnished and degraded gold and silver threads, layers of upholstery and of course the tunnels and damage caused by woodworm. The potential for using X-radiographs as a tool for condition assessment, and to aid conservation decision making and curatorial studies, is well known by conservators and curators alike. The resulting images, beautiful in themselves, were fascinating and provided a focus for a popular exhibition for the uninitiated visitors.

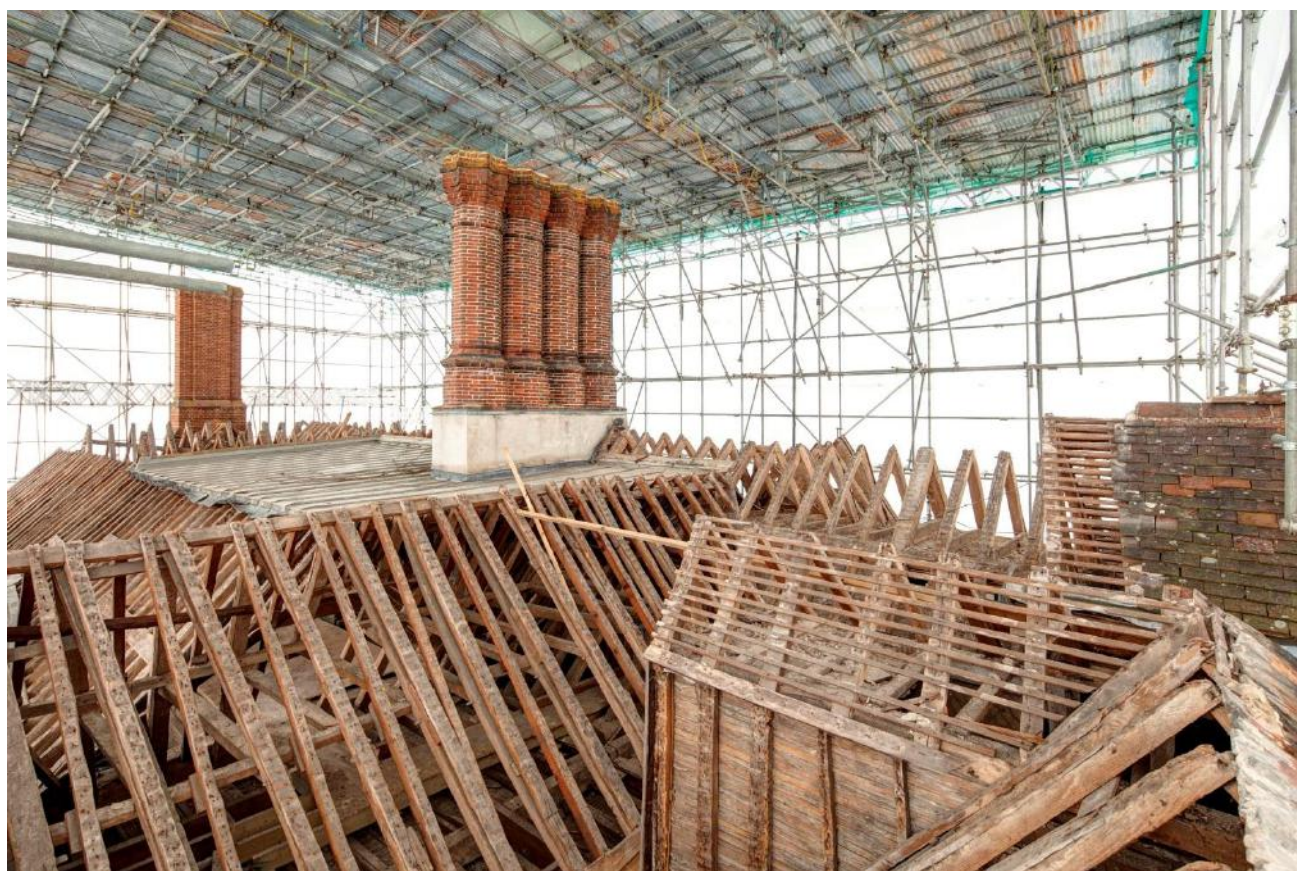
Fig. 6. Building repairs to roof, Knole. ©NT/J Millar

This year has seen the start of the biggest challenge at Knole so far – to secure the building envelope at Knole through essential roof, wall and window repairs which will stop the rain and elements getting in. The work is extremely interventive: roofs will be stripped of tiles and repaired, inappropriate cement render will be replaced with lime, and windows will be removed and conserved. By carrying out this work, conditions within the showrooms will be improved and progress can then be made on tighter environmental control and collection conservation. However during the work there would be a huge impact both on the collections and the visitors to Knole. Collections needed to be protected from possible dust ingress and impact damage, and visitors have to remain safe, but also informed and excited by the project. Their continued support is vital. After careful risk assessments, it was determined that both collections and visitors could remain in the showrooms affected by the building work. It was hoped that by being allowed to see into the heart of the building work, visitors would understand the scale of the problems at Knole and be supportive of the project being undertaken.

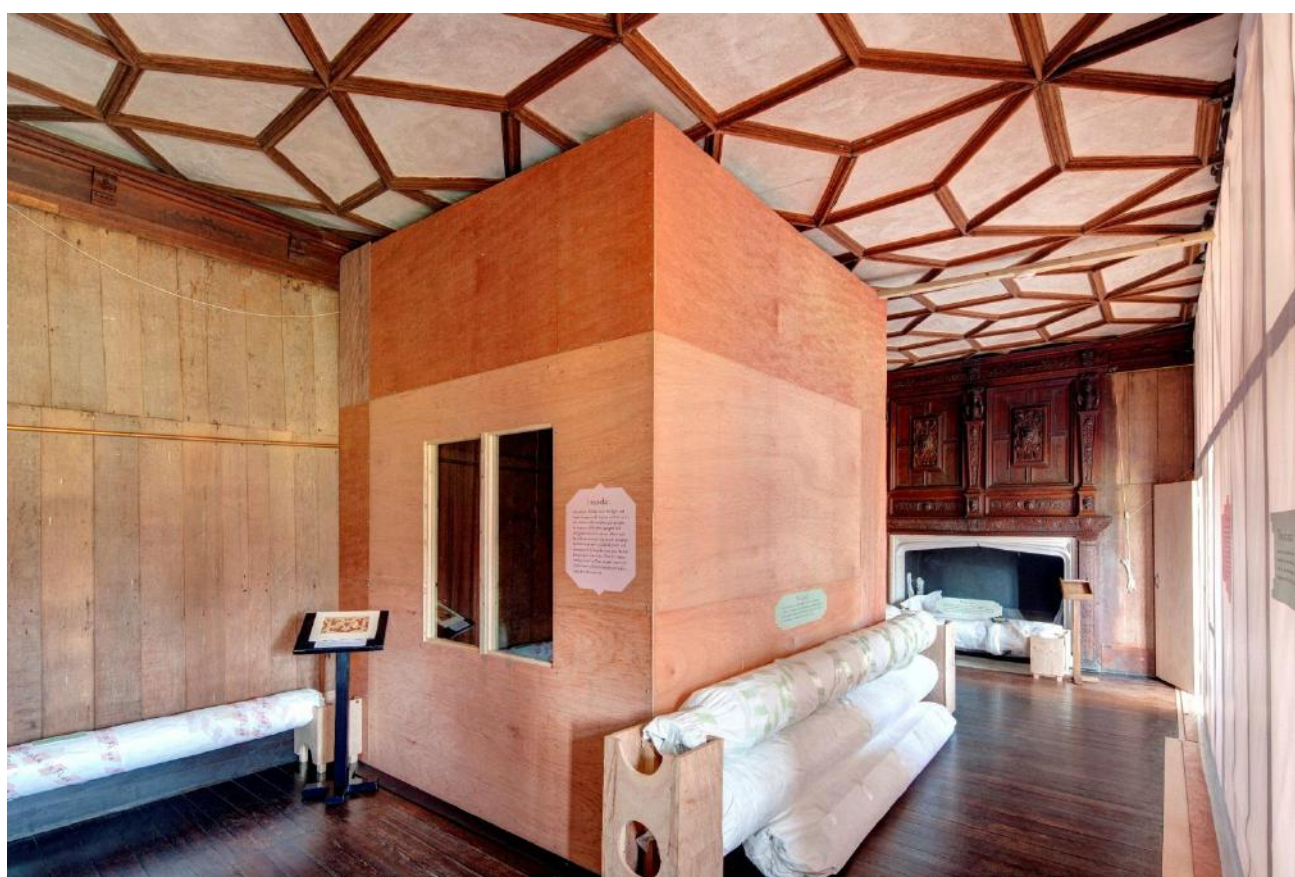
Fig. 7. Protection in showrooms. ©NT/J Millar

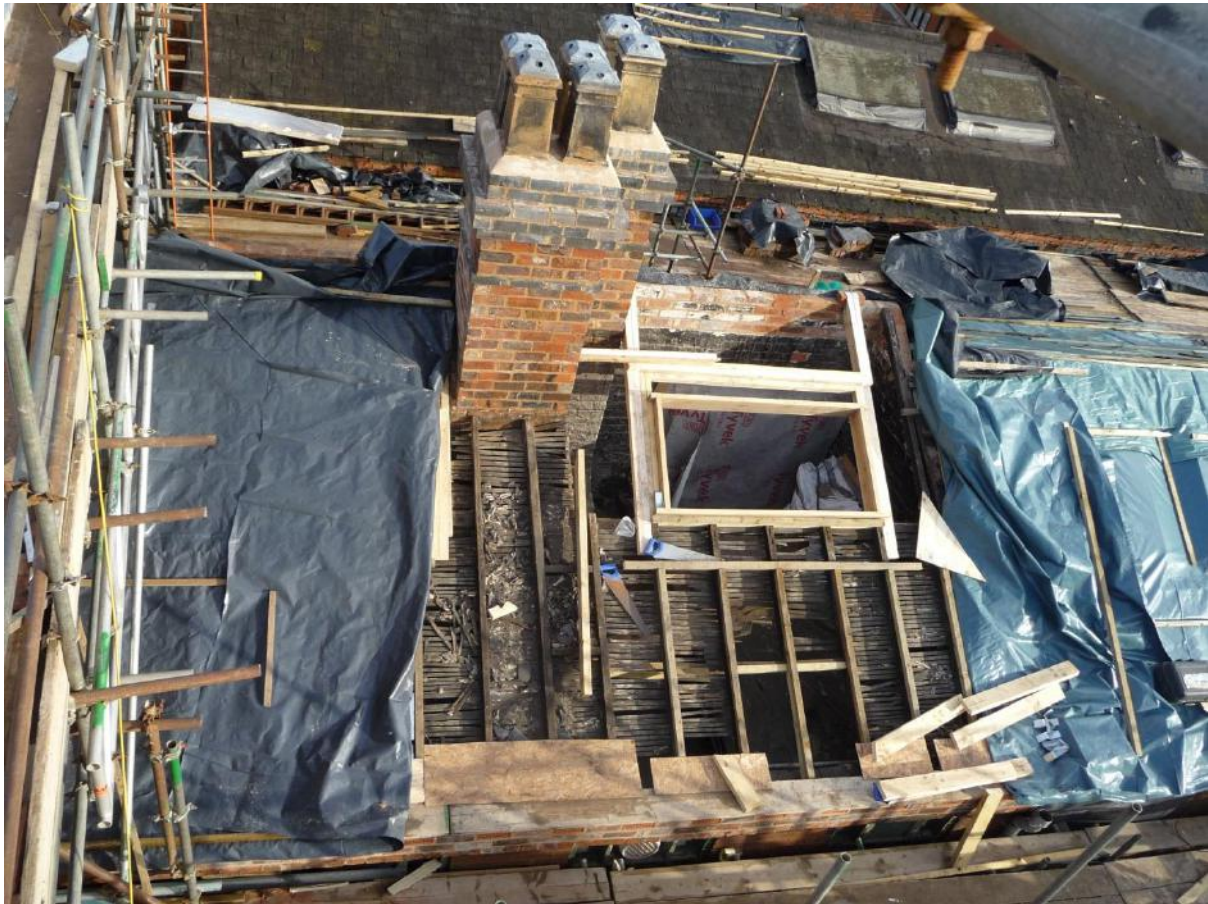
The scaffolding strategy proved to be justified. As the roofs began to be stripped and worked upon, it became clear that the plaster and lathe ceilings were in worse condition than the survey had indicated. Large parts of the ceilings were loose and some fell down as works began, but the scaffolding stood up well to these surprises and kept the spaces below clean and accessible. A great deal of supervision was required during installation due to the spaces being very narrow, difficult to negotiate with long poles and crowded with objects (not to mention dealing with the machismo attitude of the scaffolders). However, once in place, the platforms allowed the contractors to work freely above the rooms without being in contact with any contents (Figure 5).

Fig. 5. External works over protected rooms © English Heritage

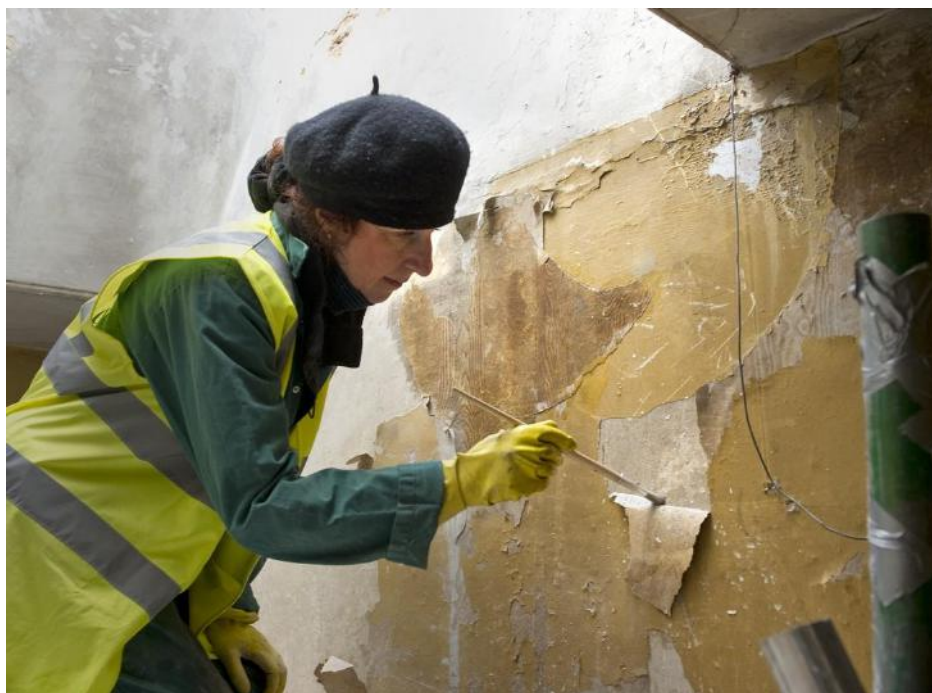
Fig. 6. Consolidation of interior surfaces. © English Heritage

Consolidation (but no redecoration) of the most deteriorated surfaces was carried out, both to slow deterioration and to make maintenance of the building and machinery practical. Vulnerable plaster edges were reinforced with a new plaster edging applied to prevent further crumbling filleted, flaking paint and plaster surfaces consolidated and peeling wallpaper was re-adhered to give greater strength (Figure 6). However a pragmatic approach had to be adopted due to the number and scale of the deteriorated surfaces. In very friable areas the loosest areas were gently brushed down, before the remaining area was consolidated. There was a programme of dust removal in certain areas, for instance in corners where the dust sealing failed and white plaster dust had fallen onto a cluster of objects. As ever this was not as straight forward as it might have been, with comic discussions of what was new and what was ‘historic’ dust, before a light hand with a pony hair brush and vacuum cleaner was employed.

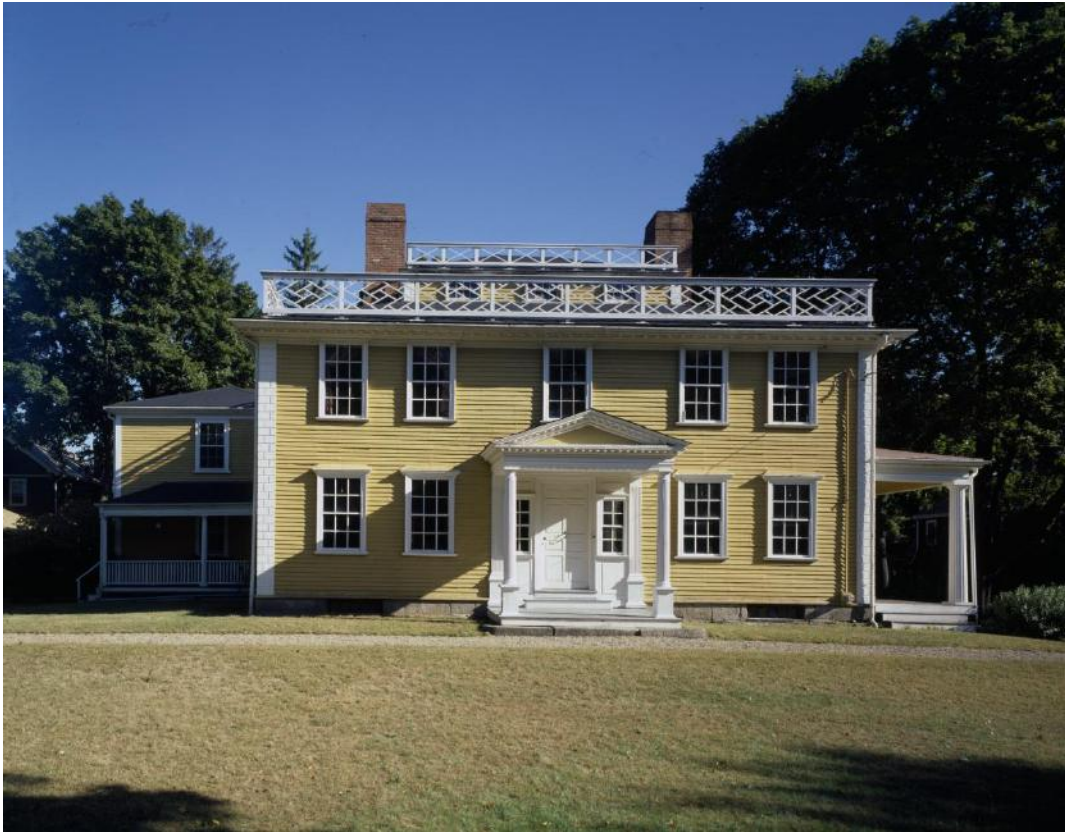
Fig. 6. Exterior of Quincy House, 1770, Quincy, Massachusetts in late 1990s with Colonial Revival paint scheme. ©Historic New England

Every year PPIP reviews the projects each team is planning to ensure the appropriateness of the project in relation to presentation of the property. As guided by an institutional preservation philosophy, the general approach to the sites is to respect the historic fabric and materials that are there and, as in the case more typically of the building preservation work, when an exterior treatment like the roof or paint needs to be renewed or replaced it is replaced with the same material or in the same color that was on the building. The genesis of PPIP in the late 1990s was related to a simple painting project. The building preservation team was preparing to paint the exterior of an early Georgian style house in the yellow base color with white trim it had long been painted (Figure 6). For many years other teams in the organization had been moving towards a 1880s interpretation of the house, which required a different color. Without the central unification under PPIP there was little discussion of work plans and overall interpretation. As painting scaffolding was being deployed at the house discussion began amongst collections and interpretation teams about the opportunity to paint the house in its 1880s paint scheme. The building preservation team, in the end, did not object to this change, but this did represent a shift in both thinking and process. At the end of the project the house was painted in its 1880s palette and PPIP was formed to provide better coordination for future projects (Figure 7).

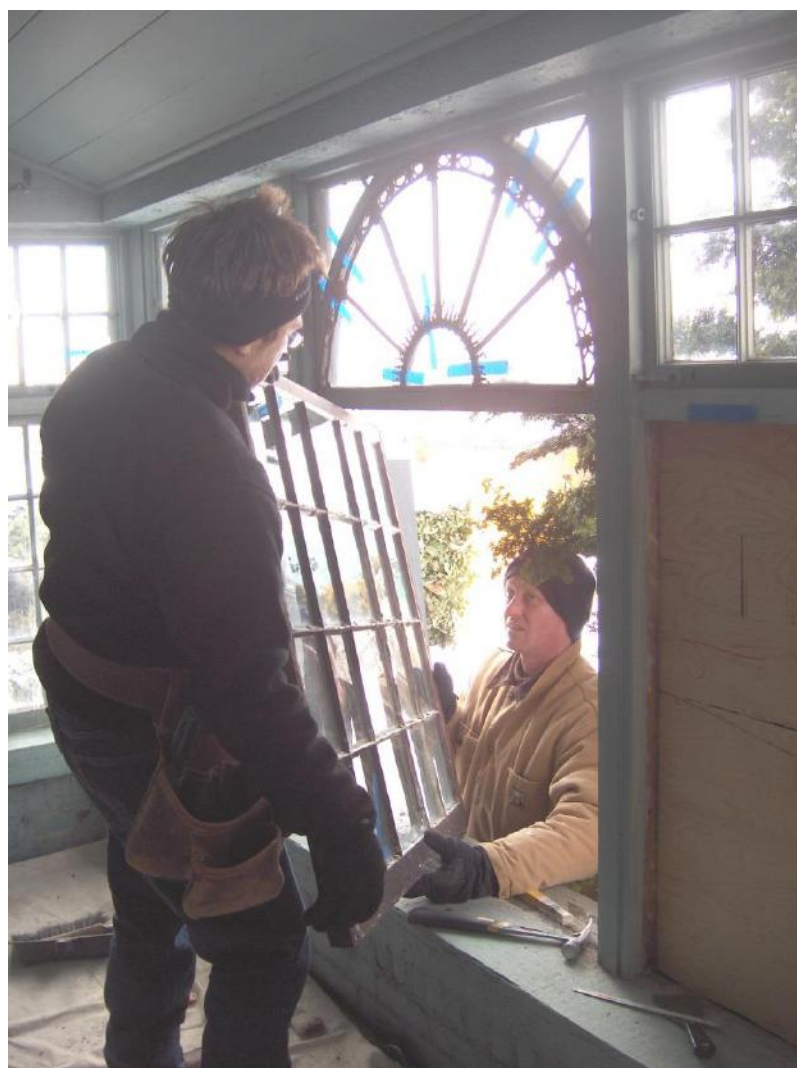
*Fig. 10. Windows being removed for conservation work at Beauport.
©Historic New England*

On the technical side, the window conservation component of the project provided excellent opportunity to begin discussions about our approach to ultraviolet (UV) protection. In order to maintain objects, historic fabrics, and wall coverings, Historic New England began installing various forms of UV protection in the 1970s and 80s. The installation mainly included thick acrylic panels cut to fit the entire size of the sash and screwed directly into the

frame from the interior. Unfortunately, this approach resulted in a microclimate and created severe condensation issues throughout the house, resulting in interior paint deterioration, failure at the bed glazing, and wood rot. Collections were thus being protected at the expense of building fabric. The damage caused by these installations was well known, but no coherent conversation had taken place to develop a mitigation strategy (Figure 10).

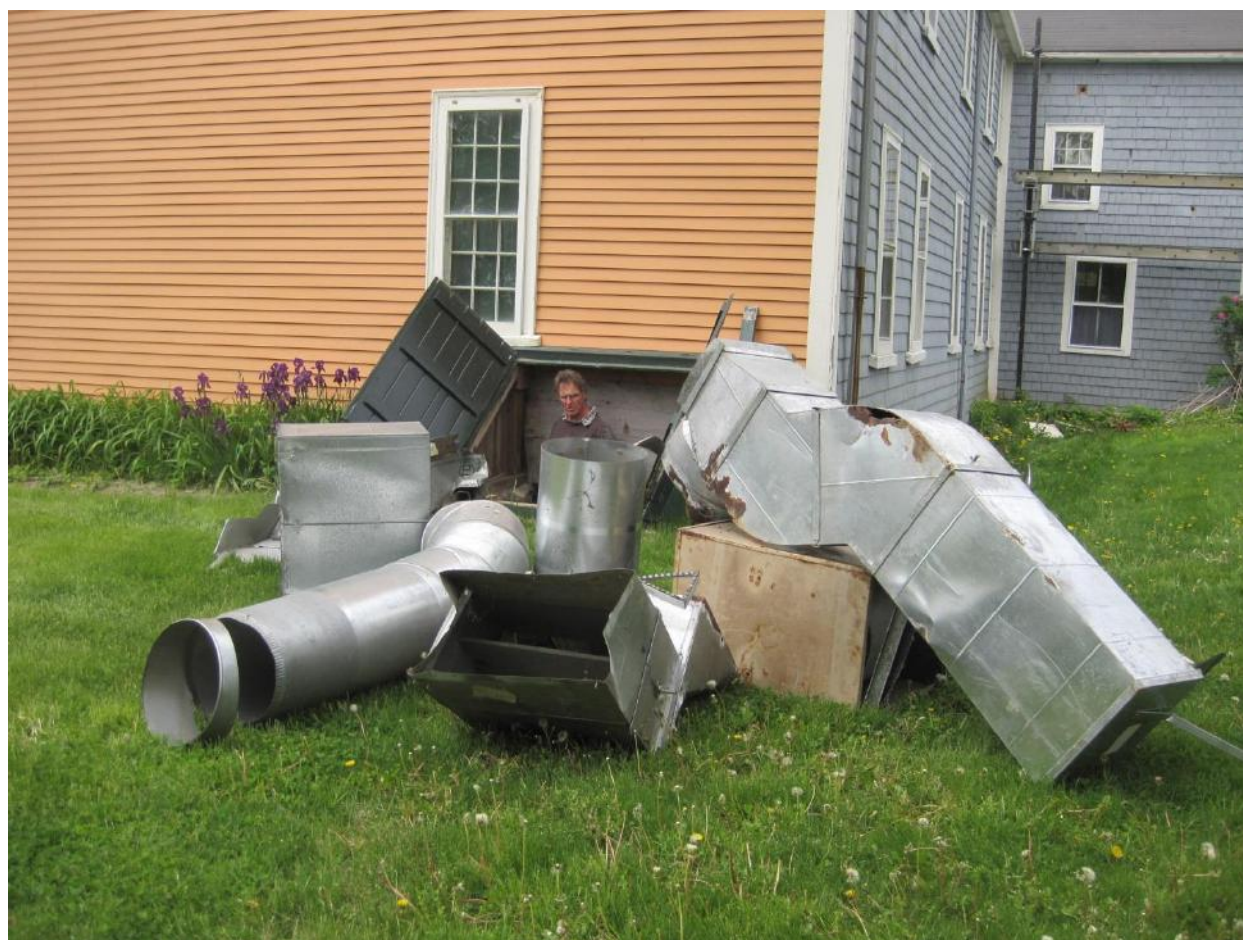
Fig. 11. Remnants from the decommissioned 1990s environmental system at Cogswell's Grant, 1728, Essex, Massachusetts.
© Historic New England
