THE ARTIFACT, ITS CONTEXT AND THEIR NARRATIVE: MULTIDISCIPLINARY CONSERVATION IN HISTORIC HOUSE MUSEUMS

A Joint Conference of ICOM-DEMIST and three ICOM-CC Working Groups:
*Sculpture, Polychromy, & Architectural Decoration; Wood, Furniture, & Lacquer; and
Textiles*

The Getty Research Institute, Los Angeles, November 6-9, 2012

Historical and Current Perspectives on the Care, Presentation, Interpretation and Use of Collections in Historic Houses

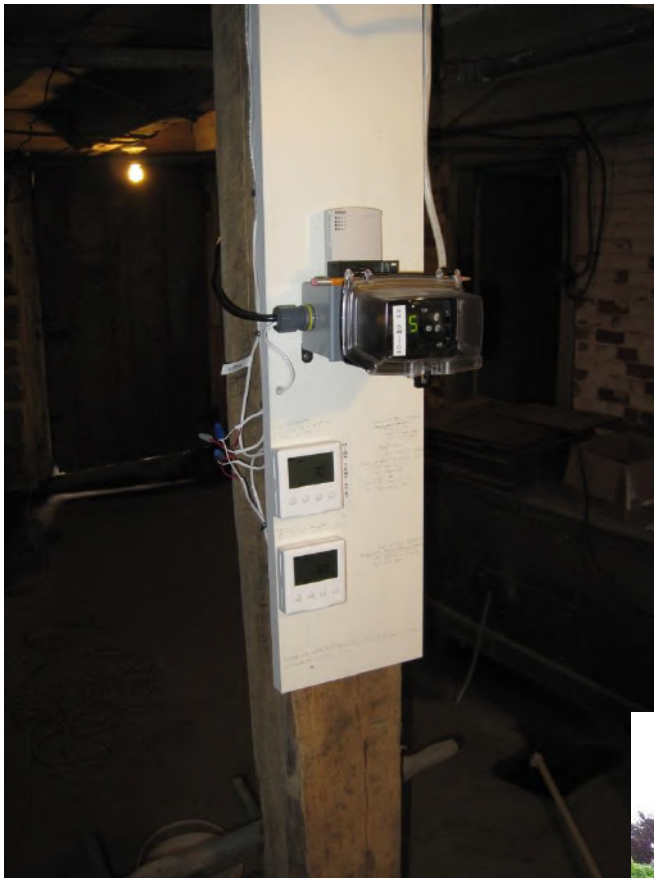
Fig. 12. Installation of a simplified environmental control system includes a thermostat and a humidistat. © Historic New England

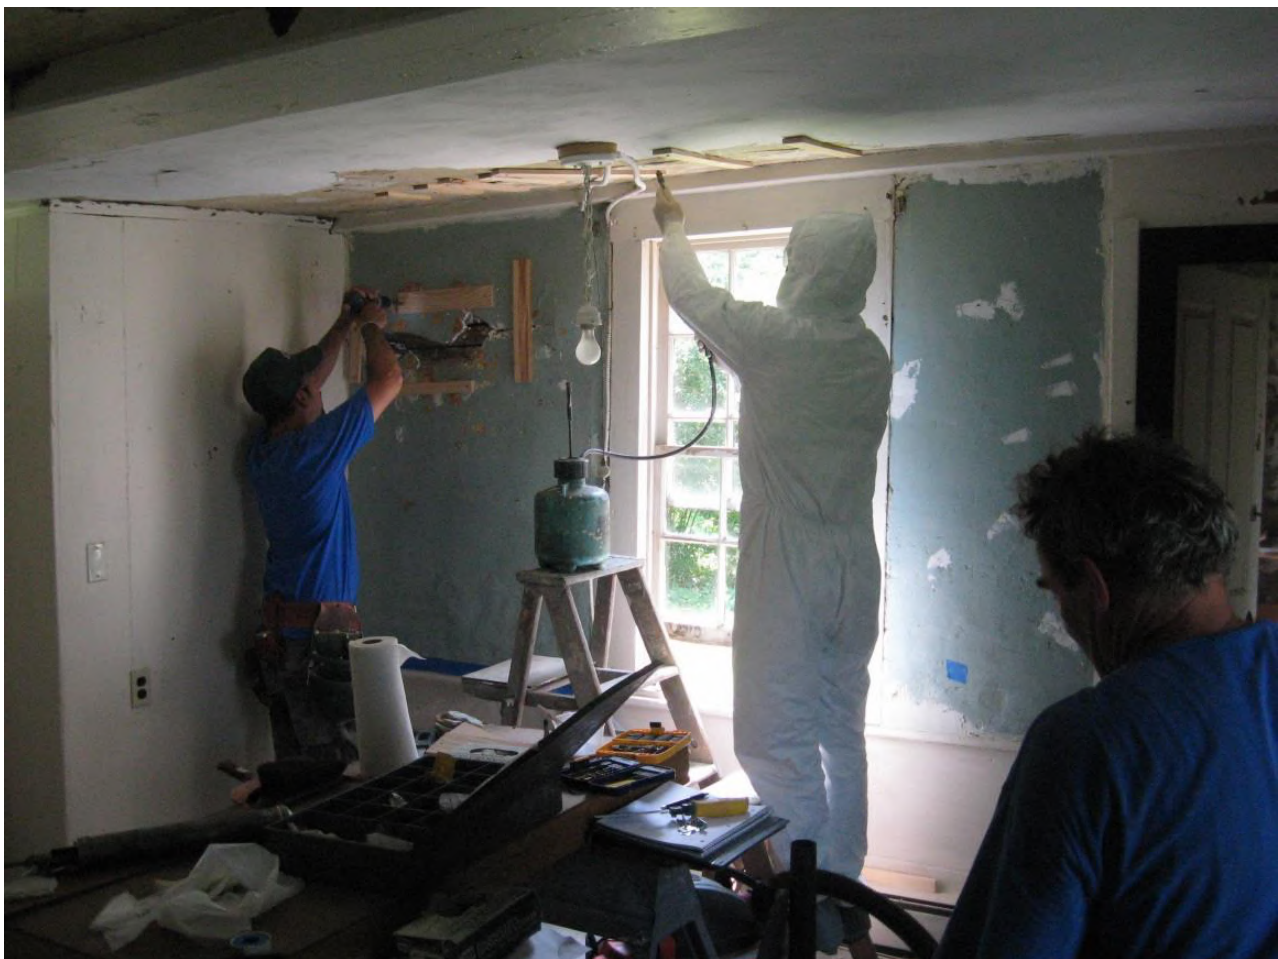
Fig. 14. Plaster conservation and repair in kitchen of Stekionis tenant farmhouse, Spencer-Peirce-Little Farm, 1690, Newbury, Massachusetts. ©Historic New England

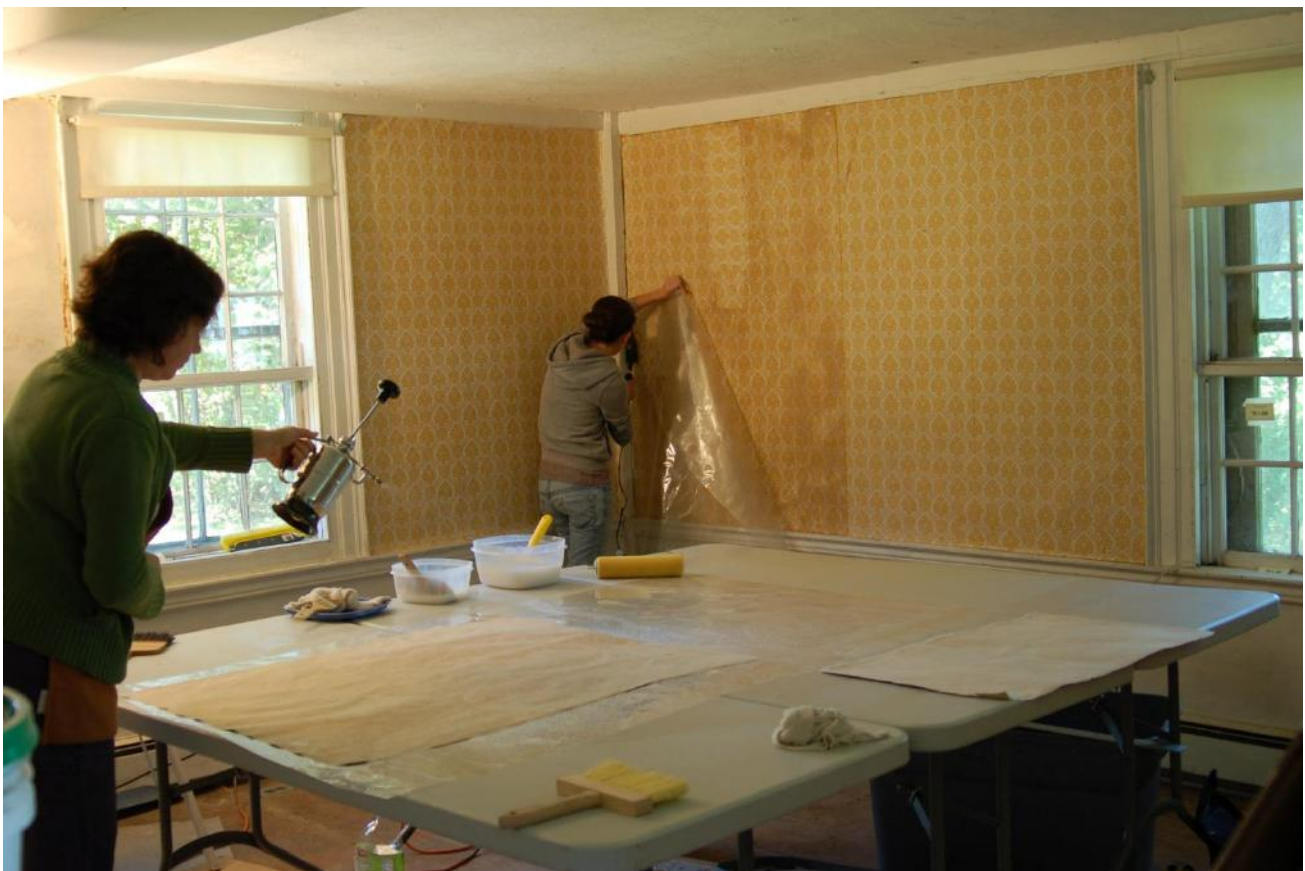
Fig. 15. Installation of conserved wallpaper in parlor of Stekionis tenant farmhouse, Spencer-Peirce-Little Farm, 1690, Newbury, Massachusetts . ©Historic New England

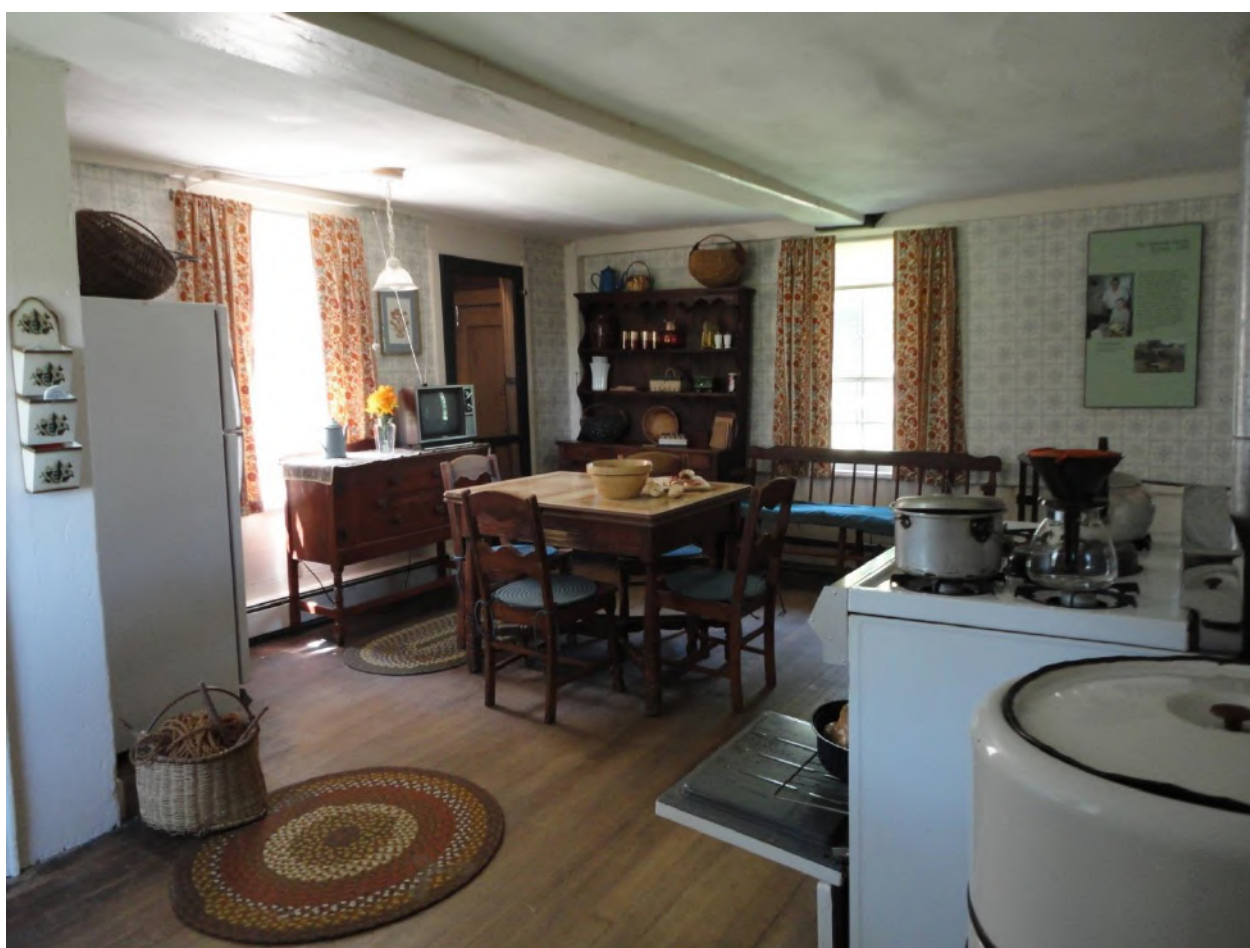
Fig. 16. Completed installation of kitchen of Stekionis tenant farmhouse, Spencer-Peirce-Little Farm, 1690, Newbury, Massachusetts. ©Historic New England

All of the furnishings and objects were removed from the first floor rooms and brought to Historic New England's conservation lab for cleaning and stabilization. As with the finishes in the house, the goal of the conservation treatments was to present the pieces as they would have looked after years of use, rather than as they looked when they were new. The furnishings range from an overstuffed set of parlor furniture from the 1930s, to the clothes washer in the kitchen purchased in the 1960s. Using photographs, inventories, and the recollections of the Stekionises' daughters, Historic New England staff reinstalled the family's furnishings to appear as they did in the early 1980s (Figure 16).

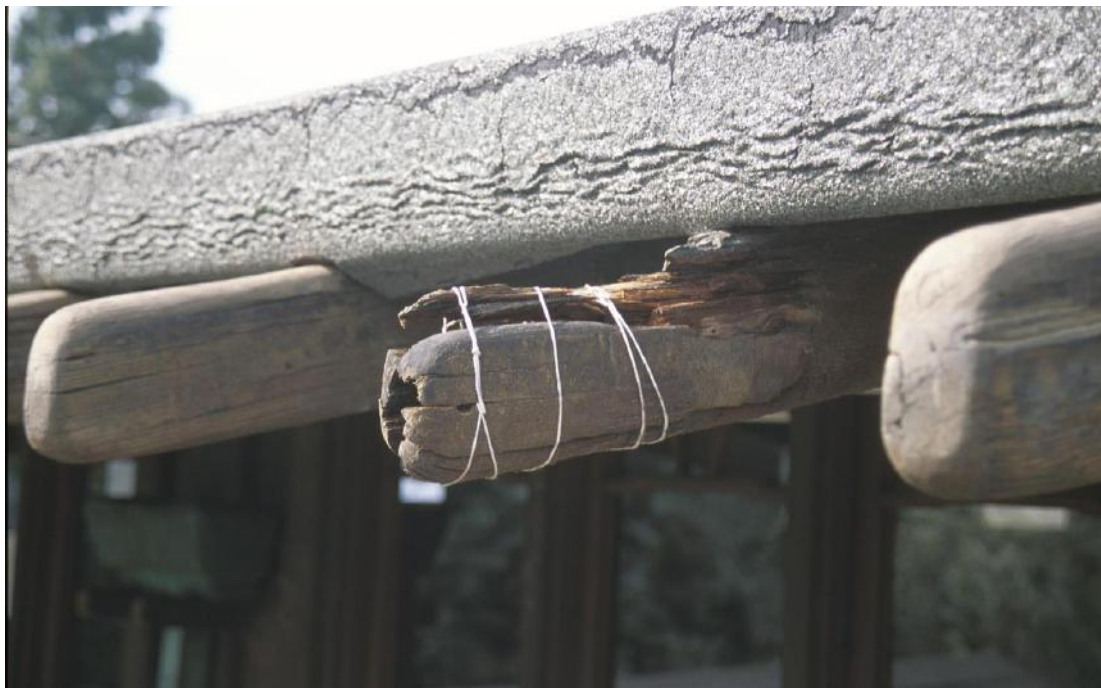
After decades of outdoor exposure, the exposed ends of many rafter tails and beam ends were infected with a common fungus that consumes wood. Previous repairs filled wood losses, and impermeable epoxy exacerbated continuing damage by not allowing water to evaporate. The environment was ideal for fungal growth. Flowering bodies emerged from the surface of some rafter tails (Fig. 2).

Fig. 2. Rafter tails before restoration. Courtesy Historic Resources Group

Rotted wood was removed from 262 rafter tails and beam ends, leaving all sound wood intact. The principal conservator, John Griswold, revised the earlier treatment by using materials that perform better under these circumstances. The wood and new patch repair materials are more compatible to changes in temperature and

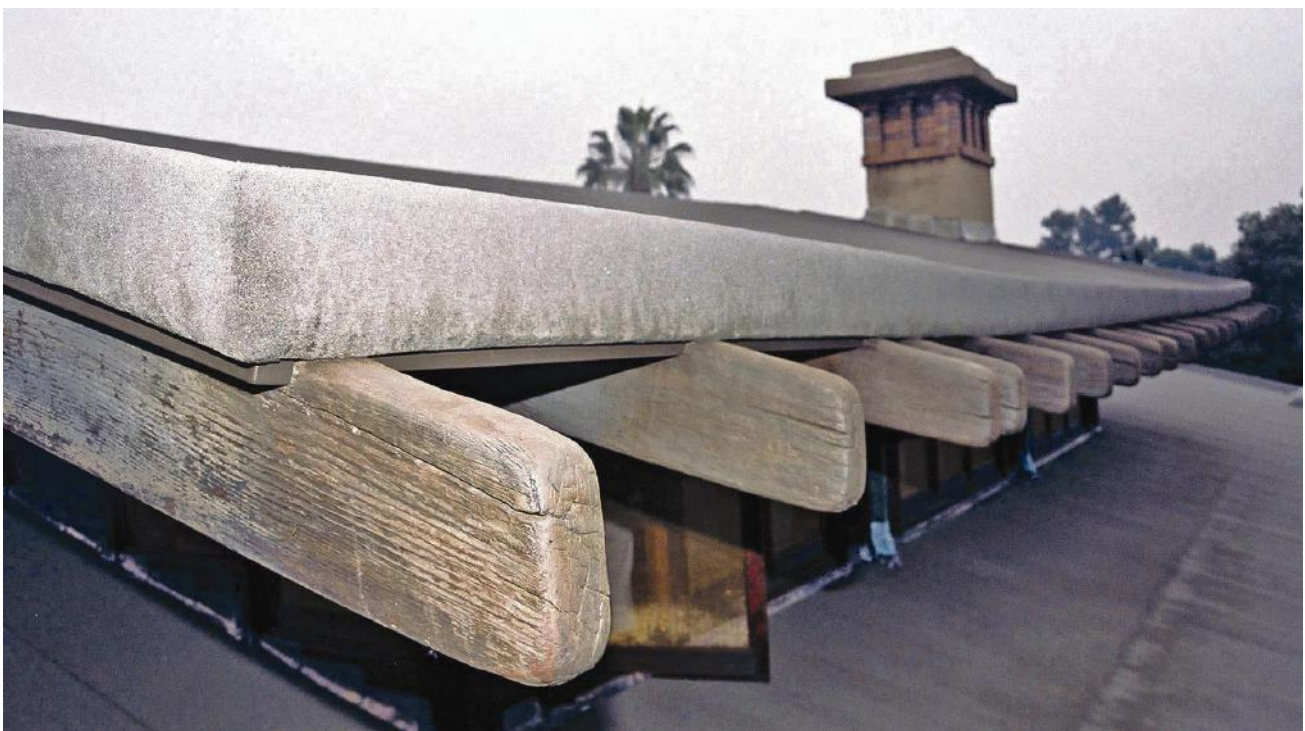
Fig. 3. Rafter tails after restoration. Courtesy Historic Resources Group

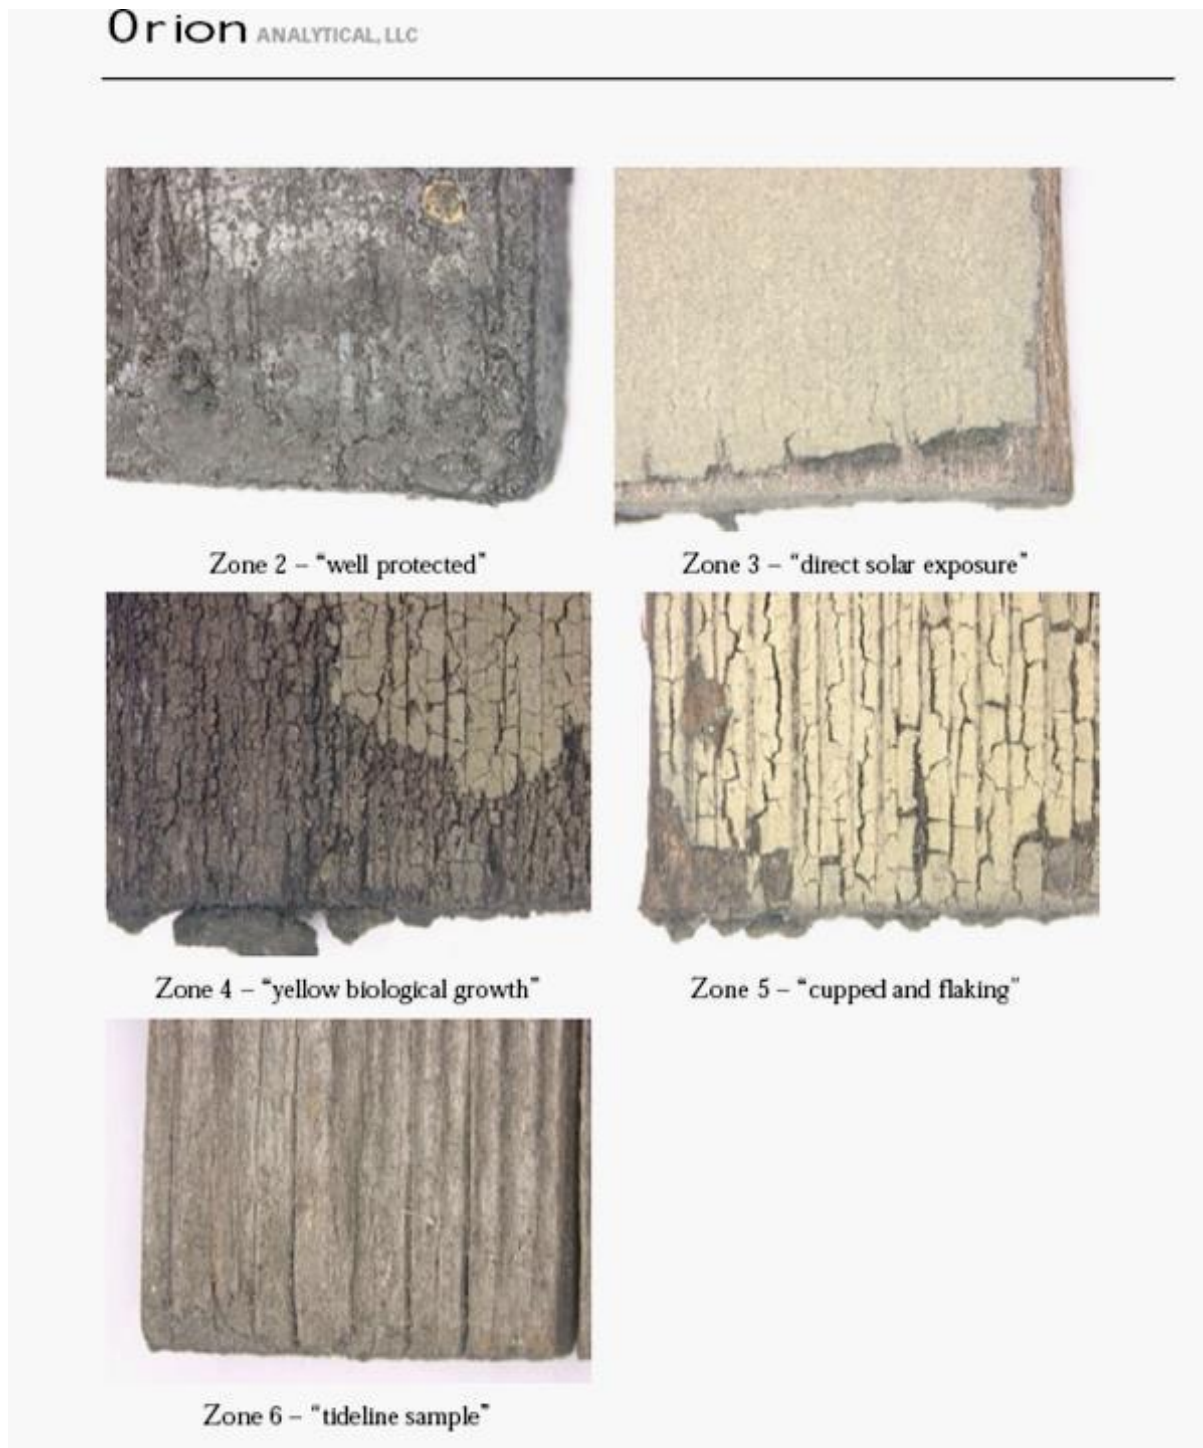
Fig. 4. Shake conditions before restoration. Courtesy Orion Analytical, LLC

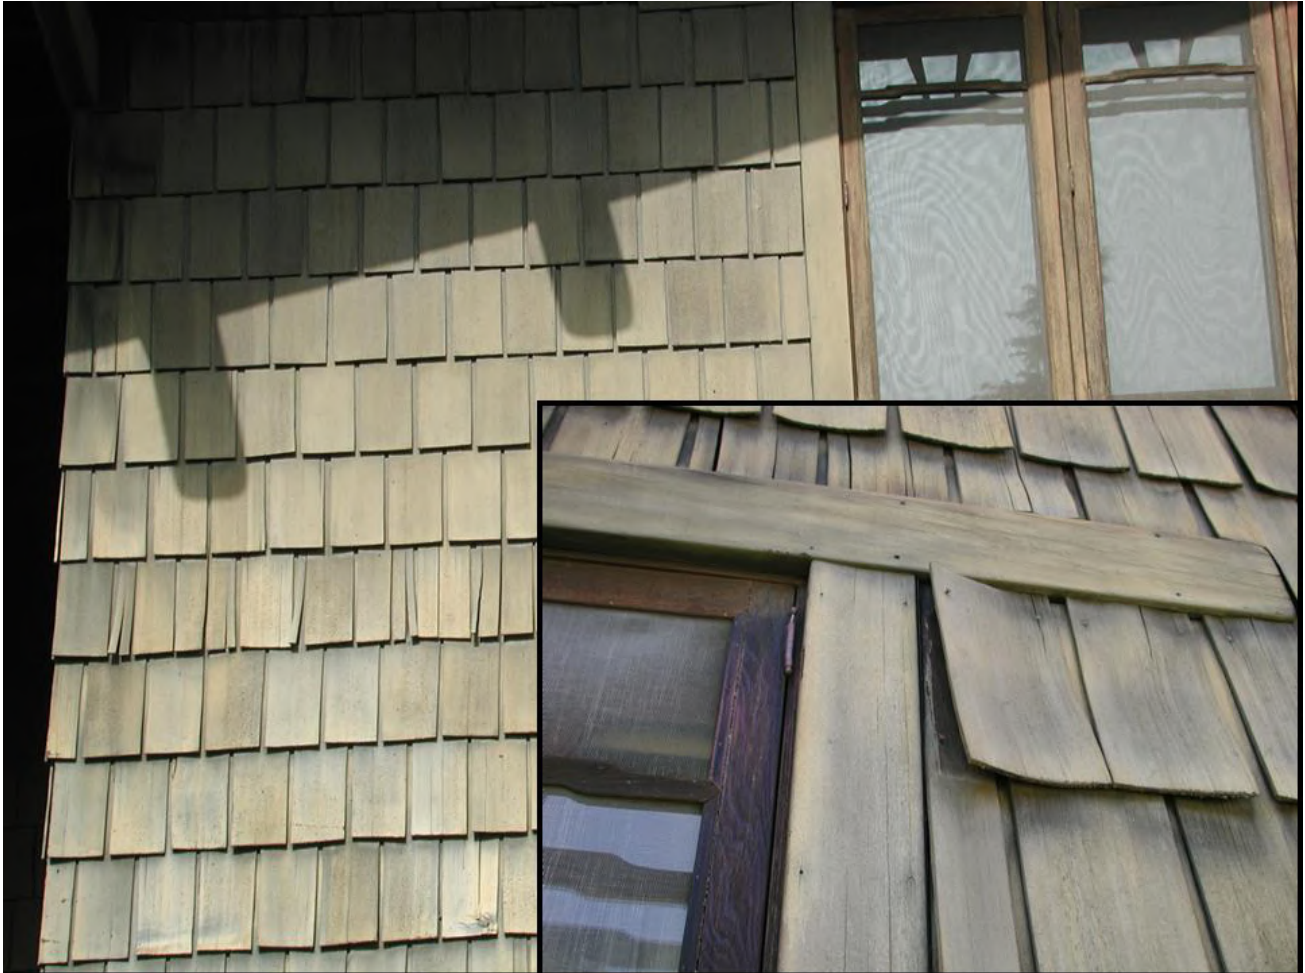
Fig. 5. Warped shakes before restoration. Courtesy Historic Resources Group

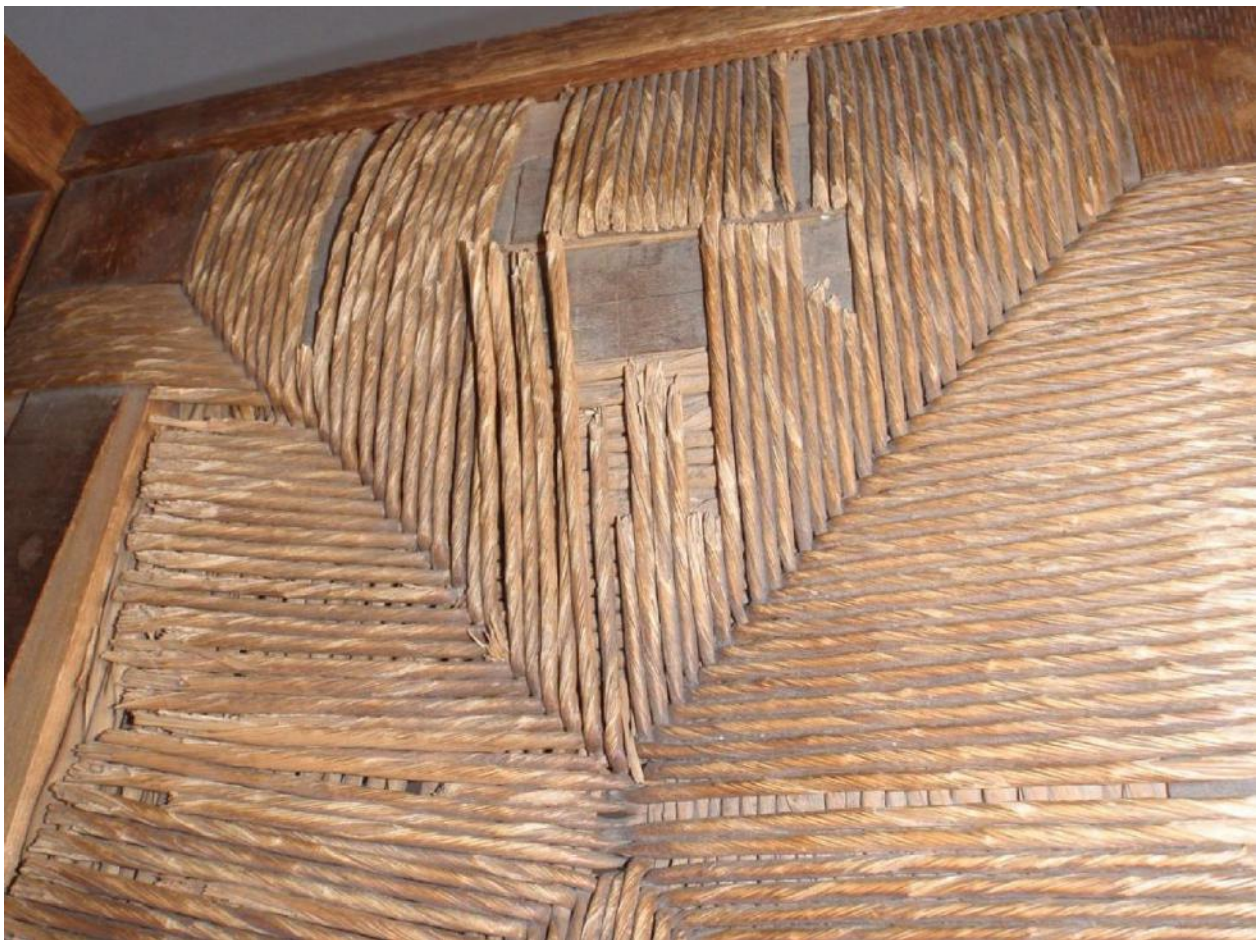
Fig. 3. Rush seat, detail, before treatment. ©John Griswold, Griswold Conservation Associates, LLC

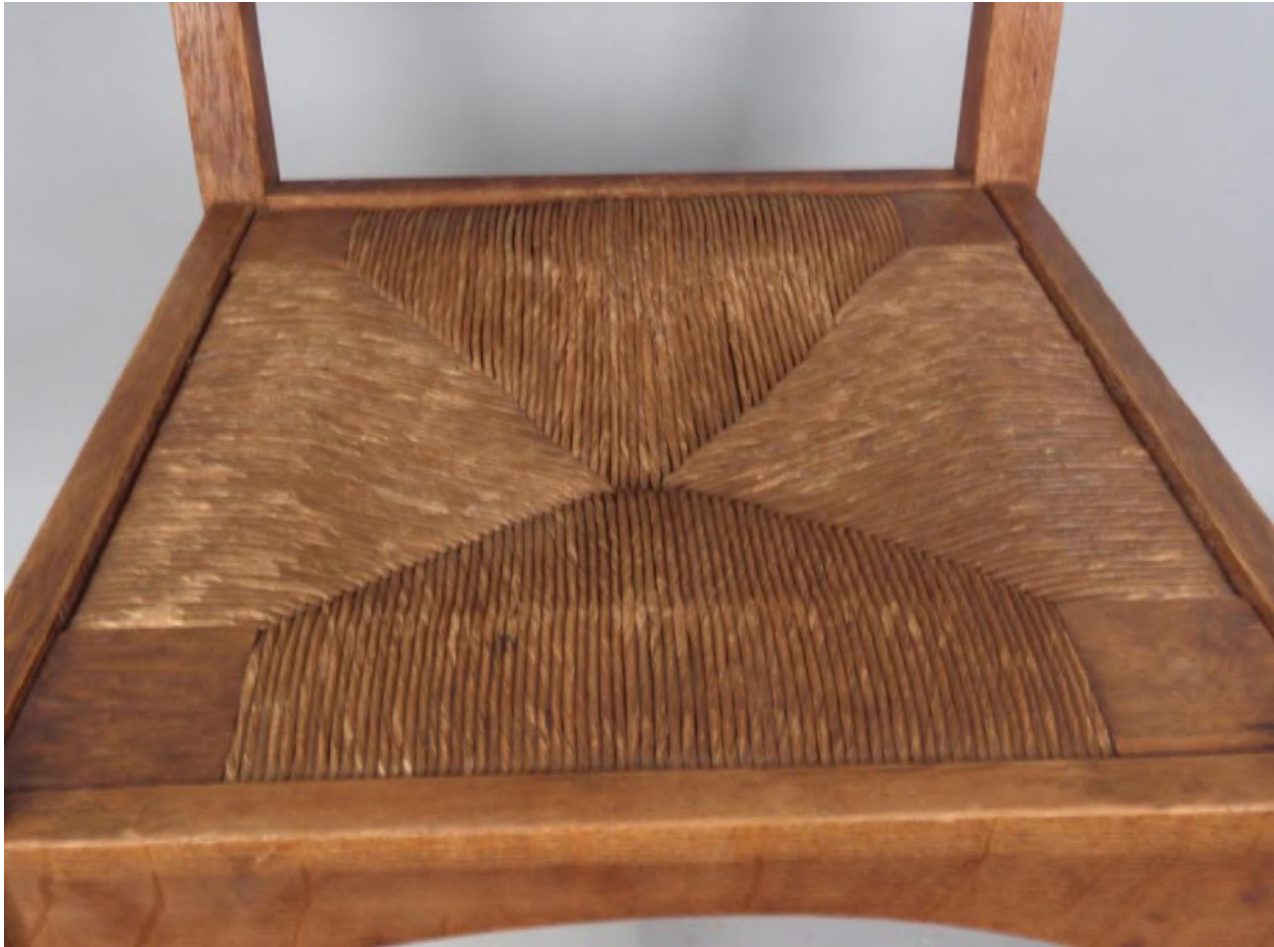
Fig. 4. Rush seat, detail, after treatment. ©John Griswold, Griswold Conservation Associates, LLC

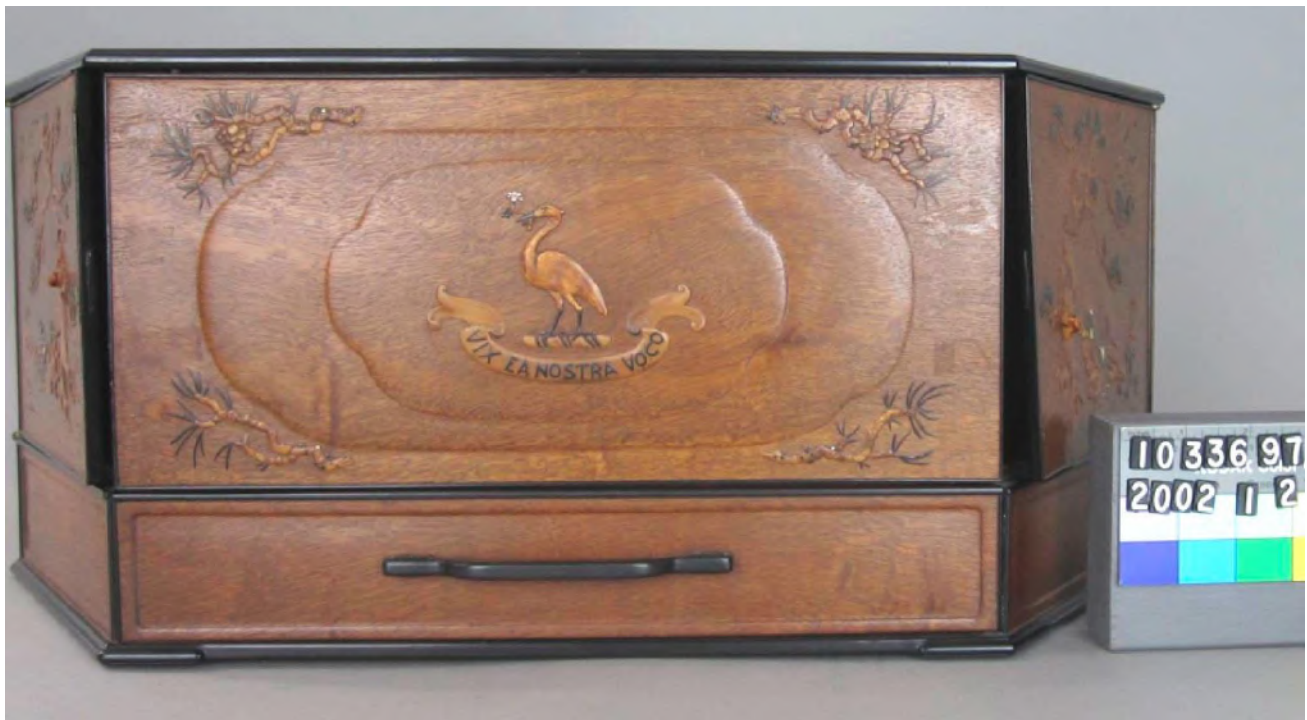
Fig. 5. Letterbox, before treatment to correct warped door at right of image. ©John Griswold, Griswold Conservation Associates, LLC

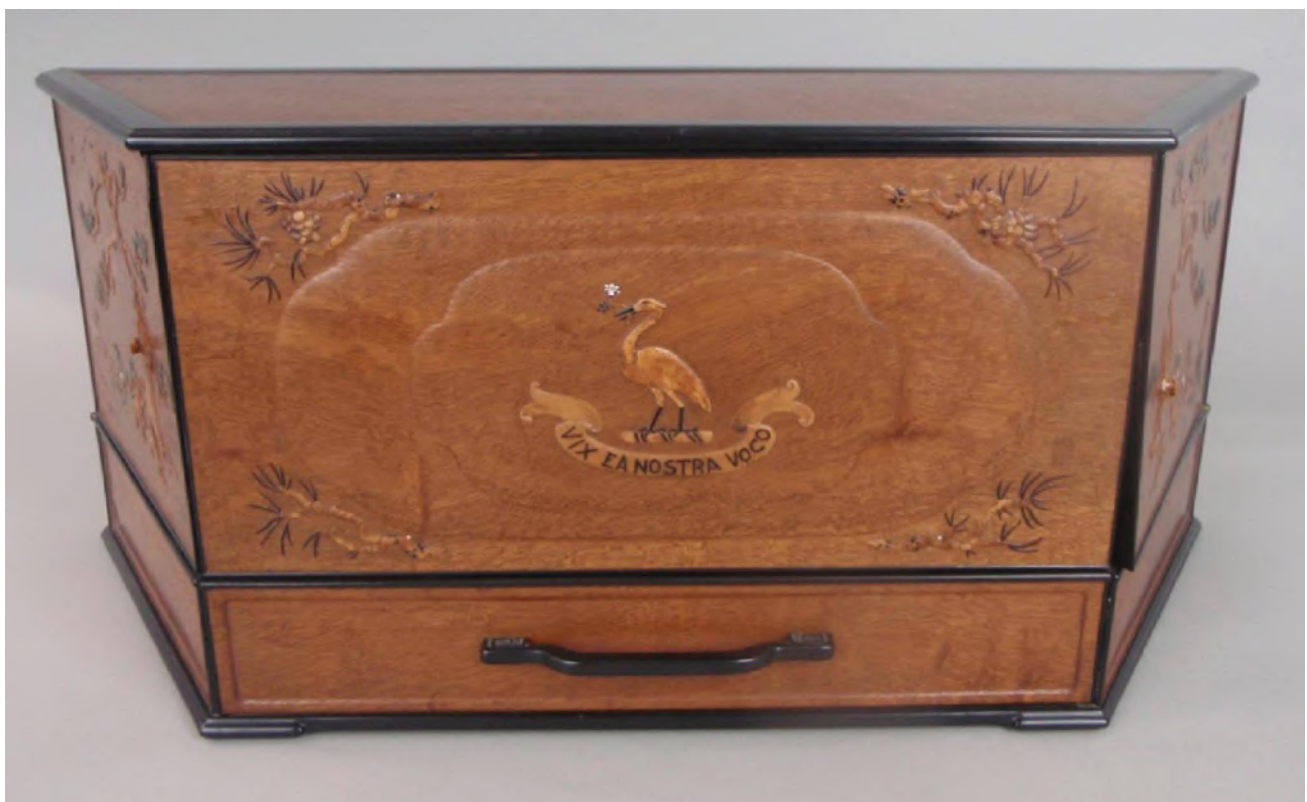
Fig. 6. Letterbox, after treatment, retaining some warping but improved. ©John Griswold, Griswold Conservation Associates, LLC

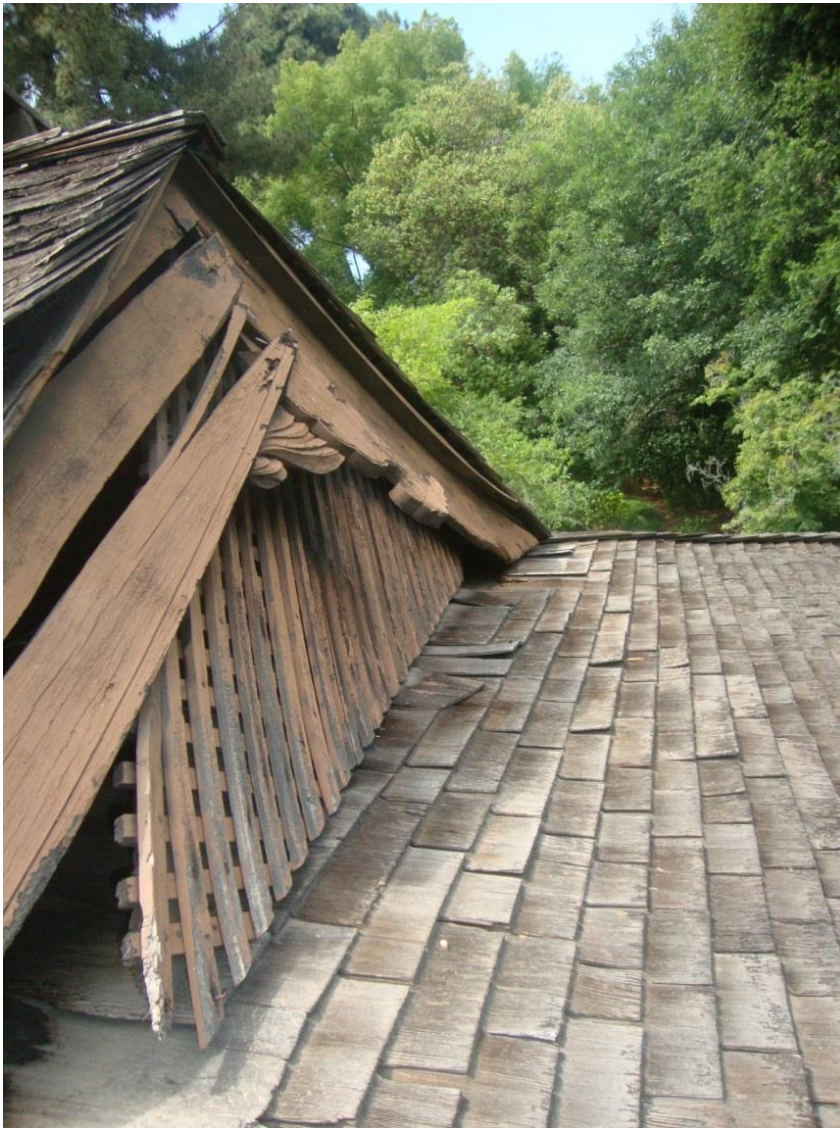
Fig. 3. Deterioration at the roof gable, ca. 2010. Courtesy of The Huntington Library, San Marino, California

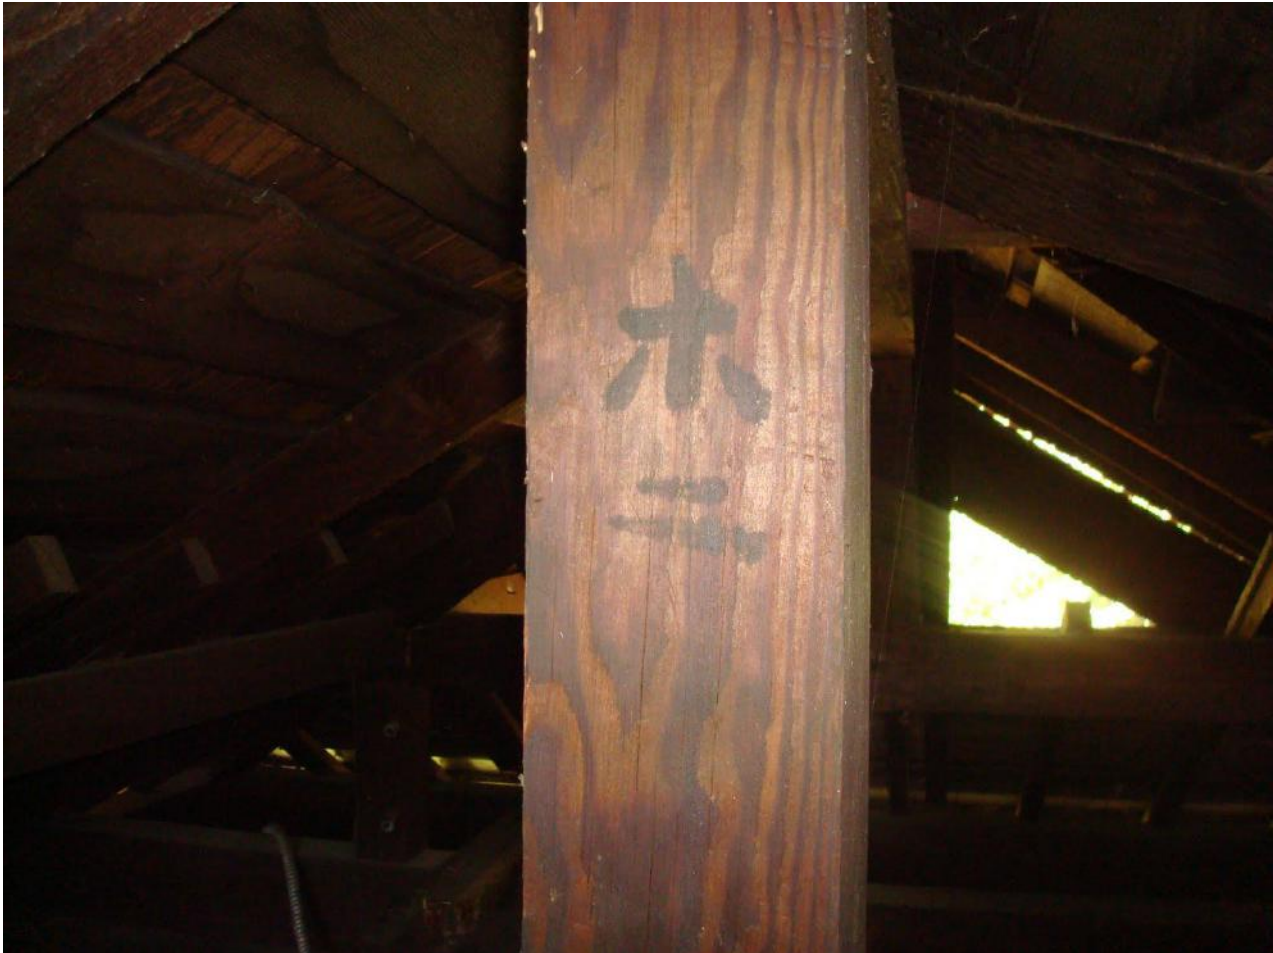
Fig. 4. Japanese characters (kanji) painted on wood framing. Courtesy of The Huntington Library, San Marino, California

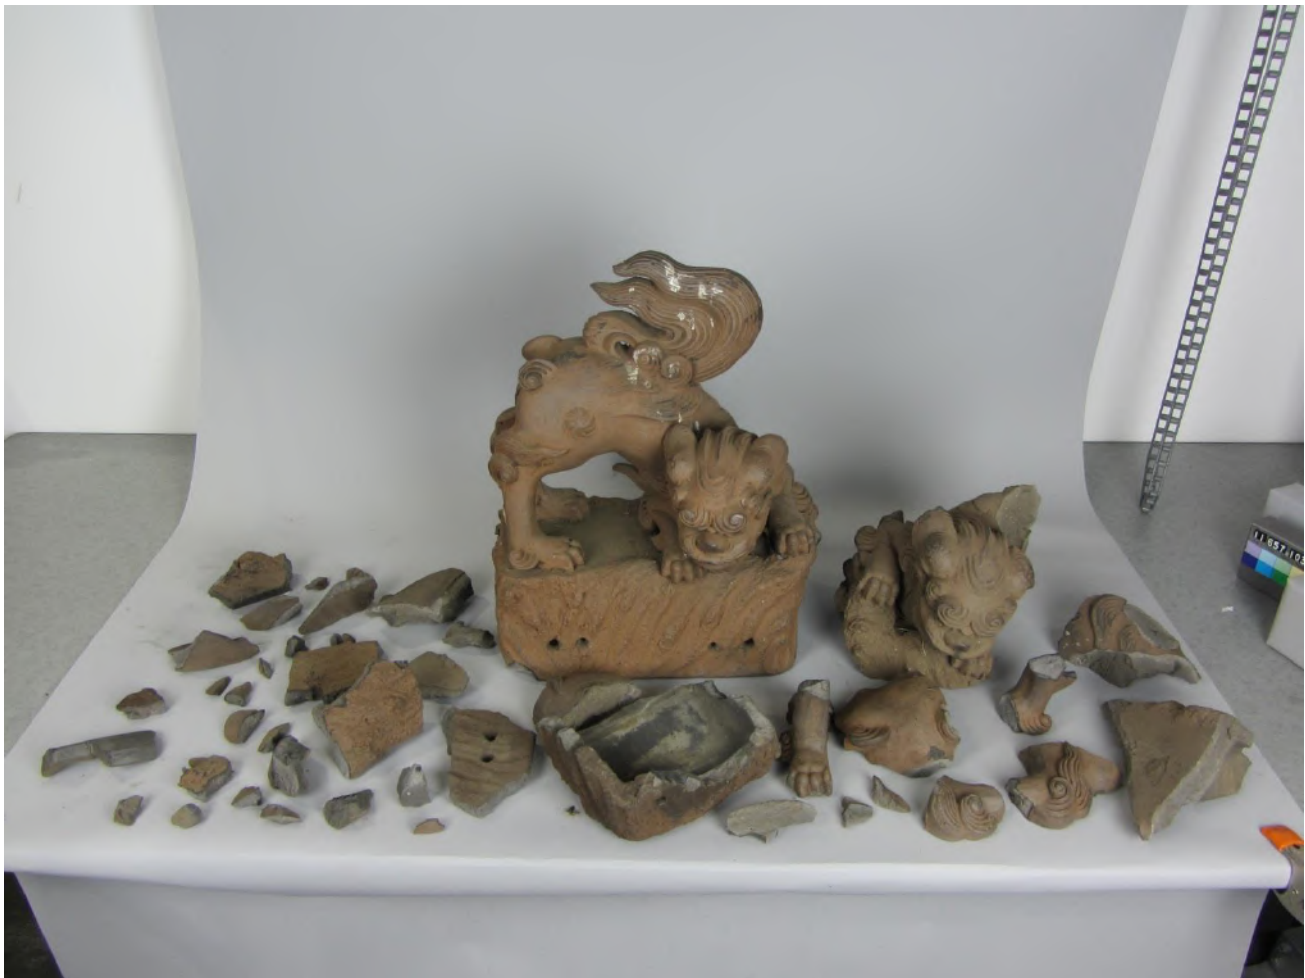
Fig. 6. Ceramic roof finials prior to restoration, ca. 2010. Courtesy of The Huntington Library, San Marino, California.

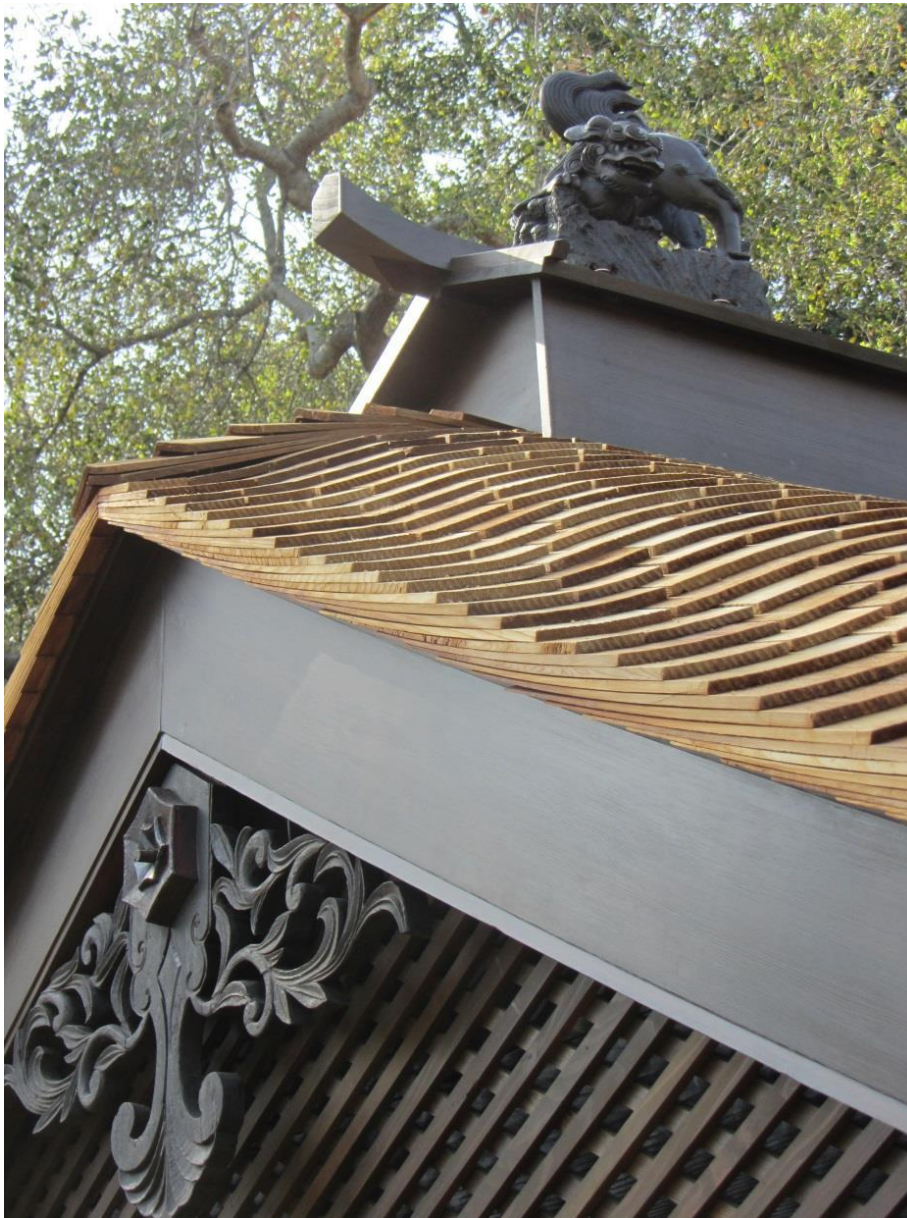
Fig. 7. Restored roof, gable vent, carved wood medallion, ridge box, and roof finial, 2012.
©Griswold Conservation Associates, LLC

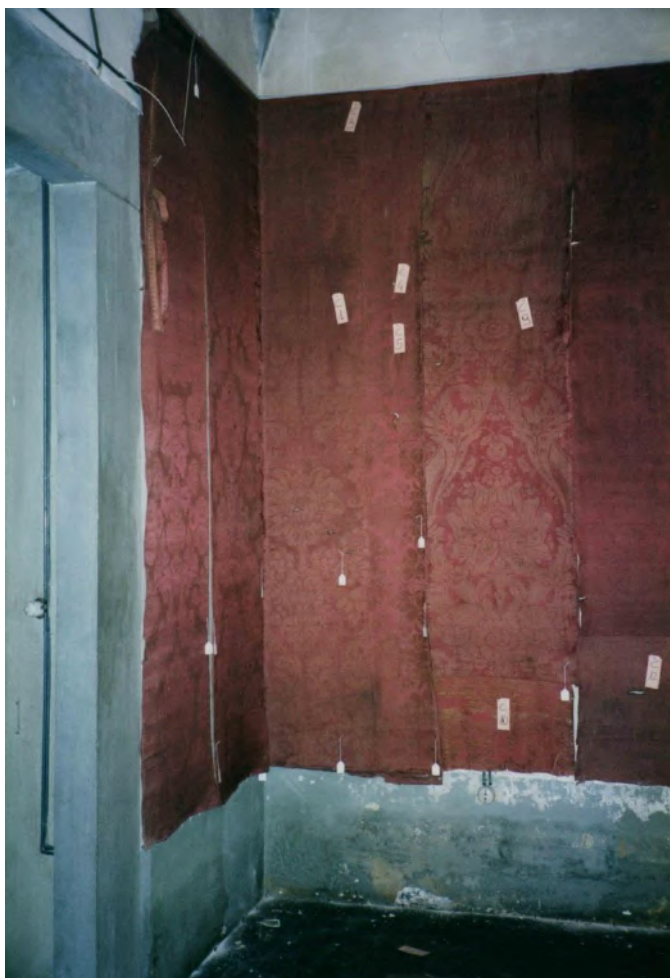
sixteenth to eighteenth centuries. Historical photographs show that they had been in place as early as the 1930s. The fabrics—totaling 220 square meters, sewn together piecemeal and nailed directly to the walls—had to be removed for renovation and reinstalled in time for the opening in 2002. The fabrics were in various states of deterioration with some disintegrating at the slightest touch (Figure 3). Several alternatives for the conservation of the wall hangings and the re-installation of the rooms were discussed:

Fig. 3. Documentation of original damask wall hangings during renovation.

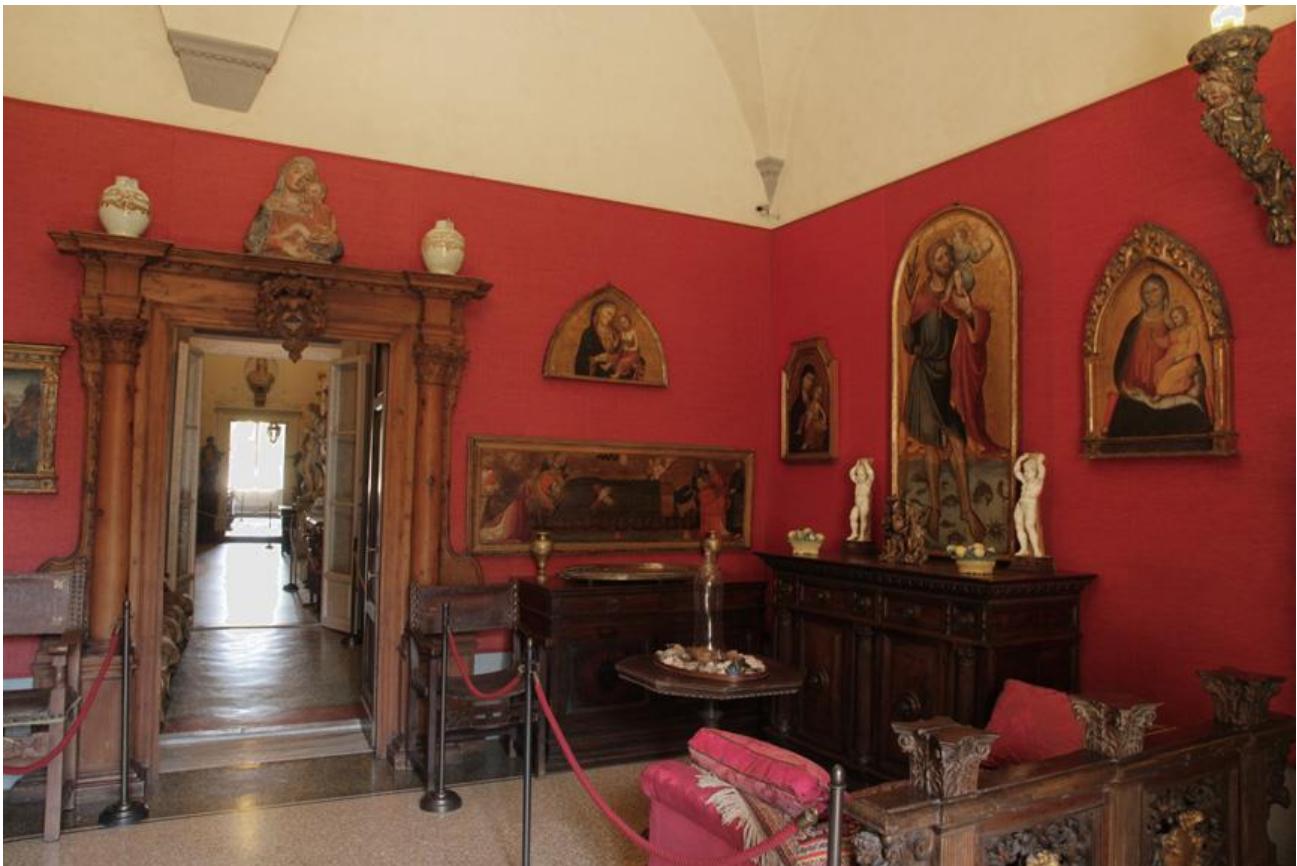
Images of the rooms today show the neutral fabric which serves as a sign that the walls were once red; it is a compromise, like many preservation decisions. Only when confronted with the historical images of the rooms does one gain a feeling for the layer of historical authenticity that is now missing. Ten years later, the

Fig. 4. Sala Rossa after installation of new fabric wall hangings.
©New York University, Acton Photograph Archive, Villa La Pietra, Florence

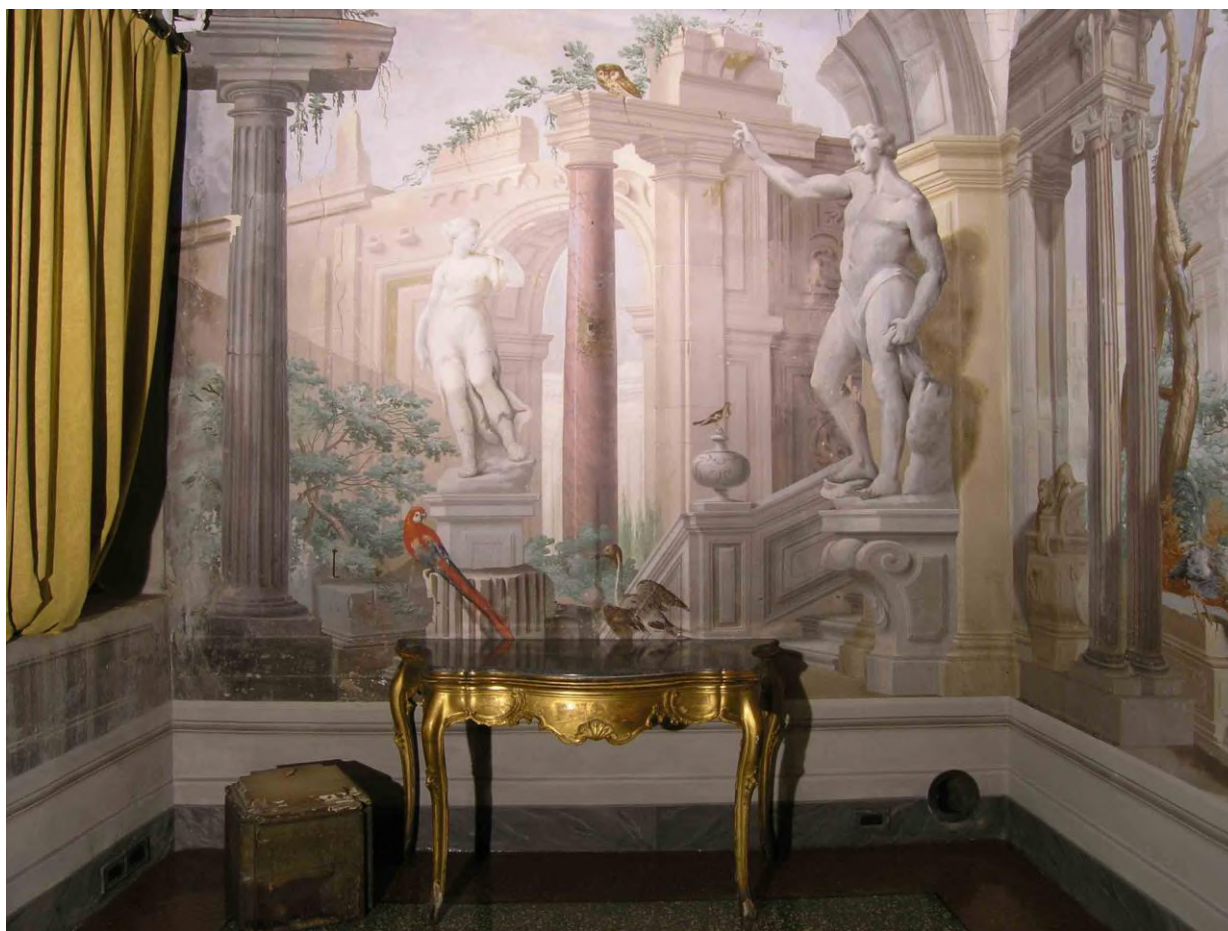
In 2005, examination showed that this room was in need of conservation treatment (Figure 9). The pictorial layer, applied in the *bianco di calce* technique, a variation on the more robust buon fresco, was actively flaking and losses had occurred. In addition, soluble salts in the walls were damaging the frescoes, especially around the window. Daniela Murphy, the Italian partner for this project, carried out a conservation assessment and a treatment plan was developed. The main focus of the treatment was stabilization and elimination of agents of deterioration. Treatment would include consolidation of the pictorial layer and poulticing to reduce the salts, both necessary to prevent further damage. In addition, the animal glue layer that had been applied to the walls in the nineteenth century would be removed because it was, with the force of its contraction, pulling the pictorial layer off the plaster.

Fig. 9. *Salletta delle rovine* before treatment.
© New York University, Acton Collection, Villa La Pietra, Florence

The project would also address aesthetic issues. Prior to treatment the room looked dirty and neglected. Surface cleaning tests showed that removal of the damaging glue layer would also remove soot and bring the colors closer in tone to their original appearance; poulticing the soluble salts would reduce staining as well as the risk of further damage. Although this project was begun before the conservation statement was formalized, many of the ideas in it were already being discussed by the collection team: it was decided that the dirt and staining, along with the flaking, were signs of neglect that did not reflect the Acton Aesthetic such that even the most necessary stabilization treatment would also improve the look of the room (Figures 10 and 11).

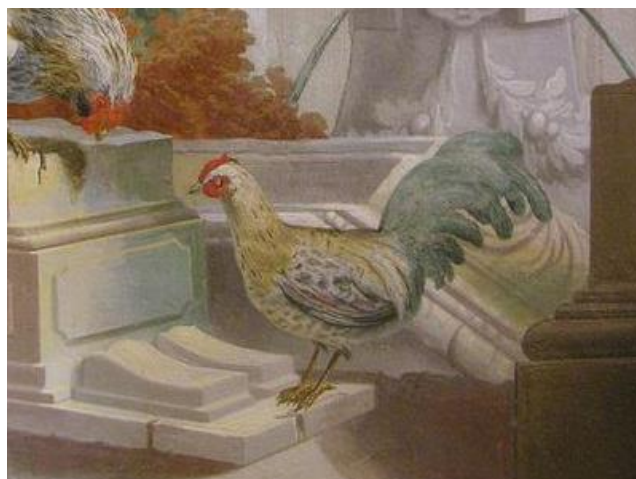
Fig. 11. Detail of surface after treatment.
© New York University, Acton Collection, Villa La Pietra, Florence
