THE ARTIFACT, ITS CONTEXT AND THEIR NARRATIVE: MULTIDISCIPLINARY CONSERVATION IN HISTORIC HOUSE MUSEUMS

A Joint Conference of ICOM-DEMIST and three ICOM-CC Working Groups:
*Sculpture, Polychromy, & Architectural Decoration; Wood, Furniture, & Lacquer; and
Textiles*

The Getty Research Institute, Los Angeles, November 6-9, 2012

Historical and Current Perspectives on the Care, Presentation, Interpretation and Use of Collections in Historic Houses

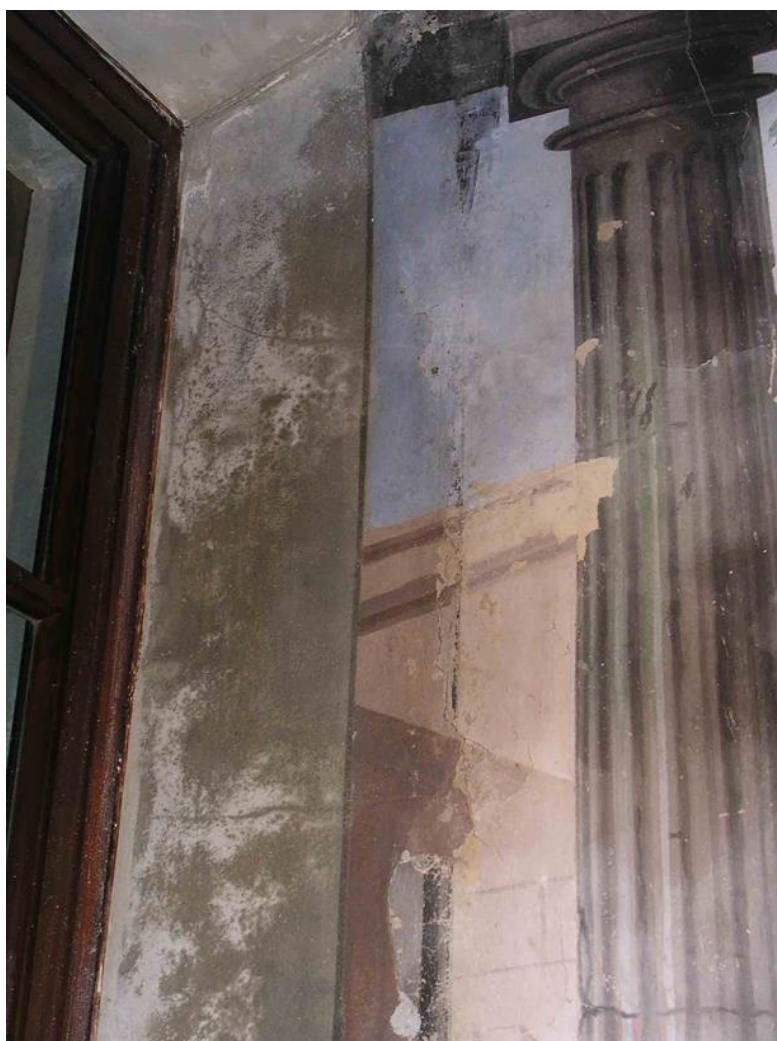
As with any conservation treatment, unanticipated problems came up along the way. The Portland cement placed around the window in the nineteenth century proved to be a major source of soluble salts, and was removed and replaced with stable lime mortar (Figure 12).

Fig. 12. Detail of deterioration around window.
© New York University, Acton Collection, Villa La Pietra, Florence

This revealed more of the 18th-century design, but created a problem as to how to reintegrate this area. Treatment also revealed that the overpaint on the *zoccolo* was part of the nineteenth century remodeling of the room. Unlike the glue layer applied at the same time, however, the overpaint was doing no physical harm. There were many losses in this layer, revealing a fairly well preserved eighteenth century layer that was not

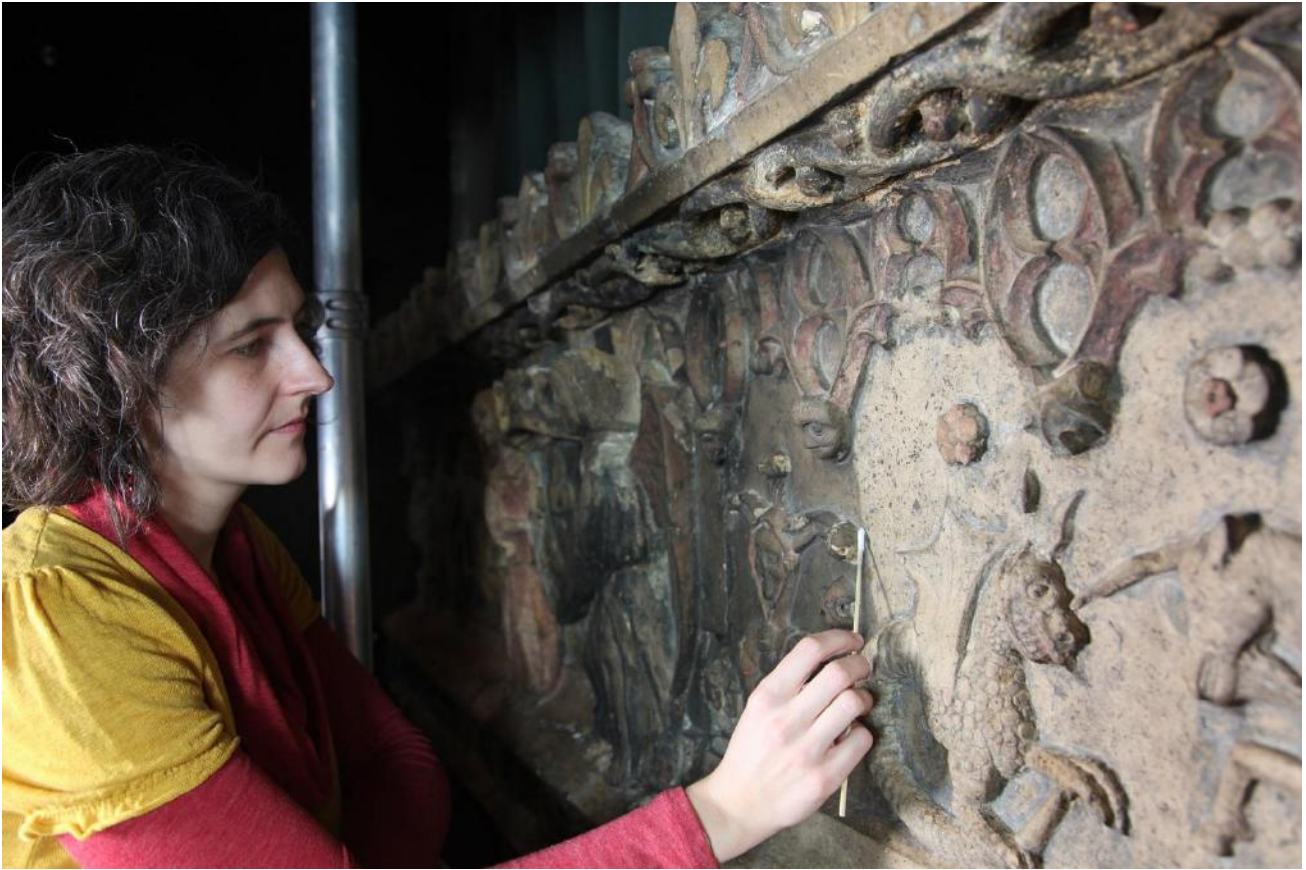
Fig. 6. Surface cleaning the fireplace.

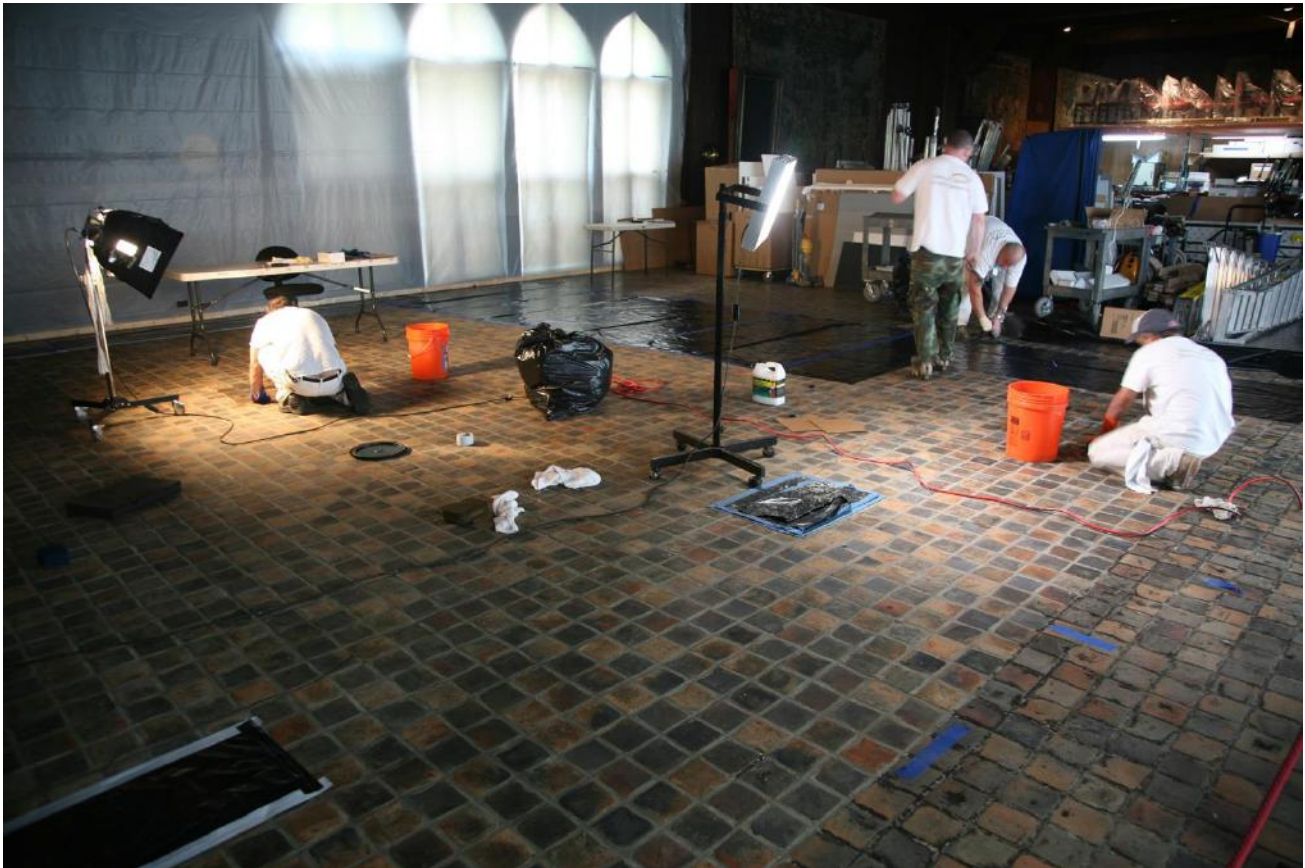
Fig. 7. Contractors removing old coatings from floor tiles.

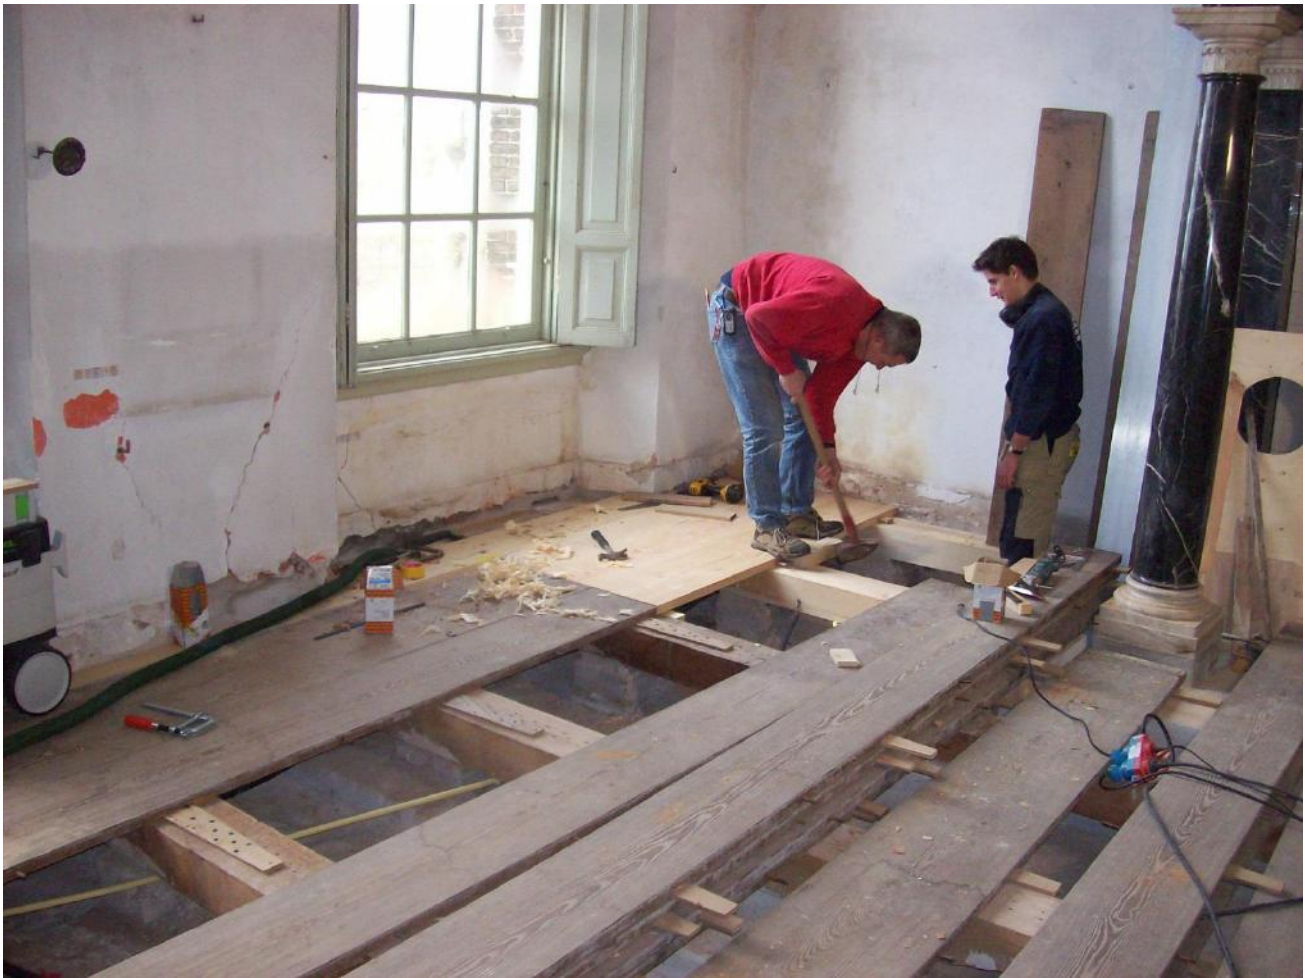
Fig. 5. Grote Zaal, drawing-room, original floor planks are re-positioned with wedges (2007).

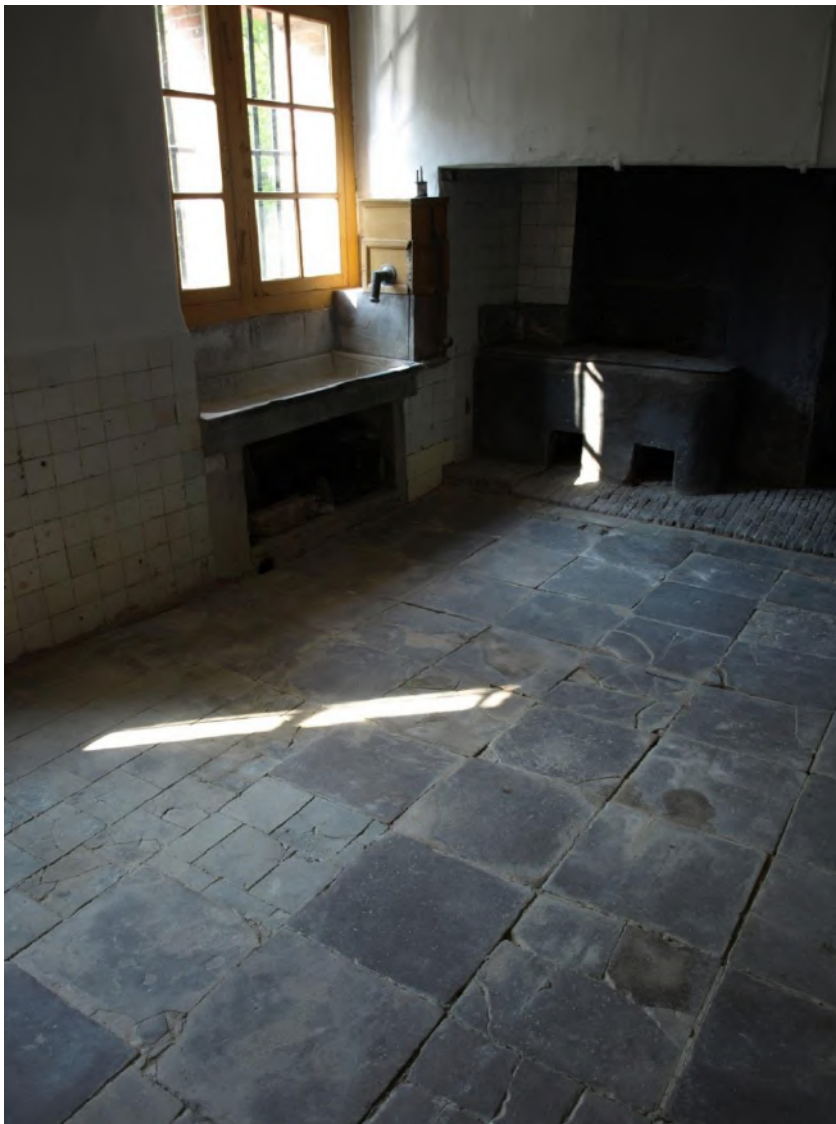
Fig. 6. Old Kitchen, the tiles and stones of the floor tell their stories.

Two cases demonstrate such a contradiction. The first one is that of a stone paved floor of Old Kitchen found the oldest part of the building, dating back to the Middle Ages. The floor of the vaulted room in the service basement consists of a variety of tiles, slabs and stones, many of which were either broken or damaged. The diversity of components and their condition tell the story of the household and of the floods which often occurred in past centuries (Figure 6). A drainage pipe above the floor in outer wall at the south side, installed to dissipate the floodwater, is witness to these. While the current condition of the floor shows history in a charming way to the visitors, it also proved quite a health and safety risk. In the initial conservation plan, the decision was to lift the tiled floor in order to install floor heating. Subsequently, the previously unsteady floor would be levelled to improve safety. However, the curator had second thoughts and suggested leaving the room unheated so as to respect the floor in its present fragile state. It was reasoned that the oldest part of the building

should stay ‘old and cold’, as castles usually were. These arguments were convincing and plans were changed. Only a few of the broken tiles and loose stones actually required stabilisation to improve safety. There remain some functional limitations to Old Kitchen, which does not contribute to improving the indoor climate; however, the space retains a sense of historical authenticity for the visitors to see, feel and understand.

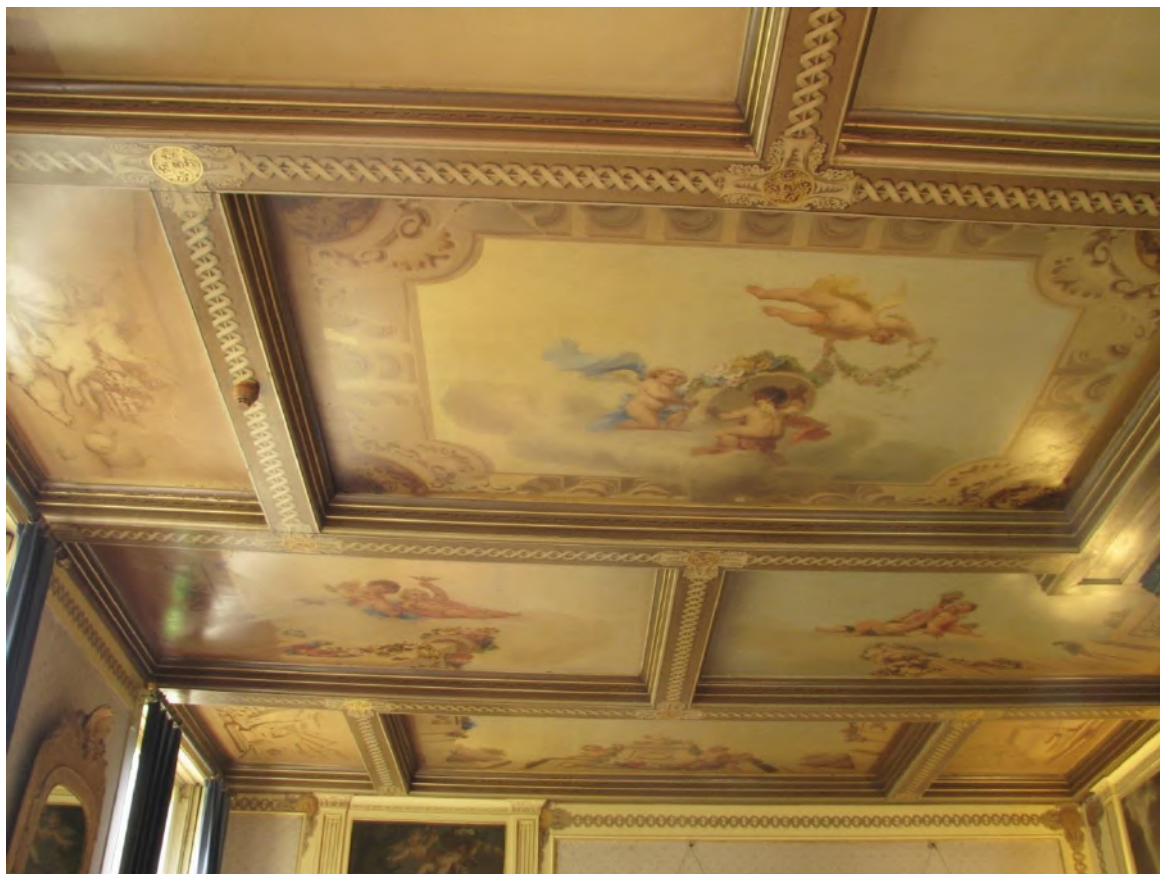
Fig. 2. Blue Salon: detail of the ceiling and walls with the decorative strap-work. ©E. Geldhof/R. Keppler

The Blue Salon is the most representative room of the castle. The architectural outline of the room is part of the seventeenth century floor plan. The room is situated on the *piano nobile*. Its most prominent features are the early eighteenth century mantelpiece decorated with a blue veined faux marble, and the coffer ceiling in which twelve paintings by Johannes Stortebecker (1821-1899) are recessed. The decorative strap-work (painted in a dark faux-wood on linen and cut out) is glued on the painted light yellow wainscoting. This dark linen strap-work on a light coloured background on the panelling is mirrored in the ceiling. Here, a light coloured decoration is painted on the dark wood imitation of the beams in the ceiling. (Figure 2) The current light

If the aesthetical values of the room are observed, it is clear that the linen strap-work on the wooden panelling has a three-dimensional purpose. The dark strips applied on the light background, enhanced with a painted shadow line, give the panelling its architectural three-dimensional features. This pattern is repeated, but mirrored in the ceiling where the decorative motive is painted directly on the wooden beams. Thus, the decorative strap-work on the panelling forms a unity with the painted decoration on the ceiling. If the strap-work was initially glued on dark green painted panelling and later replaced on the light yellow panelling, traces of dark green paint on the reverse of the strips might be expected. Investigation of a few loose linen strips did not show any residues of green paint. Stylistically, it also seems strange to have a dark green panelling with dark decorative strips on it. This would not give as much of a visual three-dimensional effect in the room as it has now (intangible aspects - the synergy). Understanding and clarifying this stylistic aspect of related decorative elements allowed the authors to preserve this light yellow colour, maintaining this decorative scheme and the synergy of the room for future generations.

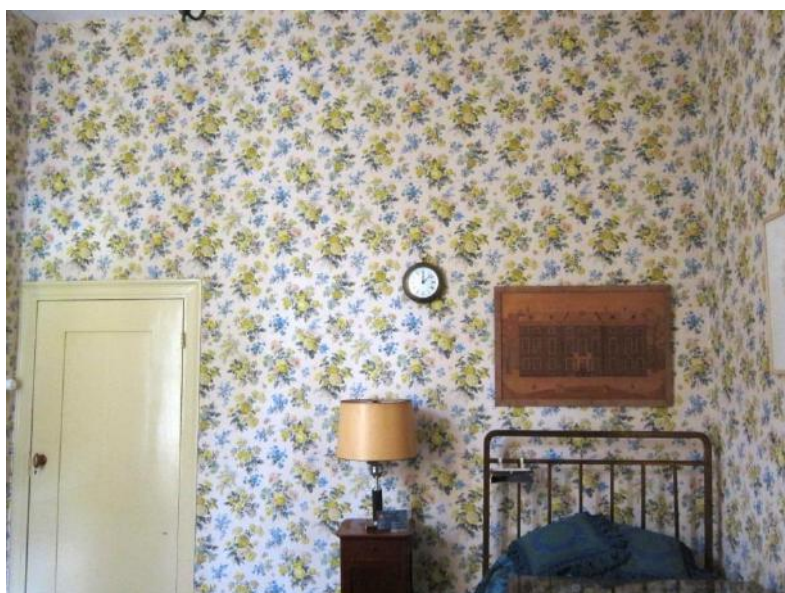
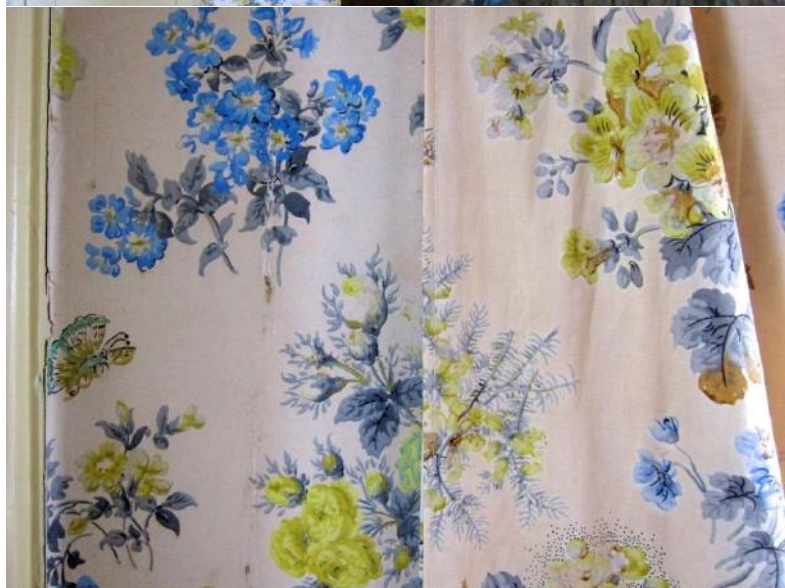
Fig. 4. Top: Count's Bedroom: after conservation. © E. Geldhof/R. Keppler

Fig. 5. Bottom: Count's Bedroom: detail of the wallpaper with matching curtains. © E. Geldhof/R. Keppler

This dearth of information allowed focus to shift to the existing wallpaper, a colourful paper depicting flowers, and the matching curtains. This more recent wallpaper had been deemed unacceptable and 'ugly' by the conservation architect and castle administration. But the authors had no idea why this wallpaper was considered ugly and wrong for the Count's Bedroom. The authors observed that the wallpaper was block-printed using a coherent pattern and was in excellent condition. (Figures 4 and 5) By happy coincidence, an unused roll of this wallpaper was found in the attic. This find enabled further research into the provenance of this wallpaper. The paper was hand printed in France by the wallpaper manufacturer Paul D{um}AS[2] in the pre-WWII period. The twelve-colour pattern was applied to *papier continu* that was of a good quality as rag fibres could be distinguished. When comparing the unused wallpaper with the paper on the walls, it was evident that the pattern on the walls had barely

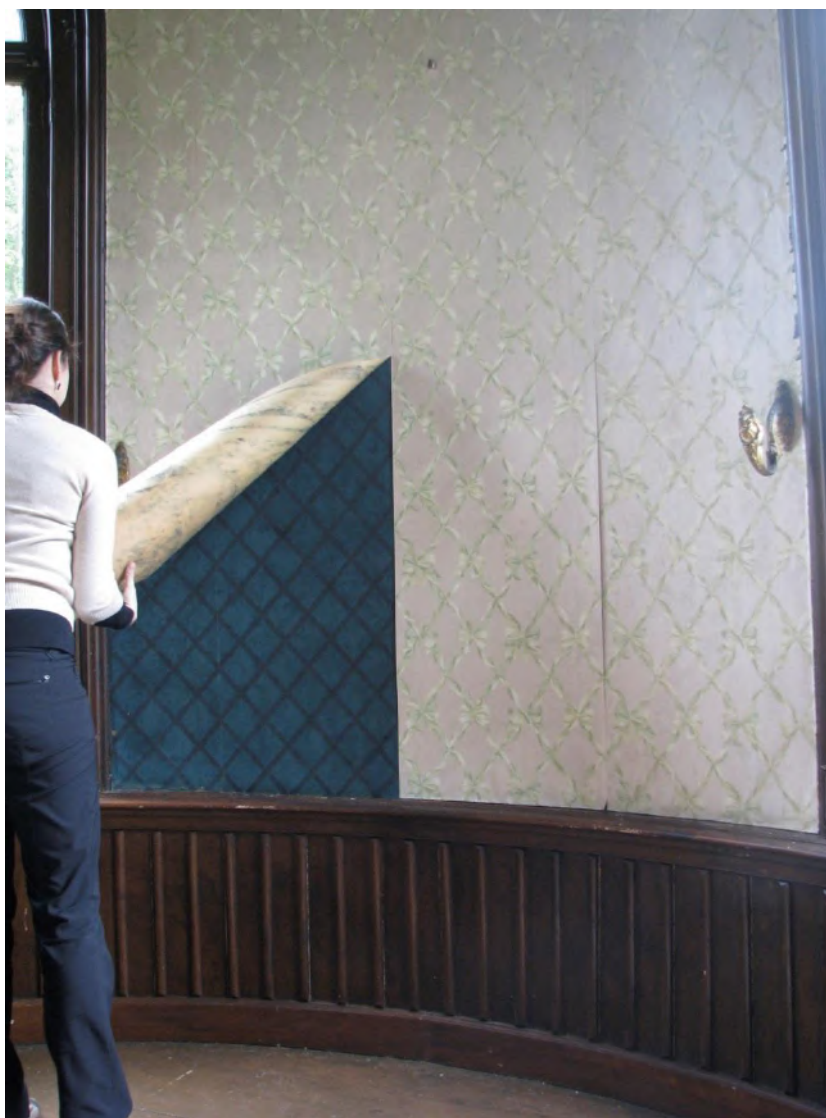
Fig. 6. Tower Room: wall with original 1860s wallpaper, and later 1950s wallpaper. ©E. Geldhof/R. Keppler

The room has an entrance door that leads to the adjoining Red Salon (Rode Salon), with an allegorical scene with *putti* painted in grisaille (a 'witje'), as a over-door painting. The room has two windows, which are curved with the walls, which show traces of came in the window frames. These came were originally

set in diamond pattern and would have reflected the trellis of the original wallpaper. In this way, the walls and the window came of the

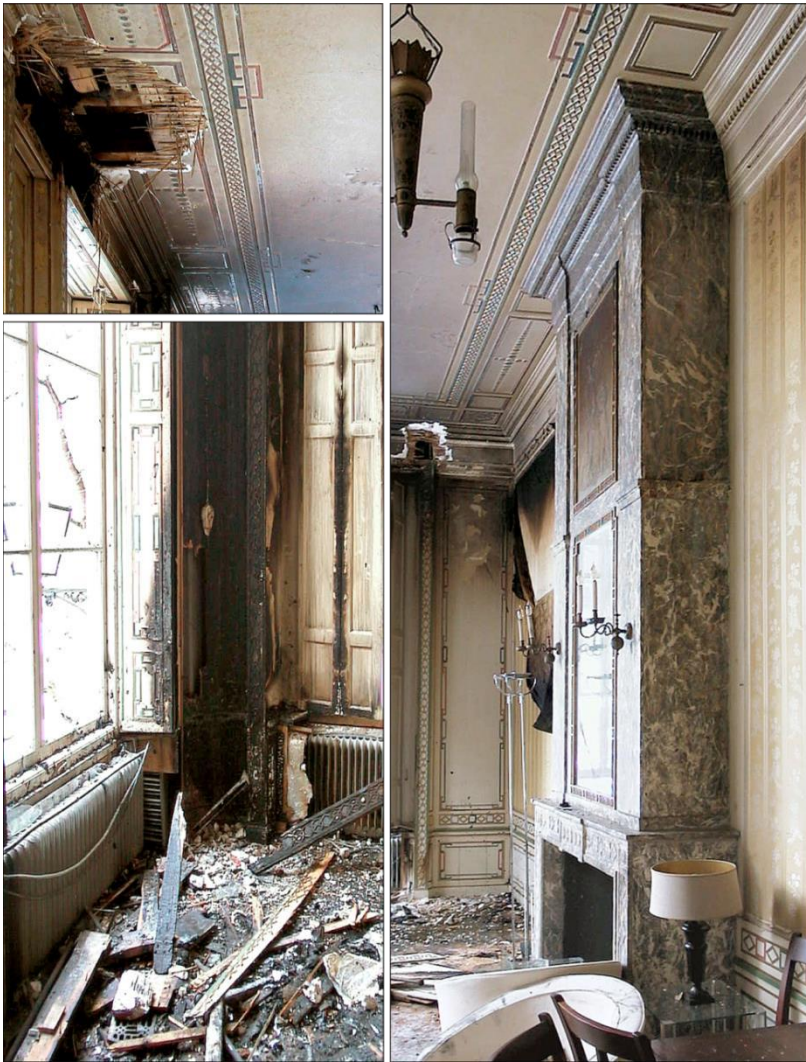
Fig. 1. Interior after the fire in March 2005. © Edwin Verweij

During the fire in 2005, the room burned briefly but fiercely, resulting in the loss of parts of the stucco ceiling, the wood panelling and the floor. Collateral damage was caused by firemen trying to locate the source of the fire and making sure it was extinguished. Certain parts were burnt beyond repair, others damaged by exposure to the intense heat. Initial concerns were for the possible development of fungi and/or growth of mould due to increased moisture content, and about the intense odour of the burnt materials. Two separate groups developed simultaneously. These factions had divergent thoughts about how to handle the situation: those who wanted to 'throw out the old and order new' and those who saw this as the 'perfect opportunity' to examine and explore eighteenth century in depth.

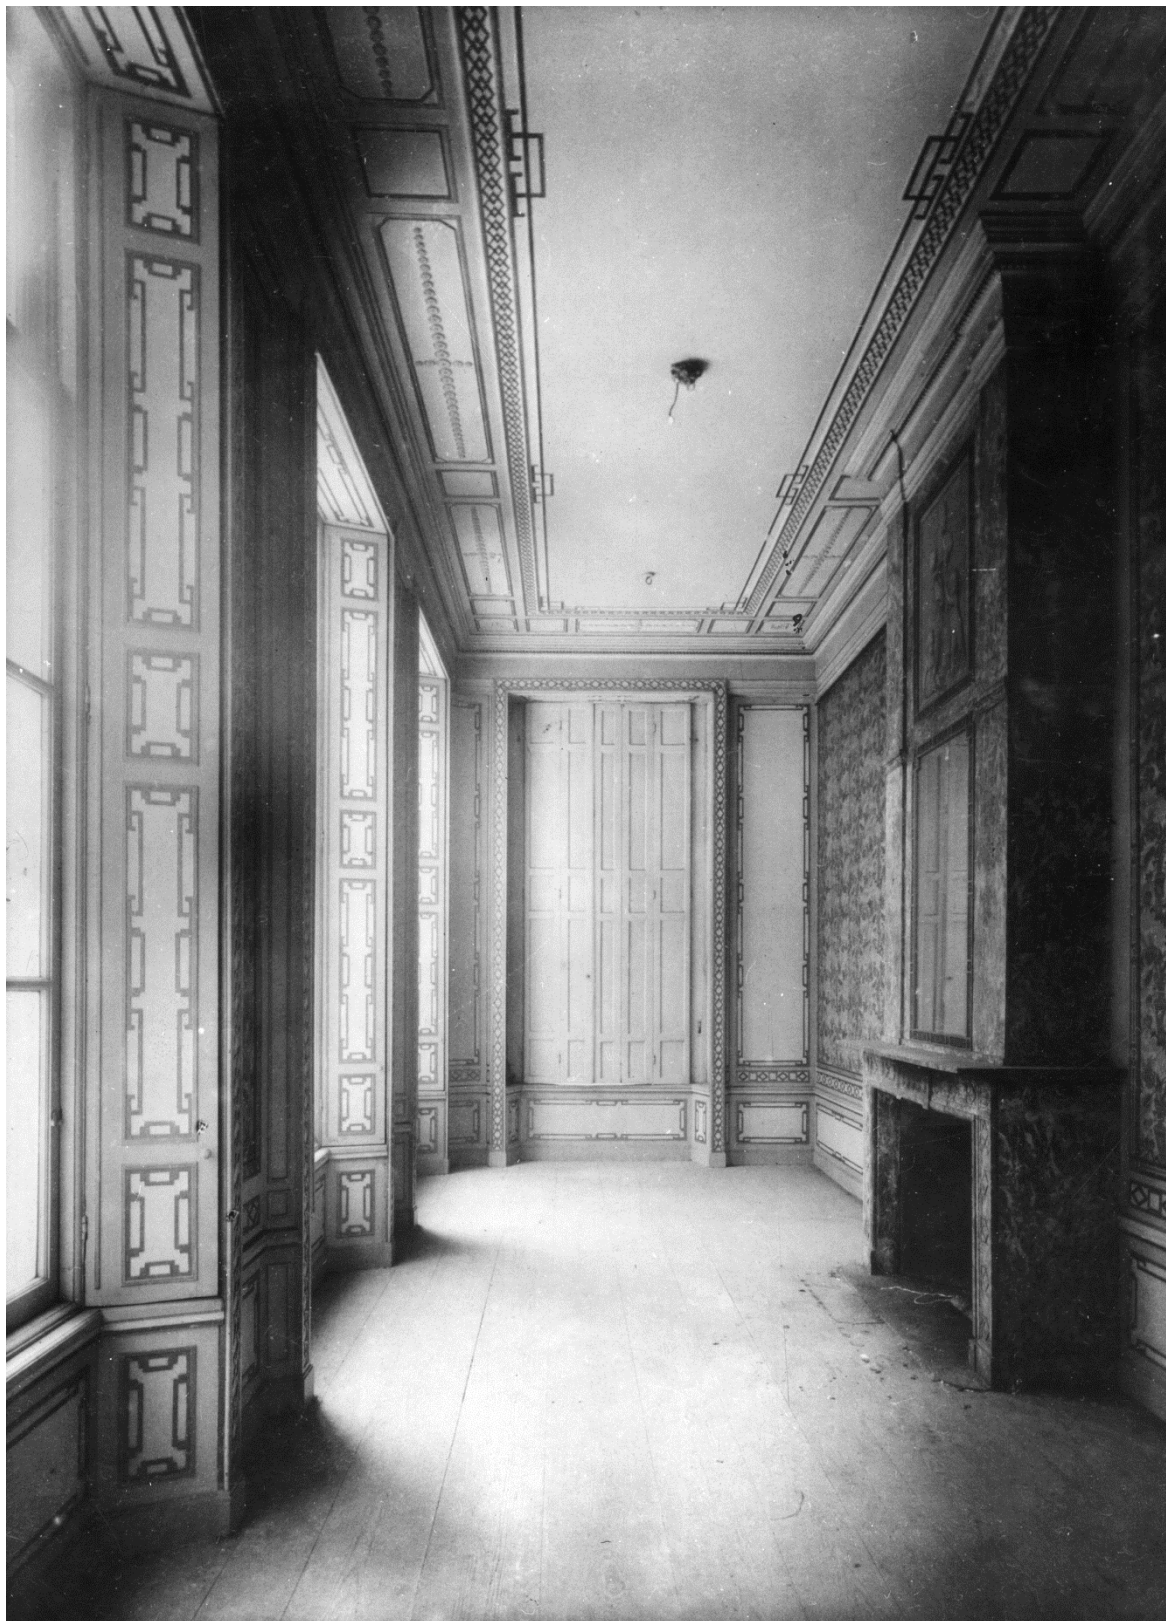
*Fig.3. Interior in 1920 before installing a heating system.
© Rijksdienst voor het Cultureel Erfgoed (RCE) Amersfoort, Netherlands.*

The presumably original wooden mouldings could be seen on a 1920s black and white photograph and the pendant lamp was artistically depicted on the 1830s watercolour. Both were studied thoroughly for the dimensions, use of material and production method. The mouldings seemed to be symmetrical designed at first sight. However, all corner elements had a different length to compensate for dimensional differences of the wall. The colour scheme and/or use of gilding were discussed in-situ with mock-ups (Figure 7). These carved and gilded mouldings proved to be an essential part in the room and served as an indispensable decorative element. The pendant lamp had Chinoiserie features, but any painted and/or inlaid details could not be identified nor the exact dimensions.

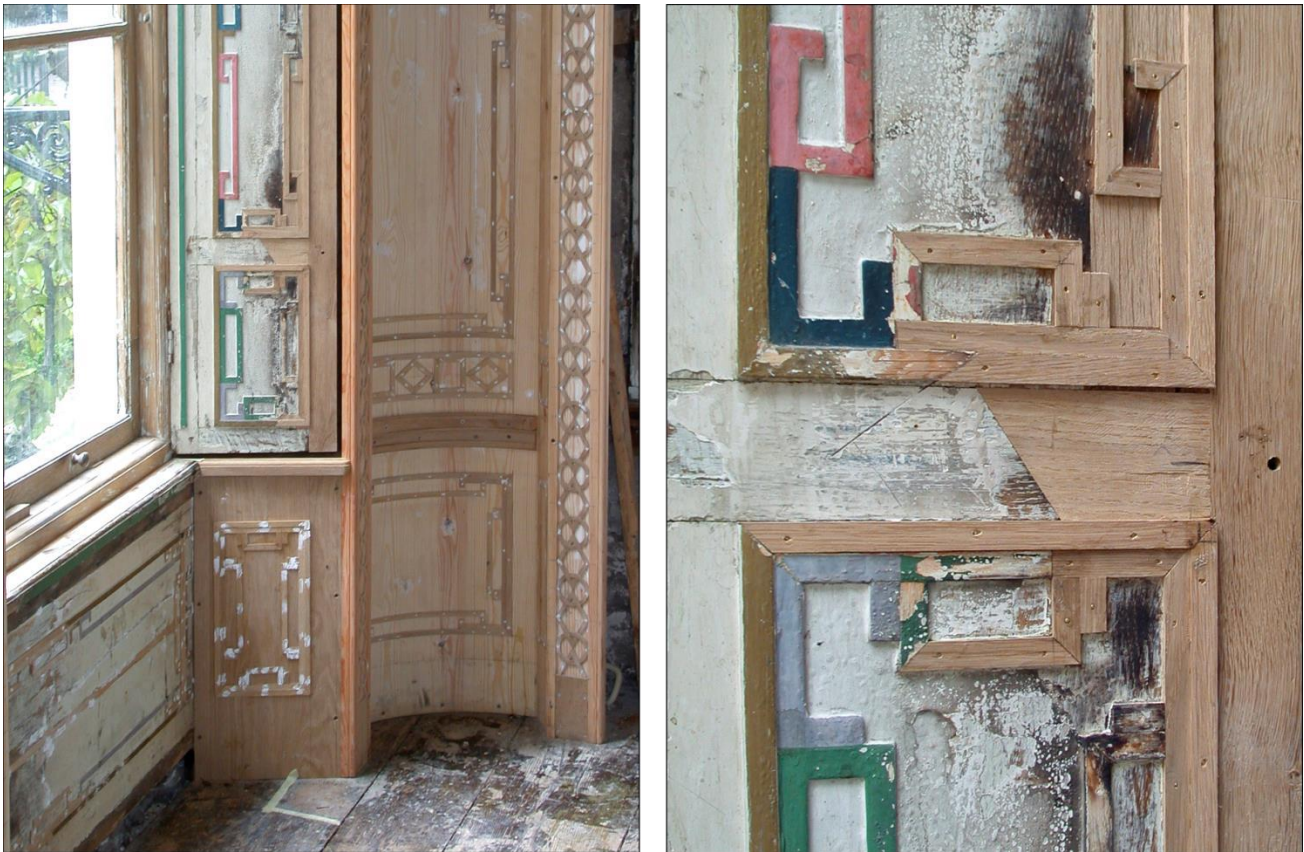
Fig.6. Restoration of woodwork. © Edwin Verweij

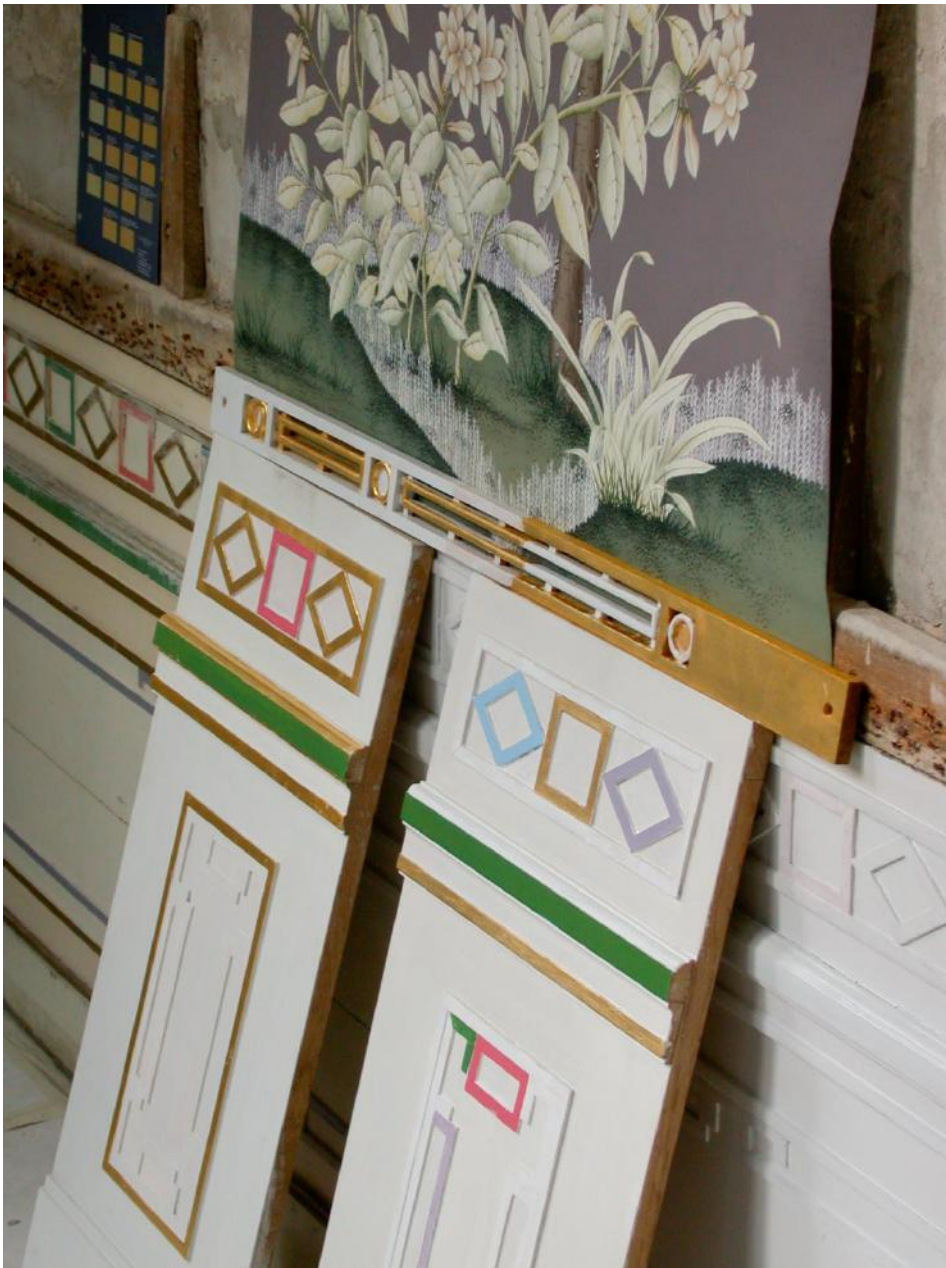
Fig. 7. Work in progress at the building site determining colours and materials.
© Edwin Verweij

As soon as the project team had collected enough information on a specific architectural element, the conservators tried to reconstruct it as accurately as possible, in both the use of materials and techniques [Brouwer and Verweij, 2009]. For example, the decision to use a lead white-based oil paint on the wood-panelling was made after the results of the architectural paint research were combined with the analysis of the pigment and binding media [Jongsma and Verweij, 2002; Verweij, 2005; Keune and Van Loon, 2006]. The paint was coloured appropriately with pigments and gildings were applied in pertinent patterns. The wooden panelling and floor were restored using the same materials as originally were used: oak and pinewood (Figure 6). The quality of the original floorboards after sanding, local wood fillings and a slight treatment with a natural soap. The ceiling had to be conserved by mechanical fixation of the flat field and by reconstructing the missing stucco mouldings. The marble of the chimneypiece had been restored several times and this required therefore individual cleaning and polishing for each marble slab to establish a uniform appearance.

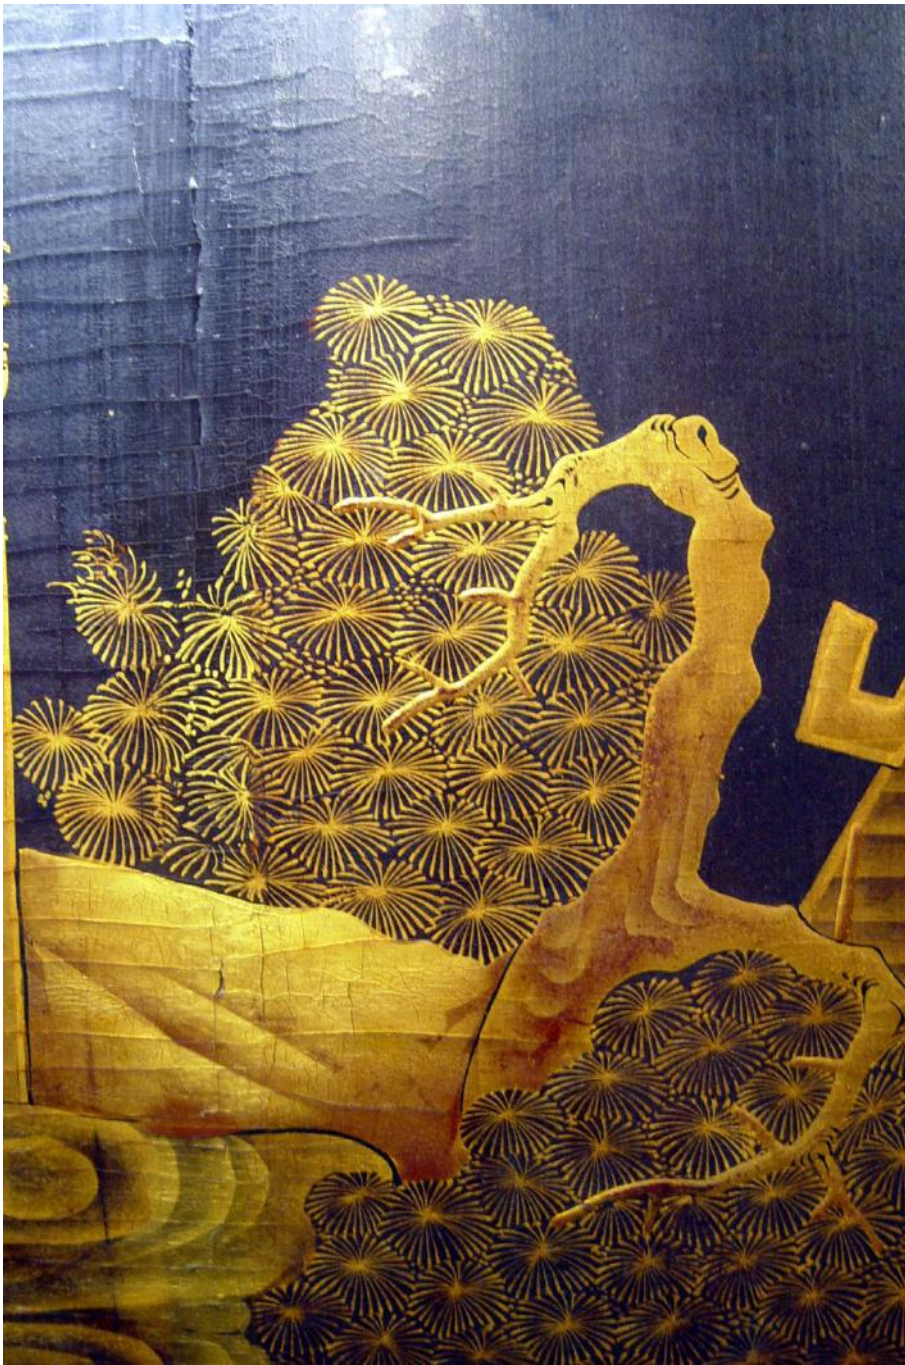
Fig. 3. Detail from the South panel. ©C. Moore.

The highest conservation priority at The Elms was determined to be the conservation treatment of a group of black and gold Asian lacquer panels located in the French Regency-style Breakfast Room, which has other Chinoiserie elements as well (Figure 2). There are three large panels and three overdoors that were substantially fabricated in China for export to Europe in the eighteenth century. The large antique panels are approximately 207 cm wide and 300 cm high. Each of them was initially three separate panels - perhaps individual leaves from a folding screen - subsequently glued together. The large panels are in pairs with commemorative or domestic central designs surrounded by cartouches featuring typical landscapes, springtime motifs, and guardian lions. The overdoor panels are 165 cm wide and 115 cm high. They are decorated more generically with rocks, plants, and birds. These have a composite decoration: Asian lacquer fragments are integrated using European methods.

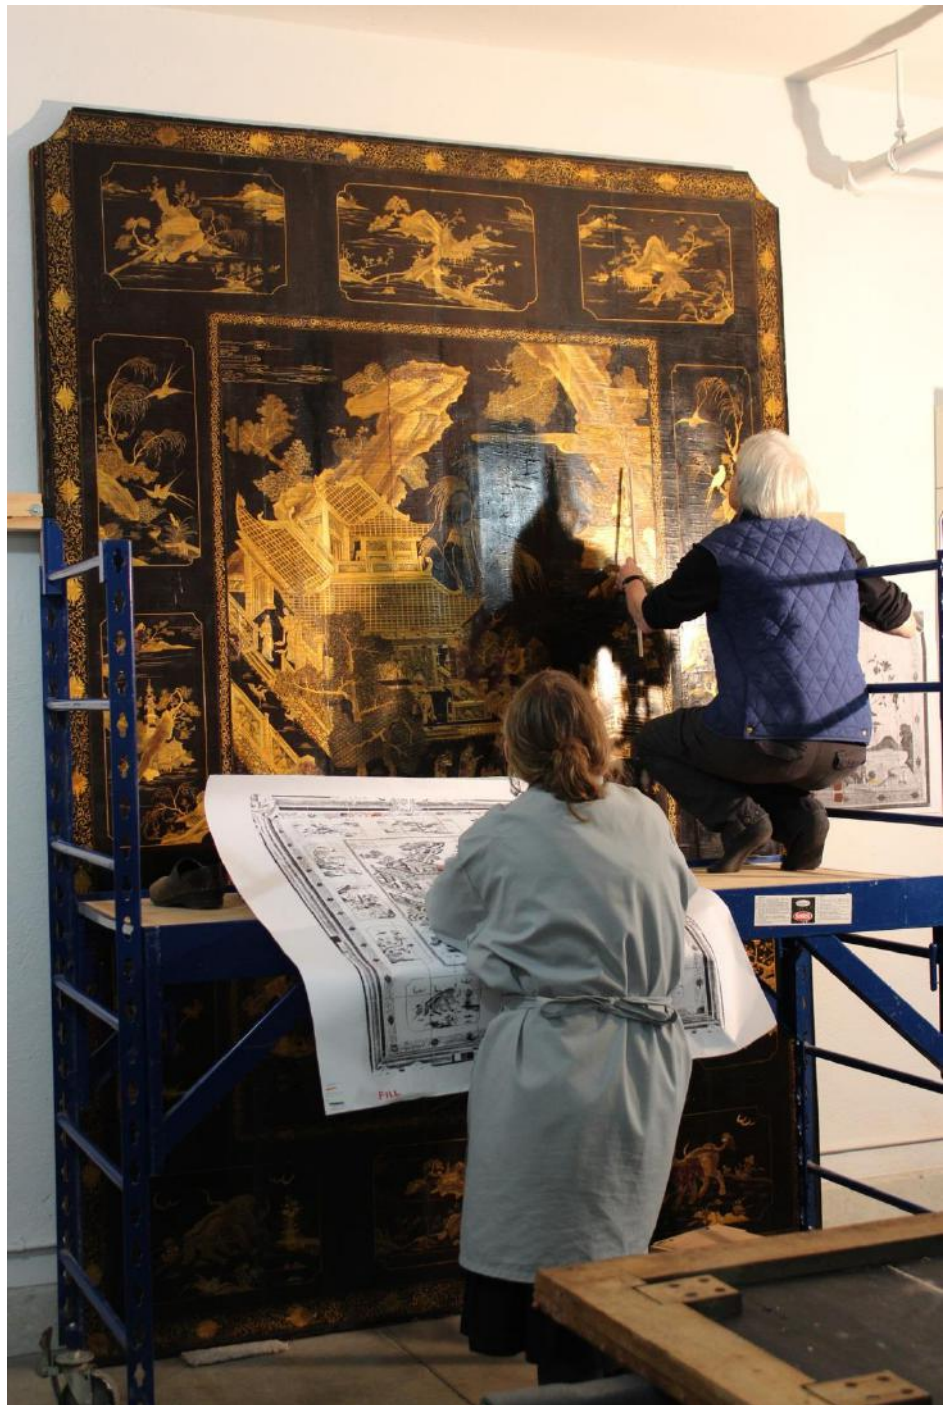
Fig. 4. M. Carr and A. Schopfer documenting one of the Chinese panels. ©C. Moore

During the planning a variety of methods were used to assess condition, structure, materials, craft techniques, and history of treatment (Figure 4). These included using visible and ultraviolet light inspection to assess surface topography and treatment history [6]; cross-sectional microscopy to document craft technique and identify original and repair materials through their layer characteristics (Figure 5) [7]; x-radiography to reveal joinery details and structure [8]; scanning electron microscopy/energy-dispersive spectroscopy (SEM-EDS) to identify three campaigns of gilding [9]; Fourier infra-red transform spectroscopy (FTIR) to identify Western varnishes [10]; pyrolysis gas chromatography-mass spectrometry (PY-GC/MS) to identify the particular kinds of Asian lacquer and associated materials [11]; and x-ray fluorescence (XRF) for pigment identification [12]. Cross-section microscopy continues to be important for documenting historic repair techniques as well as revealing the effectiveness of varnish removal; samples removed after treatment can be used to access how precisely layers are removed.

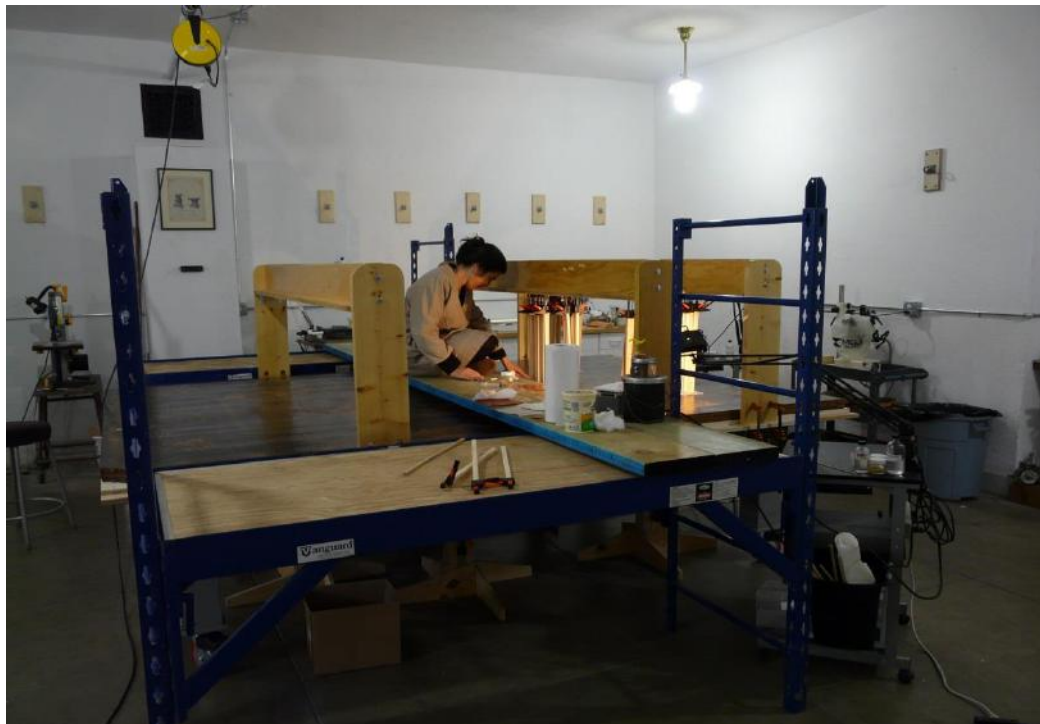
Fig. 6. M.J. Petisca at work on the middle of a panel on the clamping table. ©C. Moore

The panels were placed on a purpose built clamping table upon arrival in the workspace. Lifting lacquer was reattached: being quite stiff and brittle, the lacquer needed to be humidified and gently heated to make it flexible before attempting to reattach it. The lifting lacquer was then set down using hide glue [14]. This particular glue was selected for its setting time, workability, and solids content. Used warm, it also helped soften the brittle lacquer. Thinner flakes of decorative material were reattached with an acrylic dispersion [15].

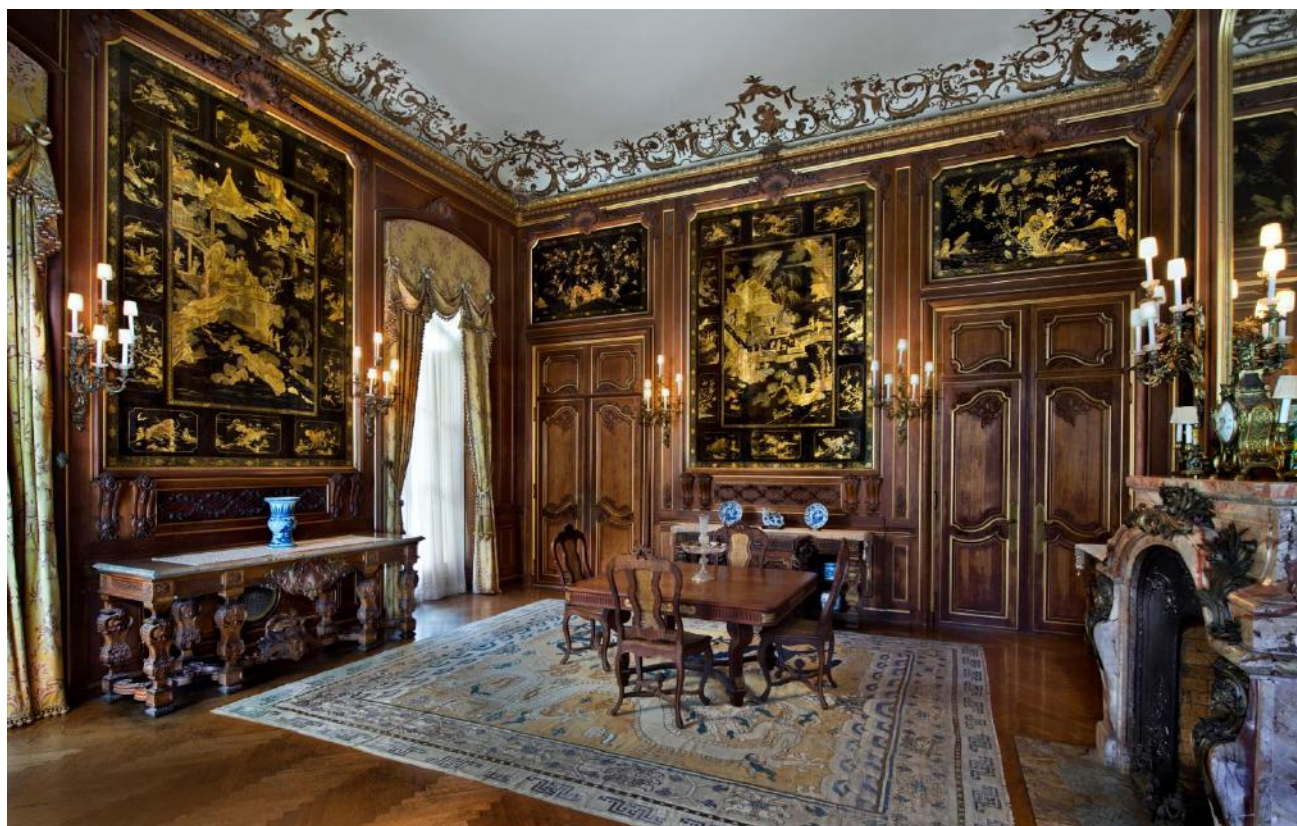
Fig. 8. *The Breakfast Room after treatment.* ©G. Ashworth.

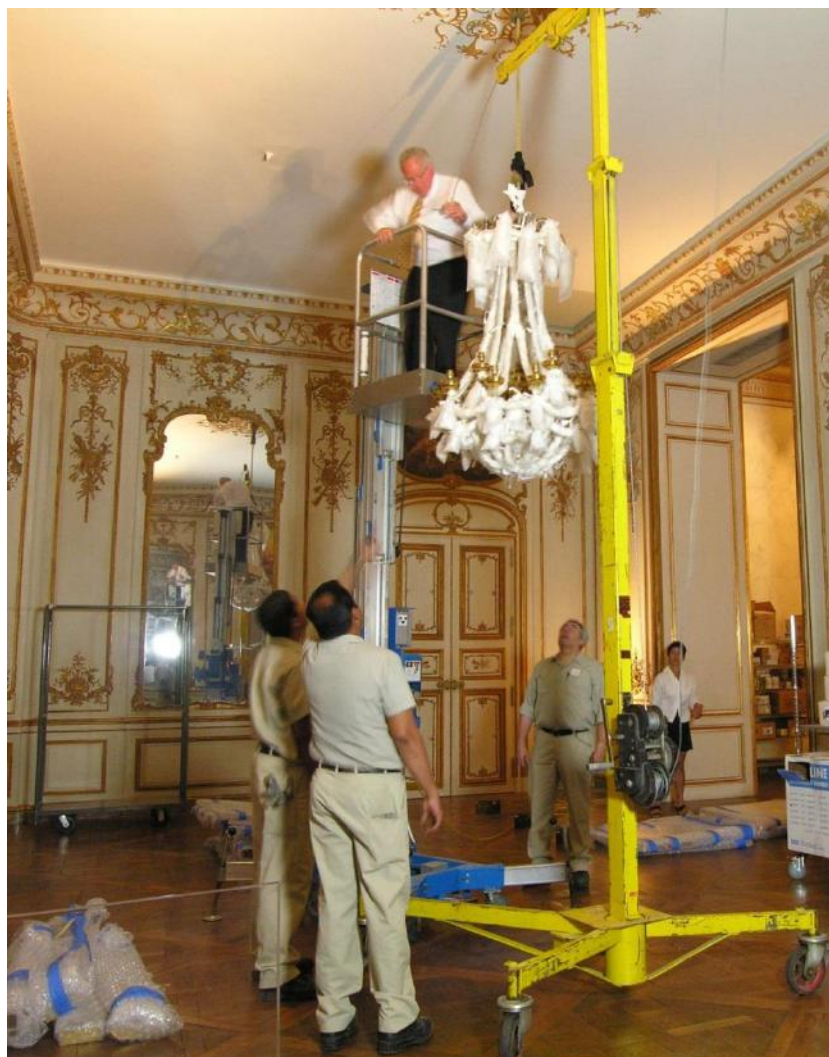
Fig. 2. Deinstallation of fifteen-light Bohemian leaded glass chandelier from the Varengeville Room. The Metropolitan Museum of Art, Gift of Mr. and Mrs. Charles Wrightsman, 1971 (1971.206.42) Photograph by authors.
© The Metropolitan Museum of Art

Since most of the chandeliers were positioned above carpets and furniture, they were the last objects removed from the rooms and the first to be reinstalled. In addition, all the lighting fixtures had to be conserved before any rewiring could begin. These time constraints necessitated a tight project schedule. After in situ assessment of the condition of the chandeliers, a decision was made to avoid the typical practice of removing pendants and dismantling ormolu frames for treatment. This conservative approach minimised handling of the objects and significantly reduced time and workspace requirements.
