THE ARTIFACT, ITS CONTEXT AND THEIR NARRATIVE: MULTIDISCIPLINARY CONSERVATION IN HISTORIC HOUSE MUSEUMS

A Joint Conference of ICOM-DEMIST and three ICOM-CC Working Groups:
*Sculpture, Polychromy, & Architectural Decoration; Wood, Furniture, & Lacquer; and
Textiles*

The Getty Research Institute, Los Angeles, November 6-9, 2012

Historical and Current Perspectives on the Care, Presentation, Interpretation and Use of Collections in Historic Houses

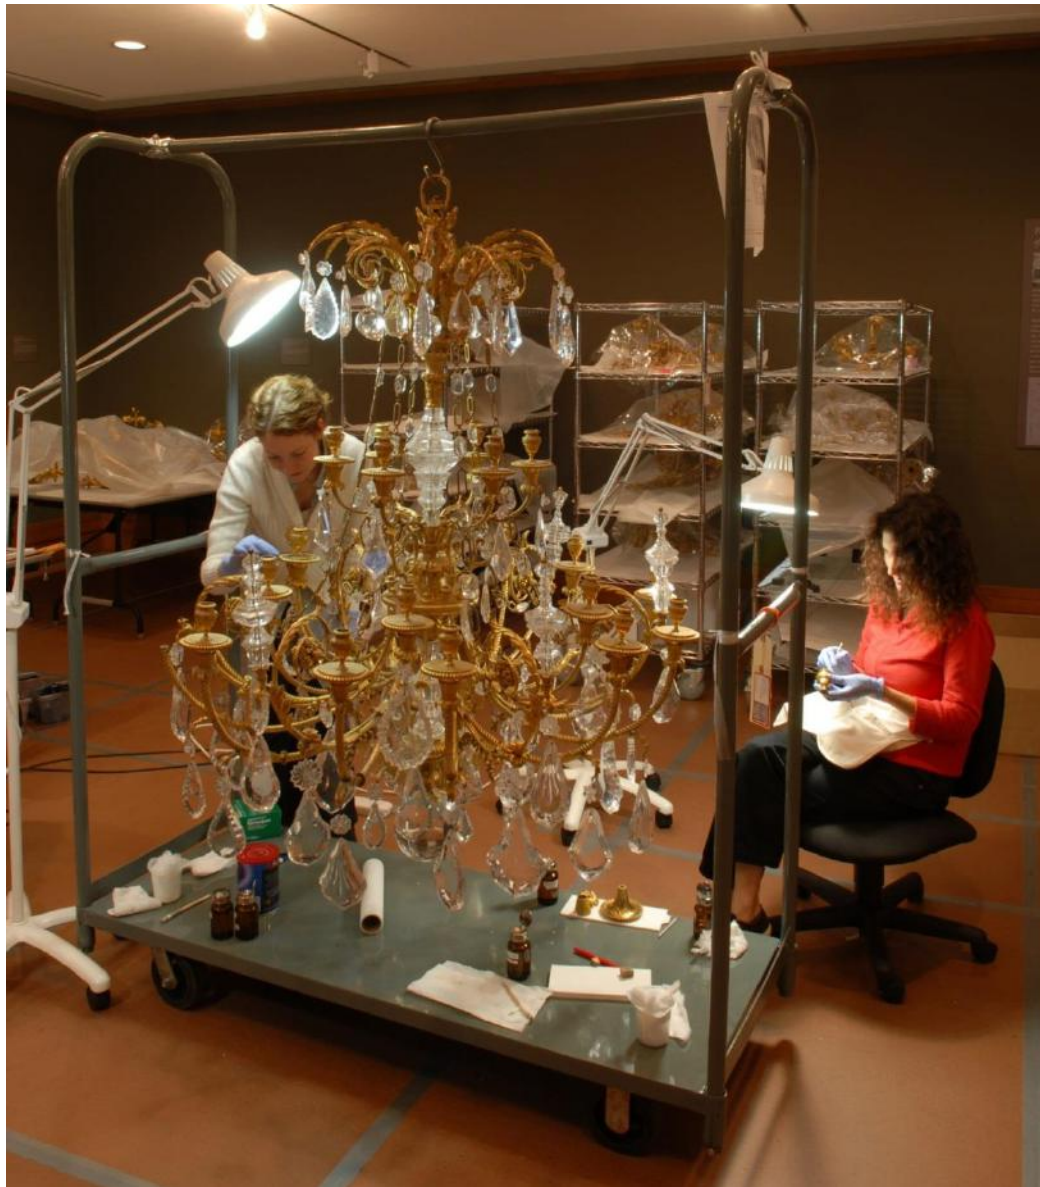
Fig. 3. Conservators treating one of a pair of twenty-four-light rock crystal chandeliers from the Louis XVI Gallery. The Metropolitan Museum of Art, Gift of Mr. and Mrs. Charles Wrightsman, 1971 (1971.206.41) Photograph by authors. © The Metropolitan Museum of Art

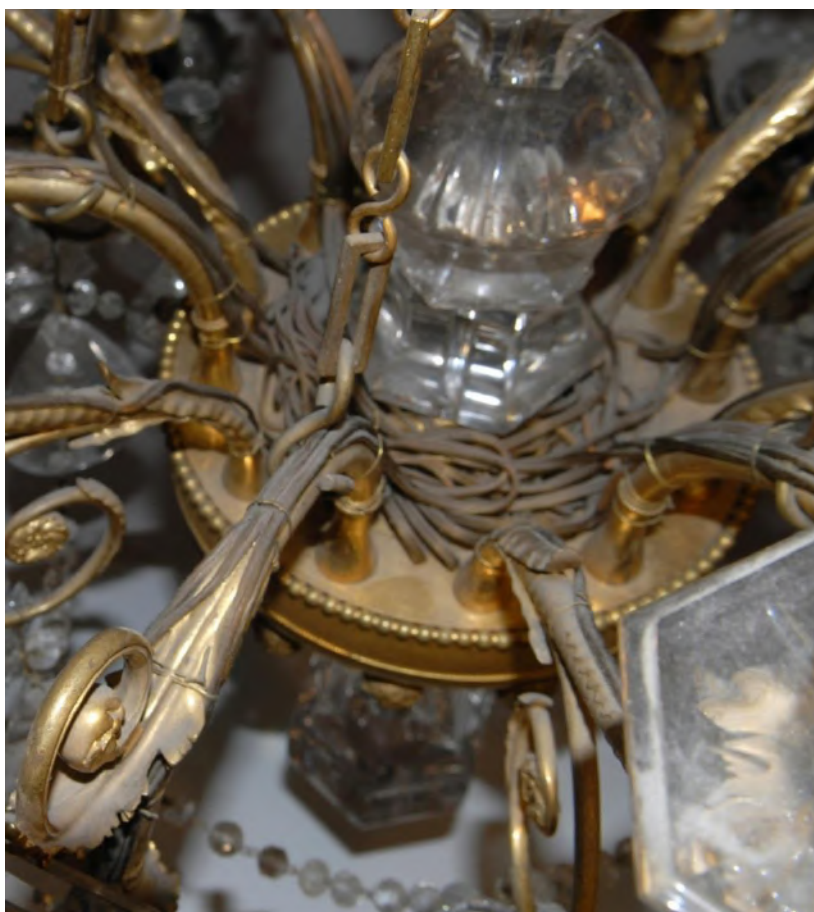
Fig. 4. Before treatment of the Lauzun Room chandelier. Detail of the arm receiving plate showing old electrical wiring. The Metropolitan Museum of Art, Gift of Mr. and Mrs. Charles Wrightsman, 1971 (1971.206.43) Photograph by the authors.

losses and scattered structural problems; however most of the condition issues were a result of previous alterations, such as the addition of electrical wiring or restorations that were either failing or aesthetically distracting. A number of links on suspension chains had been damaged, lost or replaced with incorrectly shaped links, which had altered the length of the chains, resulting in increased stresses and uneven suspension of some of the chandeliers. Surface details of some areas of ormolu were obscured by lead solder repairs or by sheet metal reinforcements riveted across breaks. Modern nails had been used to replace missing screws, tangles of copper wire held the base finials on two of the chandeliers and cardboard washers were visible in gaps between crystal candle cups and drip pans.

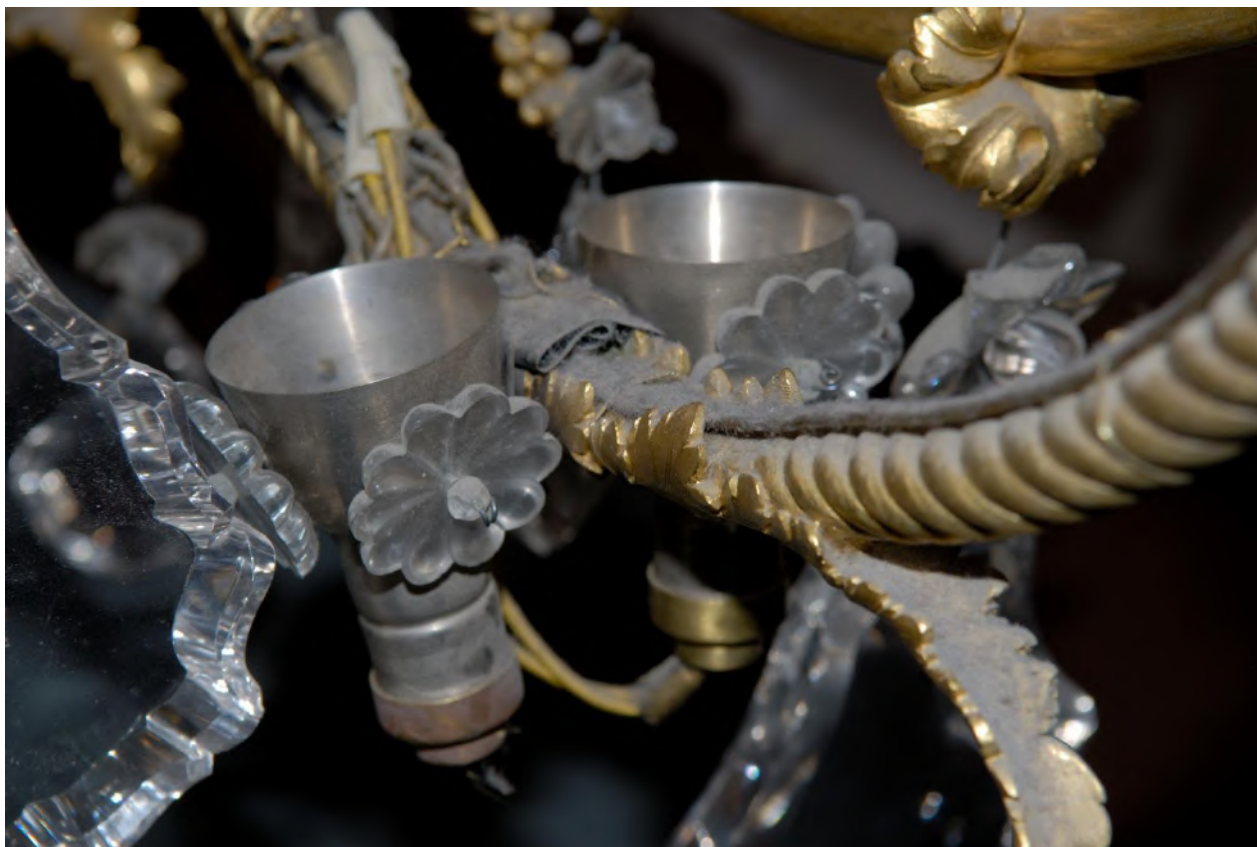
*Fig. 5. Detail of modern auxiliary lights with applied rosettes on a Louis XVI Gallery chandelier. The Metropolitan Museum of Art, Gift of Mr. and Mrs. Charles Wrightsman, 1971 (1971.206.41) Photograph by the authors.
© The Metropolitan Museum of Art*

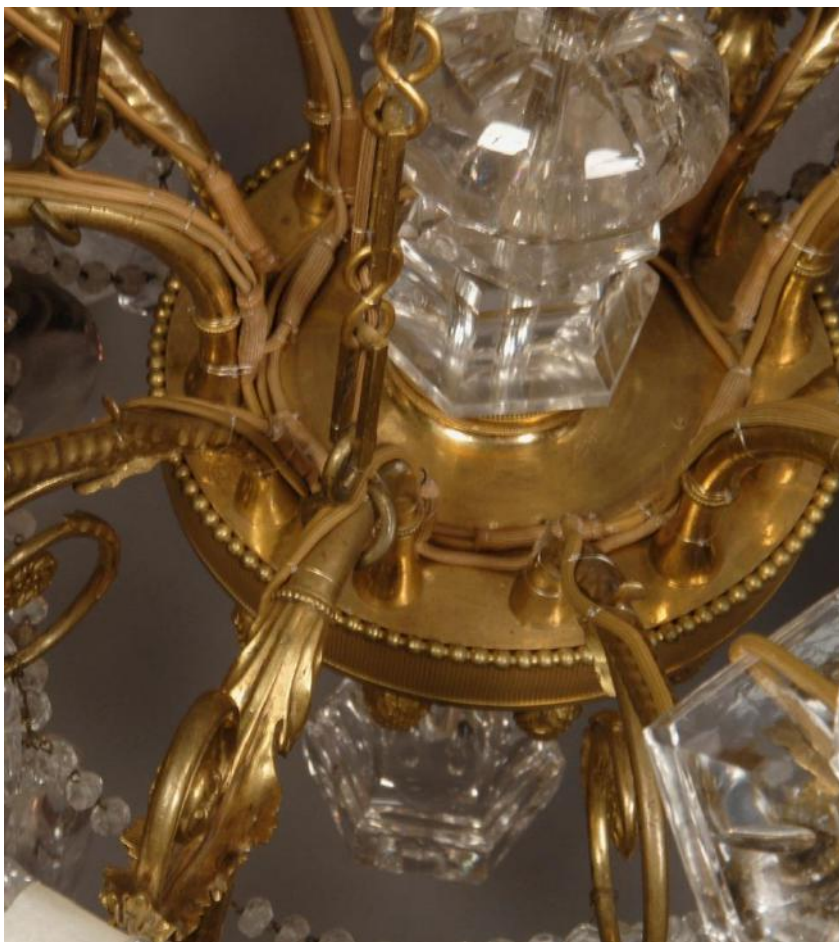
*Fig. 6. After treatment of the Lauzun Room chandelier. Detail of the arm receiving plate showing new electrical wiring. The Metropolitan Museum of Art, Gift of Mr. and Mrs. Charles Wrightsman, 1971 (1971.206.43) Photograph by the authors.
© The Metropolitan Museum of Art*

Curators and conservators consulted with the lighting restoration firm on the selection of new electrical wires. To avoid the problem of sticky degraded plastic-coated wiring, braided fibreglass sleeves were used to protect the new thinner polytetrafluoroethylene insulated wires (Figure 6). The sleeved wiring was flexible and could be easily toned with acrylic paints to match

varying shades of ormolu, crystal and patinated bronze on which the wires would rest. The old brass wire ties were replaced by less abrasive nylon monofilament. Conservators worked closely with the lighting restoration firm to ensure that the wires fit snugly yet safely along every curve in order to preserve the profiles of the objects. Great care was taken to place electrical wires in the least visible location on the fixtures, taking into account the sightlines of the visitors in the new galleries.

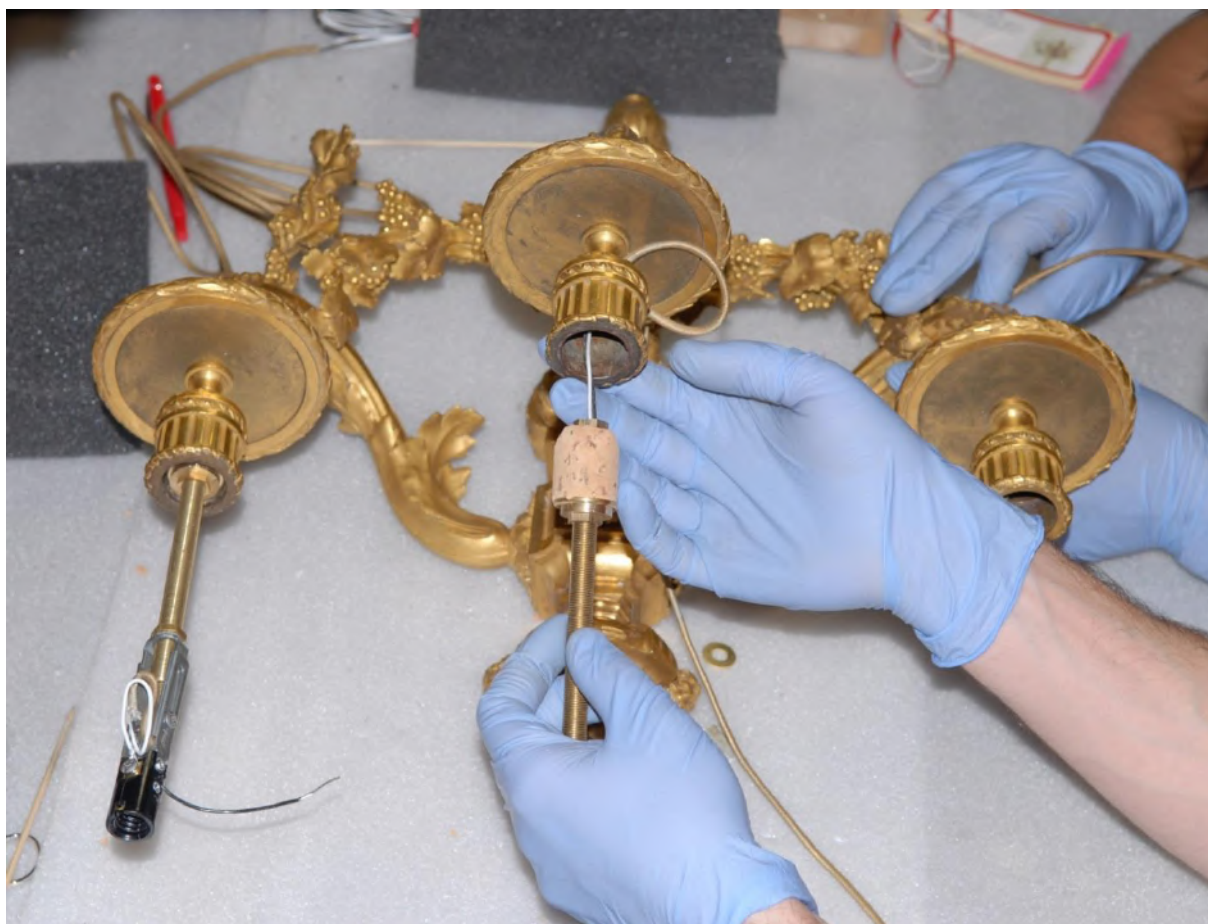
Fig. 7. Installation of electrical hardware and wiring on a three-light sconce. The Metropolitan Museum of Art, Gift of Mr. and Mrs. Charles Wrightsman, 1979 (1979.172.3) Photograph by the authors.
© The Metropolitan Museum of Art

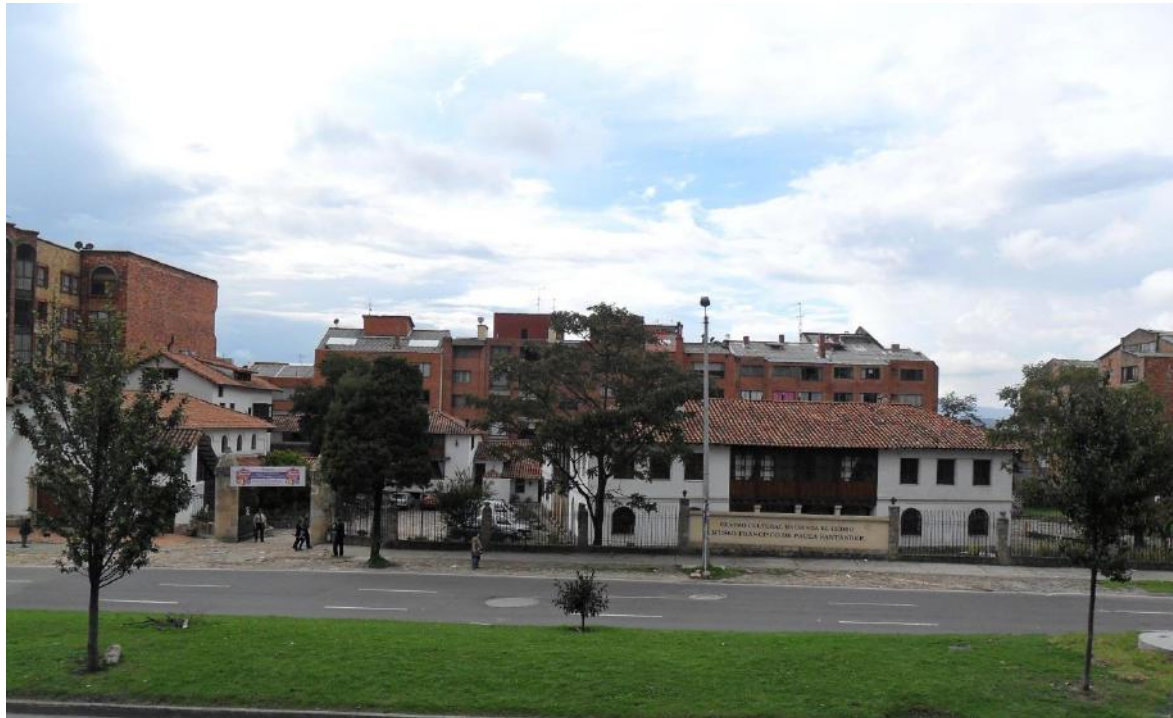
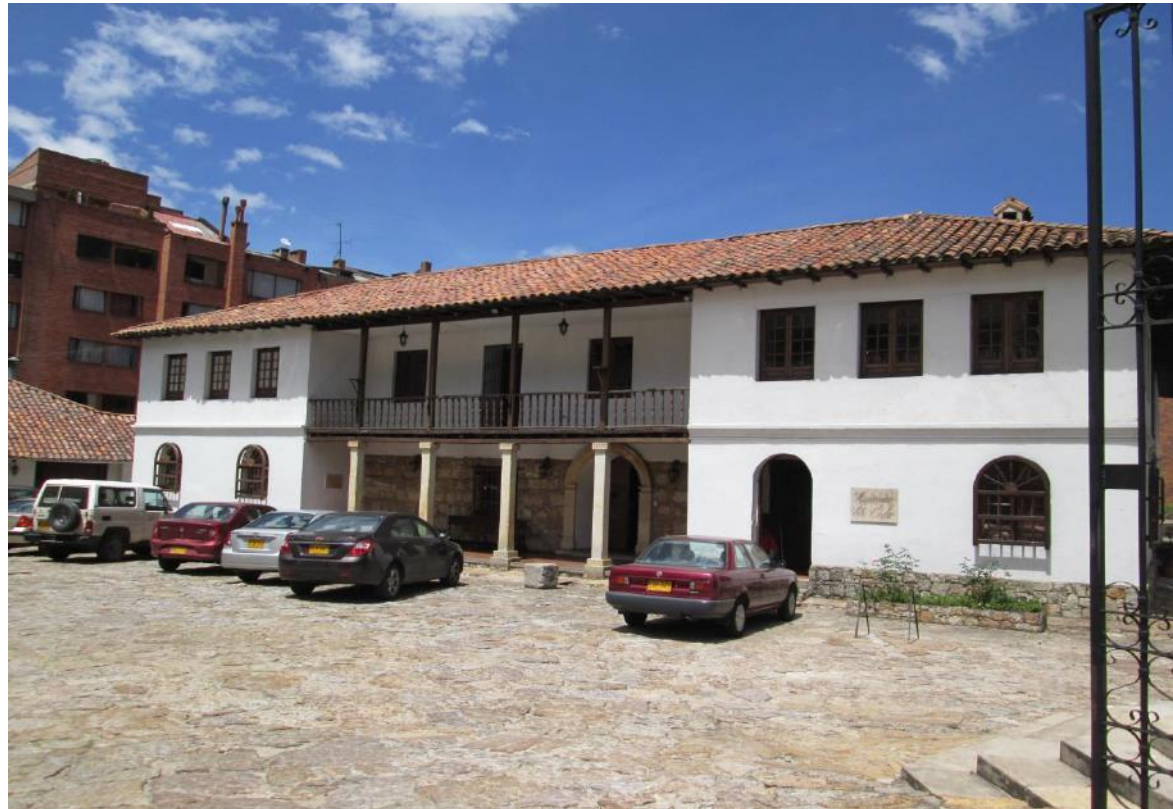
The house museum is located in the northeast of Bogota. Built in 1620, it was originally a country house (Figure 2). Currently, the house preserves its spatial conception and its architectural style with four facades, open balconies, stone pillars on the first floor, wood pillars on the second floor and thick walls in masonry built with a mixture of lime, sand bricks and stone. The roof is clad with terracotta tiles.

Fig. 2a and 2b. Facade of the house.

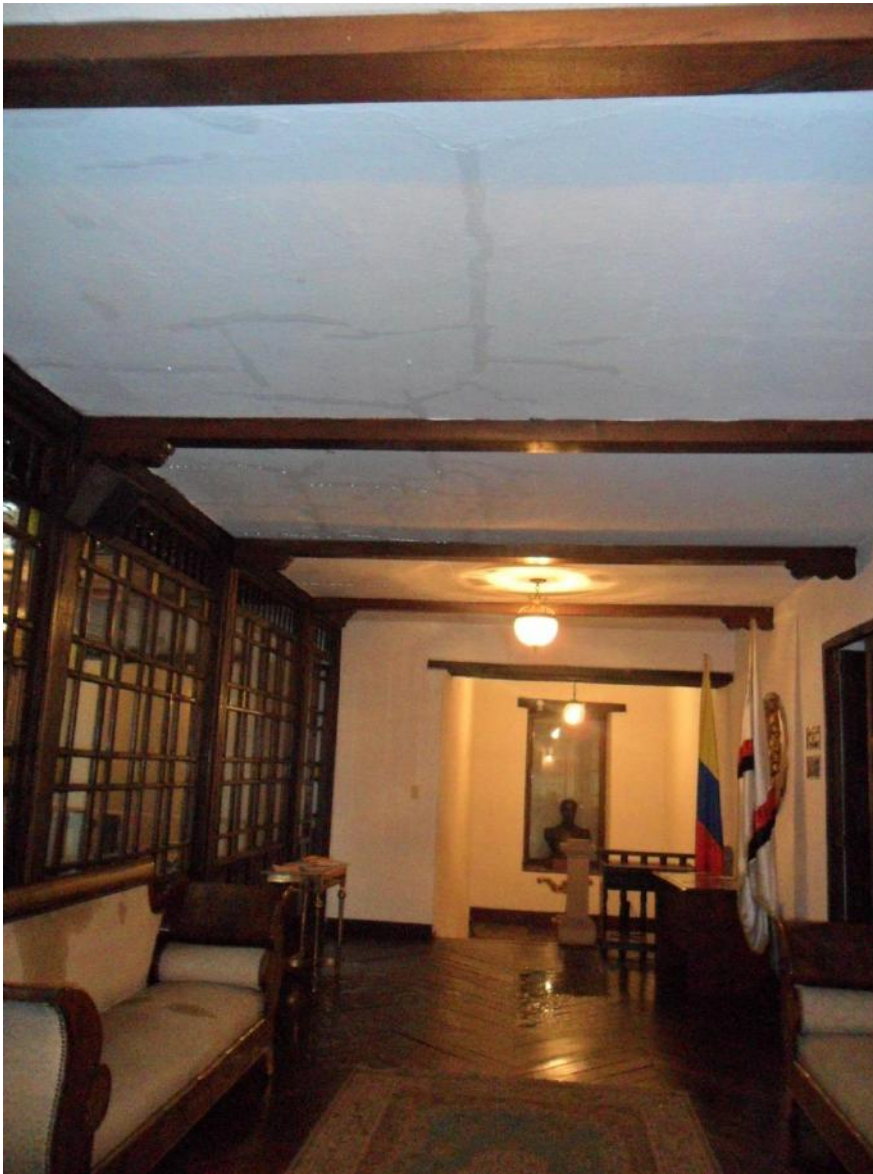
Fig. 5. Room 8. The Hall.

The building edifice requires repair, especially to the roof. Neglect and decay have resulted in leaks that affect the collection in three internal rooms, so-called *Hall*, *Habitacion de descanso del general* and *Biblioteca*. In the *Hall*, water drips directly over a piece of furniture of Imperial style, a table and the carpets. In the *Habitacion de descanso del general* water runs over the rails of Santander's bed and continues onto the floor. In the *Biblioteca*, water runs over an old light bulb socket and lands over a table.

To resolve the problem of water ingress to the edifice, it was recommended to secure leaks in the roof thus eliminating further damage due to water running over objects. Ceilings and covers were also inspected. It was recommended that biological deterioration caused by fungal growth could be prevented by first determining the type of fungus affecting the collection and then taking measures to prevent its growth. It is also important to implement a regular cleaning schedule for the collection, as well as a continuous observation in order to note further deterioration. Finally, for the third problem, actions to mitigate natural illumination are suggested, in particular installing protective layers, such as curtains or blinds, in front of the windows that reduce the levels of sunlight entering the building. It has been determined that the problems described adversely affect the collection, in particular those artifacts of organic nature, which are the most valued because these consist of the everyday objects of Santander, his wife and his daughters. It was established that the analyses of relative humidity and temperature were useful and

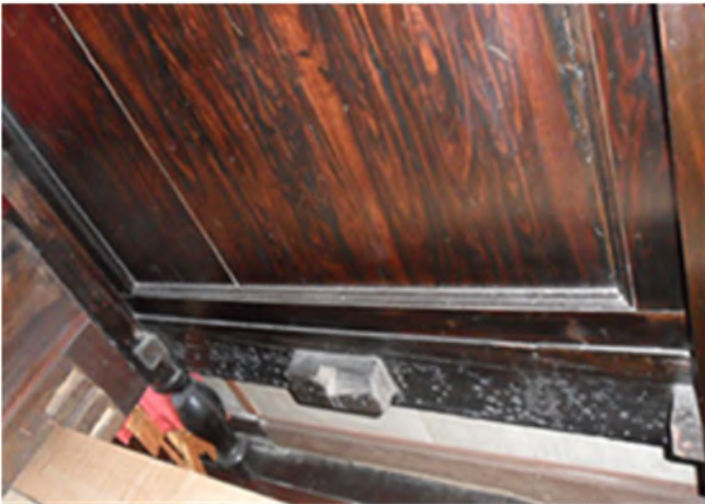
Fig. 6. Bed of Francisco de Paula Santander from room 2- Habitation de Descanso del General

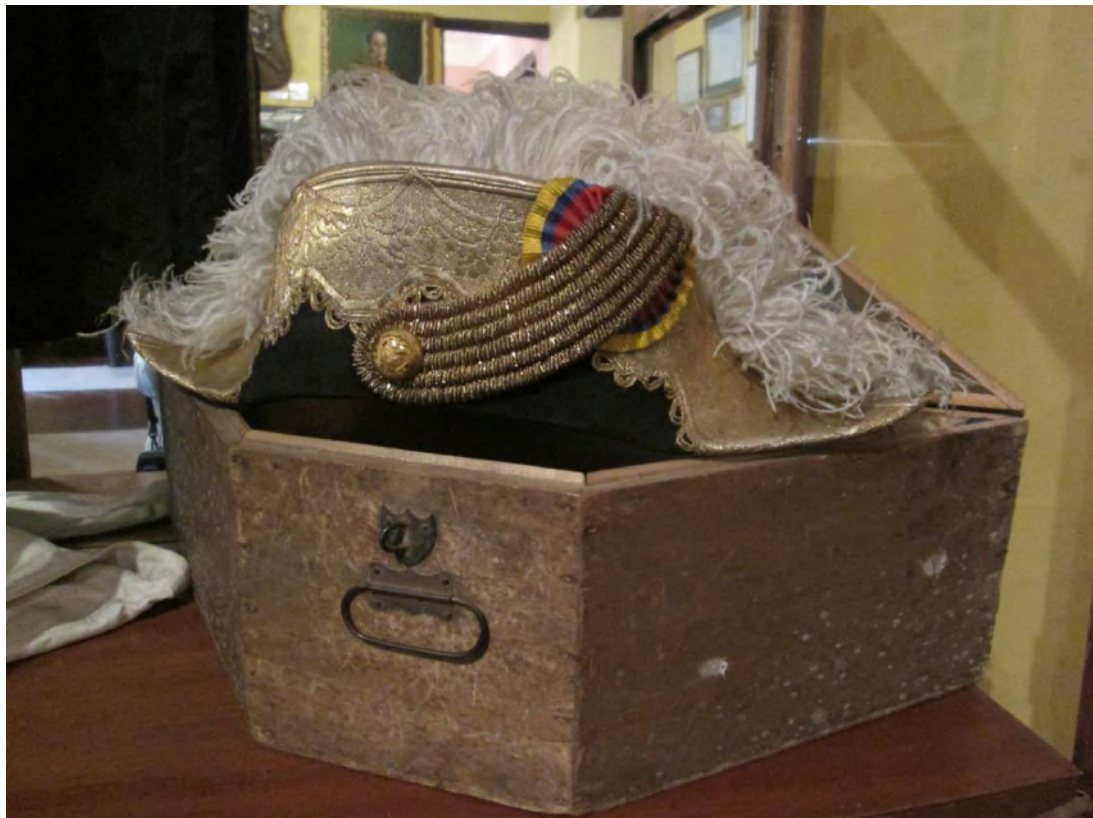
Fig. 7. Box with hats of military uniforms, suffering from biological infestation by a white fungus. Room 4: Batallas.

between 18.2 and 15.2 degrees Celsius, while the room *Batallas* presented a variation of RH between 63.1% and 59.3% and a T variation between 17.8 and 16 degrees Celsius. As a result, objects consisting of organic materials are being affected by a white-coloured fungus. In the first room, the fungus is present in a box containing hair samples of Santander's wife, on fans, in a photo album, in books and on Santander's bed. In the second room, the fungus affects uniforms and hats and the display case where they are located. On top of this display case there is a high concentration of particulate material and more fungus. According to analysis carried out by the author, the fungus is using the highly concentrated particulate matter as a feeding ground,

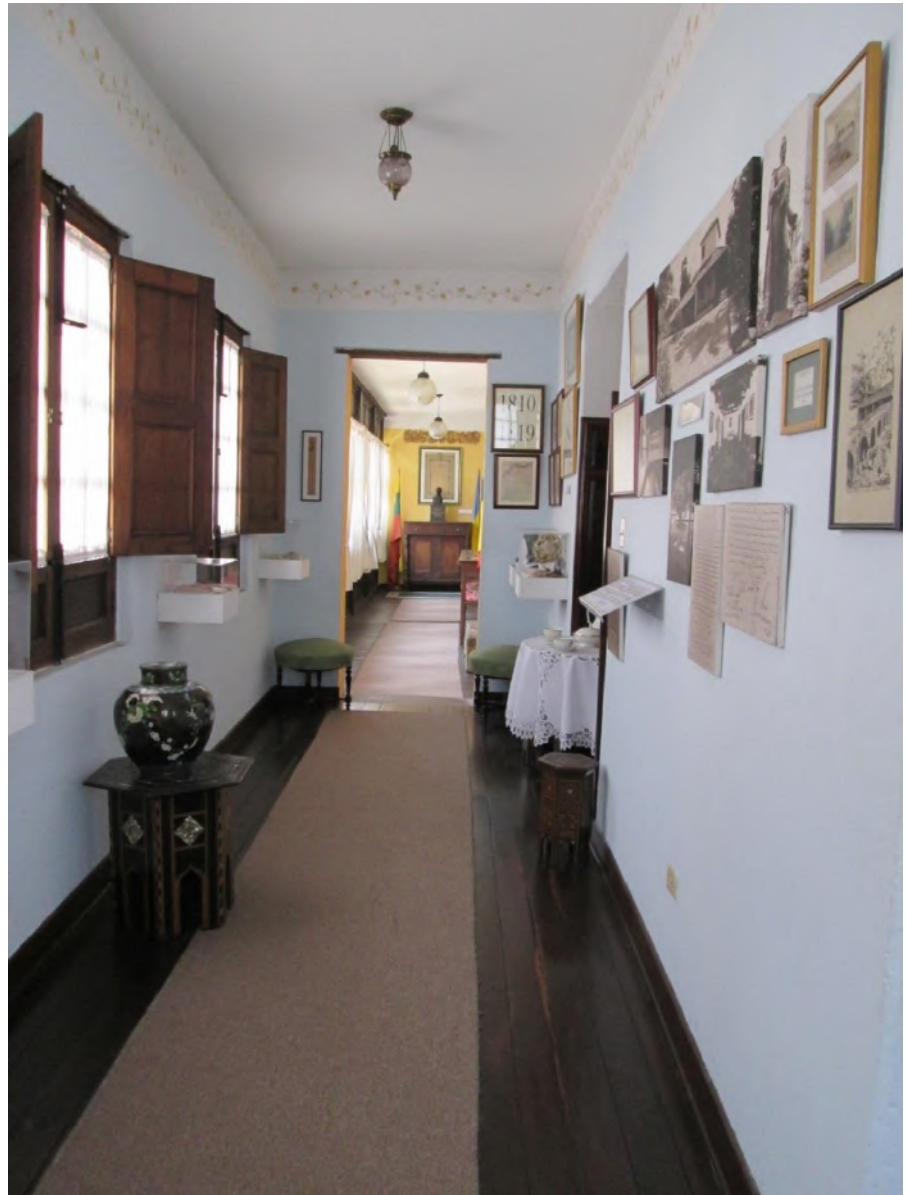
Fig. 8. Sunlight directly hitting objects of organic nature. Gallery 3: Villa del Rosario.

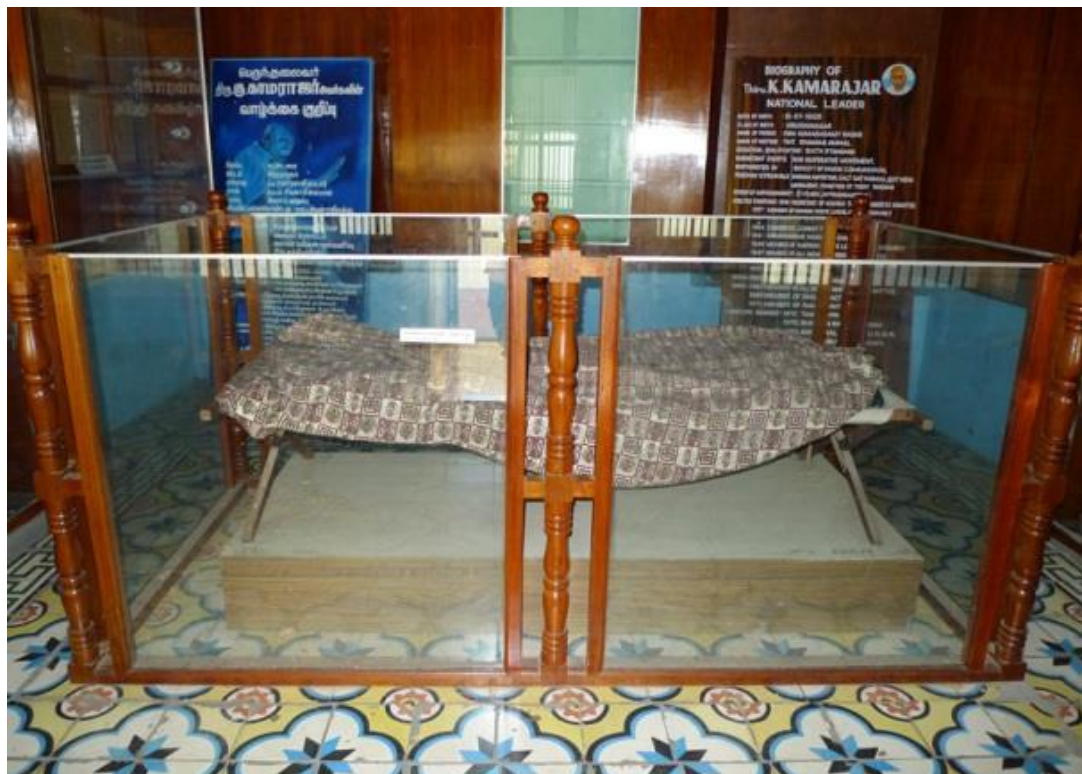
Fig. 4. Painted floor and Kamaraj's bed

The building which occupies the whole L-shaped site (approximately 80 m² or 860 feet² in area) is modest in size (Figure 3). The kitchen (which is not on display) is only c. 8m² (80 feet²) and the largest room about 5 x 6 metres (322 feet²). The ground floor consists of the main hall (lounge room/primary living space) and two small rooms to the rear. The mostly original main hall is typical of the period and is distinguished by timber (probably teak from Burma/Myanmar) detailing and includes four tapering columns with simple carved stone bases, elaborate brackets and beams with sunflowers carved to the underside. The first floor, where there is an open terrace, a much-altered anteroom and Kamaraj's bedroom, is reached by a later concrete stair- steep, but not as steep as the earlier/traditional timber stair. Kamaraj's bedroom retains a marvellous painted concrete floor imitating tiles (Figure 4), another characteristic of southern Indian houses of the late nineteenth century

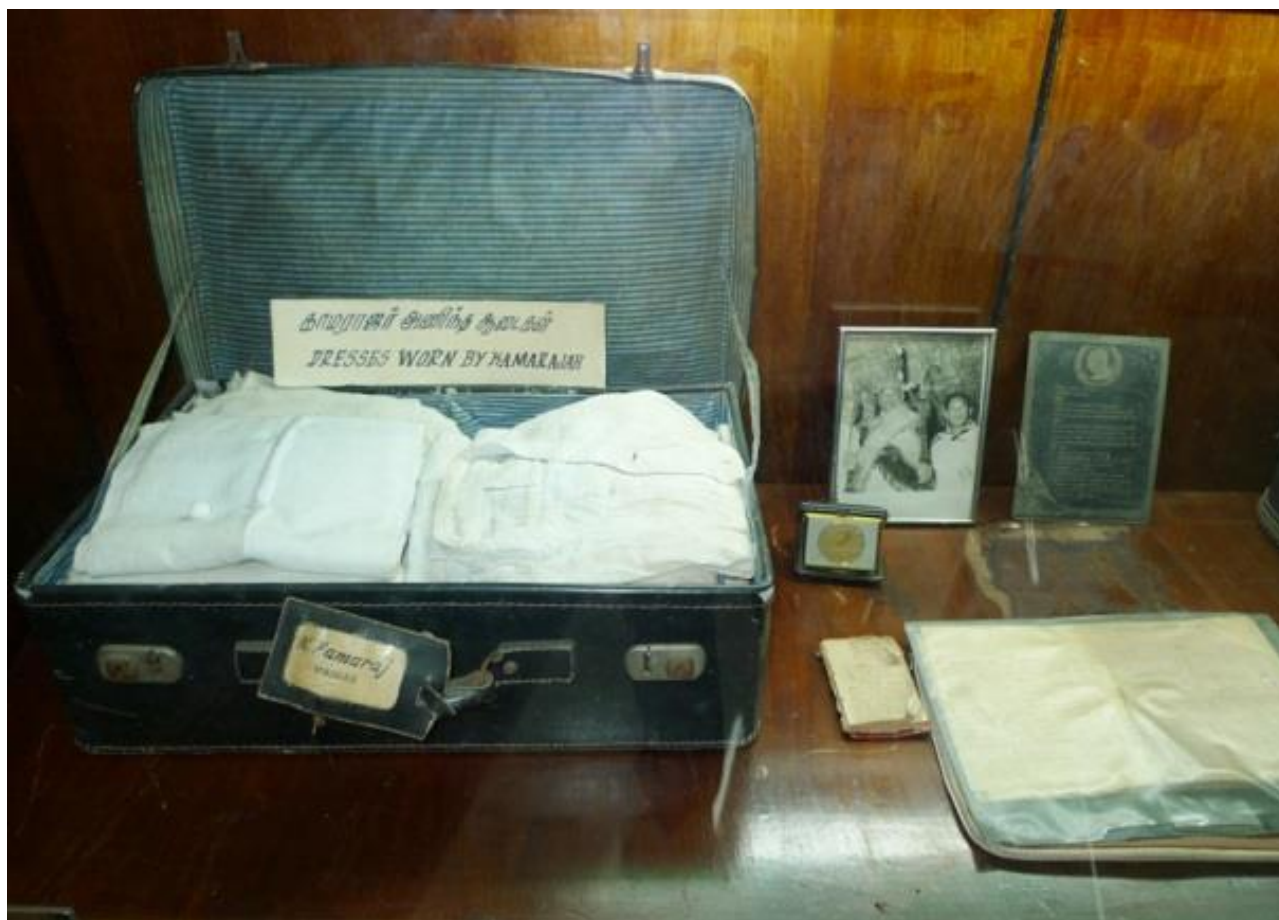
Fig. 7. Display cabinet.

The collection of the Kamarajar Memorial House in Virudhunagar consists mainly of large scale reproductions of black and white photographs, predominantly relating to Kamaraj's time as Chief Minister (1954-63) and subsequent political career, with only a few images dating to the earlier life when he was based in Virudhunagar. Cabinets are located in four rooms containing items dating to the latter years. These display ceremonial objects such as gifts from foreign dignitaries, scissors (for cutting ribbons), trowels, and the like. There are a few personal items, including simple kitchen implements, reflecting Kamaraj's austere lifestyle, travelling items, including a suitcase and some toiletries, and some clothing (Figure 7).

Like typical houses in this tropical climate, there are timber shutters but there is no glass to the windows and internal climate control is limited to basic ceiling fans, only operated when visitors are present and when electric power is available (which is intermittent). The ground floor remains relatively protected from the impact of the hot sun because of the narrow streets. Objects are displayed in contemporary timber and glass cabinets protected from dust but it is unclear what other pest control procedures are in place. The collection is not extensive and there are only a few fragile objects, such as pages from manuscripts and cloth, including traditional clothing worn by Kamaraj, and his mattress – all of which are showing signs of decay.

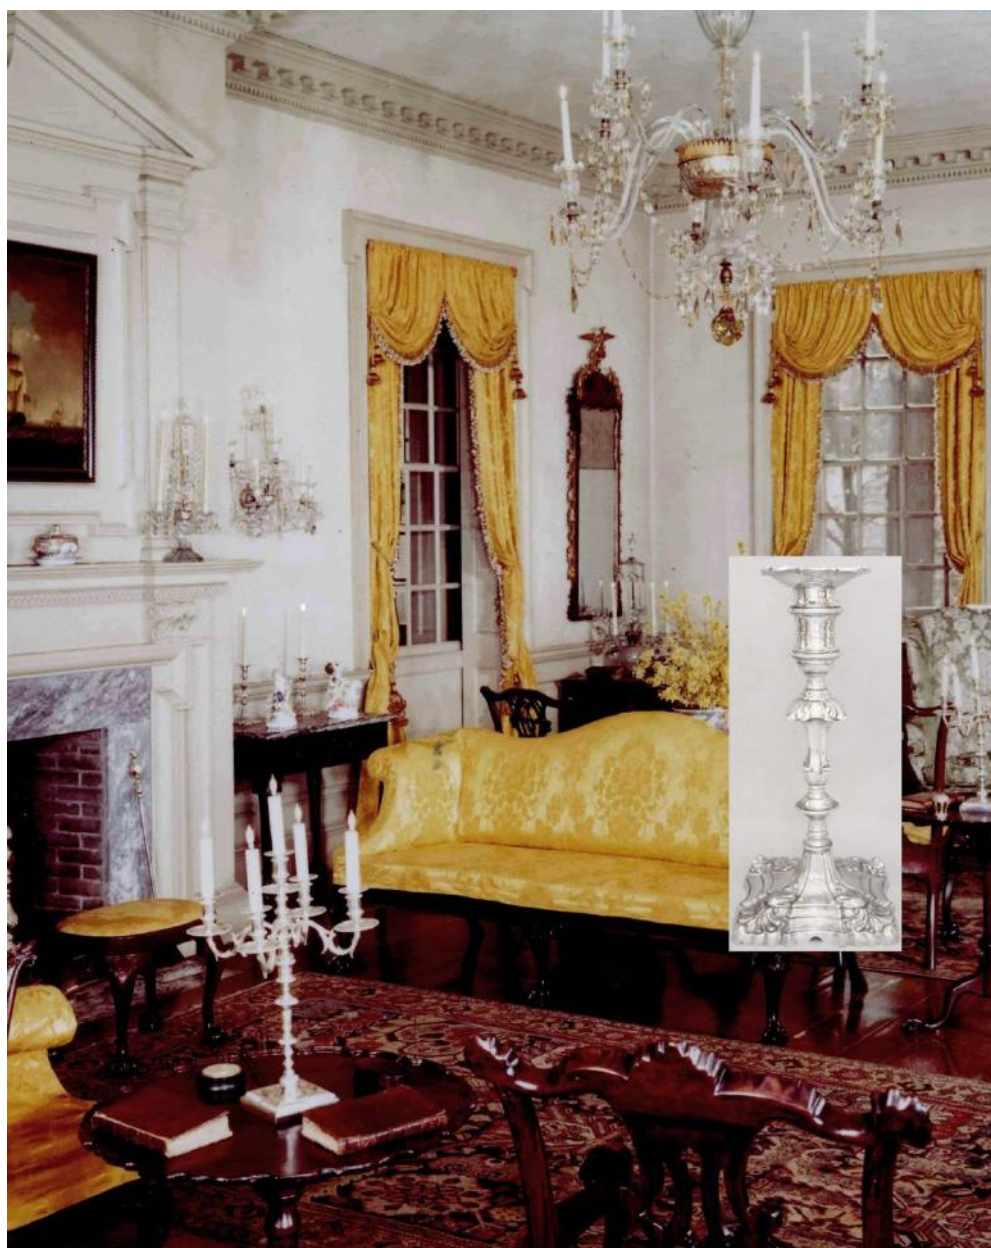
Fig. 3. Port Royal parlor with de-electrified candle in insert.

provided atmospheric electric illumination in du Pont's Port Royal Parlor and were part of the Frozen Room collection, were stripped of their wires and plastic candles in 1998 and restored to an approximation of their eighteenth century condition (Figure 3).

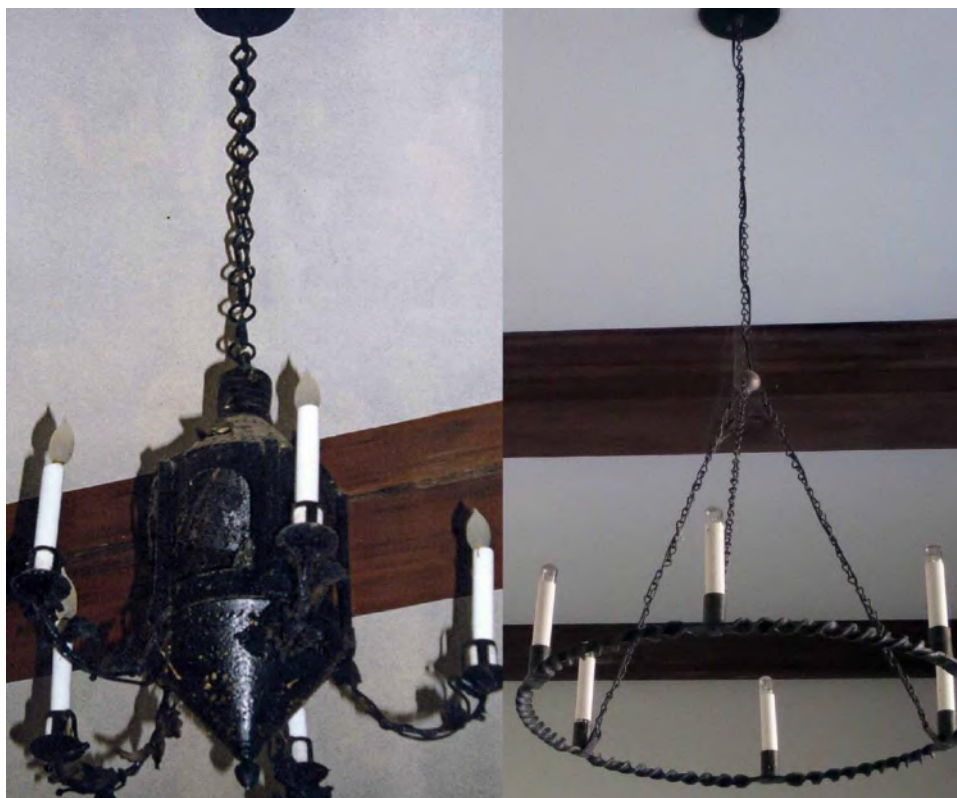
Fig. 5. Bath house lanterns. Left: one of the pair of original 1930s lantern. Right: one of the pair of 2005 replacements.

judged to be in poor condition, lacking in significance and replacements were ordered. As intended, the replacements - custom-made reproductions of a pair of nineteenth - century lanterns from one of the museum rooms - had no connection to the originals in design, date or scale. In 2005, the new garden director Chris Strand rescued one of the lanterns from the trash and stored it. The other is lost. This painful chain of events galvanized the institution into taking its twentieth century garden ornament more seriously. In 2006, the position of estate historian was created and in 2010 the responsibilities of curator of garden objects was added.

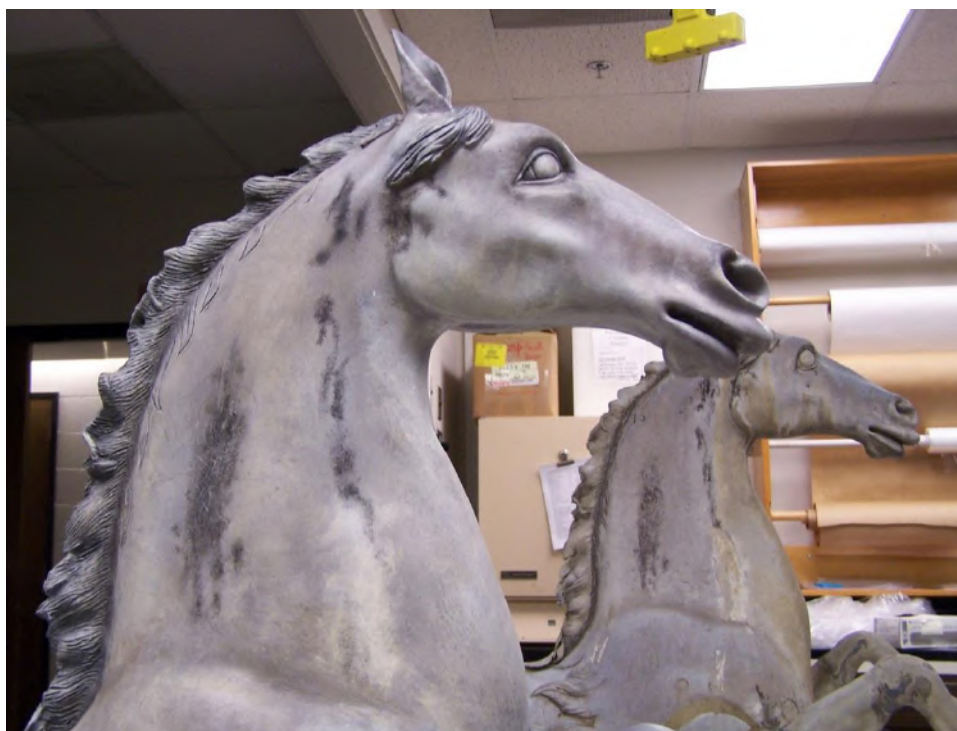
Fig. 6. Lead hippocampus (back) and its reproduction in polyester resin (front).

Purchased at auction in 1928, this sculpture was bought as English, late seventeenth century (Figure 6). A year before the garden was complete, Coffin installed it at the pool for a focal point as she completed her design (Figure 7). Over the years it has suffered significantly from the elements, handling by visitors and gnawing squirrels. In 2005, garden staff, curators and conservators, determined that it was no longer aesthetically or structurally fit for display in the reflecting pool. A reproduction in polyester resin was crafted using imaging and modeling techniques to recreate the hippocampus so that the original could be stabilized and stored [4]. The reproduction was then painted to resemble the aged original. Although more expensive and time-

consuming than anticipated, the project is considered a success. Since 2007, the painted resin casting has been on view year-round and, with two hot-wax coating applied to protect the paint, has aged well. A similar approach has been taken with twelve other lead garden objects. Creating and installing custom reproductions has preserved the original object while providing the public with an understanding of the design intent. A few years later the opposite decision was made!

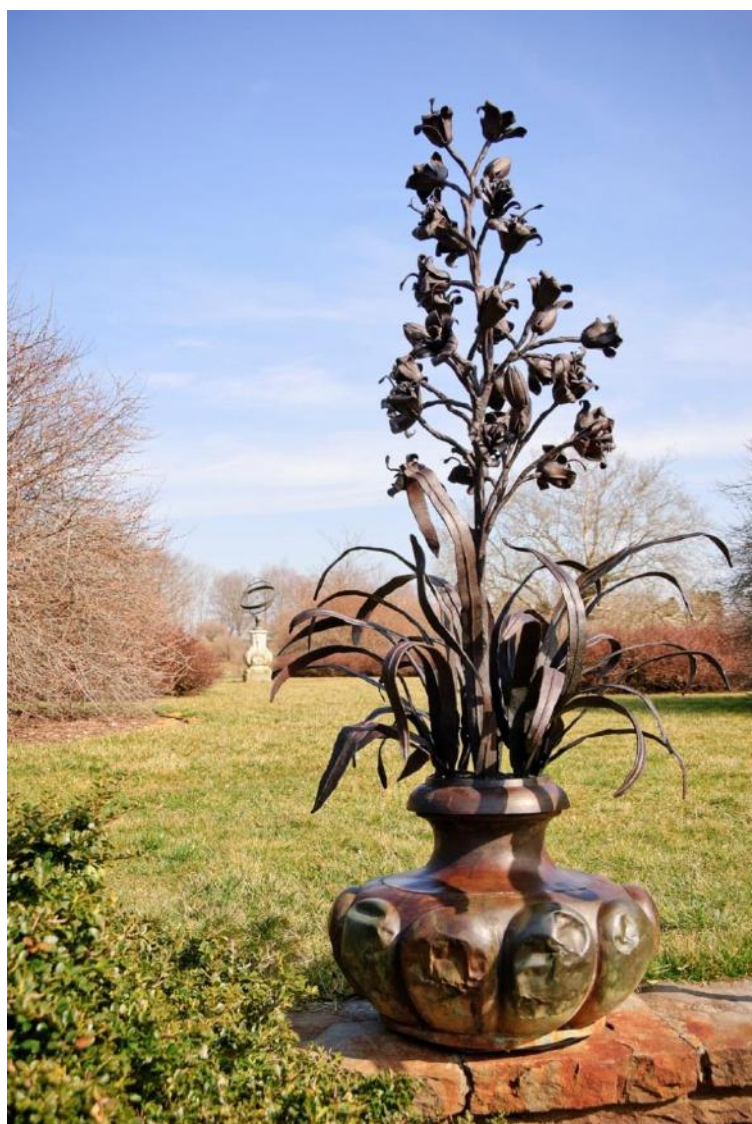
Fig. 8. One of the pair of iron lilies re-installed in their original setting after treatment.

In 1956, du Pont bought from a New Orleans antiques dealer an unusual pair of wrought-iron lilies set in a battered bronze, concrete-filled, Italianate vase (Figure 8). The lilies were placed immediately in the newly-created Sundial Garden. In 2001, they were removed because of safety concerns. In 2010, a donor pledged restoration money for the lilies. A \$30,000 estimate for the reproduction of the pair stalled the process as options were discussed. A resin reproduction was not expected to produce successful results. Commissioning an ironsmith to recreate individual flowers generated questions about artistic ownership, artistic license and objective evaluations of the end result. Ultimately, the decision was made to repair the original lilies for one-third of the reproduction price and return them to their original position in the garden. This choice included a long-term maintenance plan and permanent funding for a summer intern. The surface of the lilies will be hot-waxed each summer and covered in the winter.
